Service Bulletin

no. 14, 2008-04-08

Non-return valves for protection of air distributor

System applicability: Marinfloc CD units

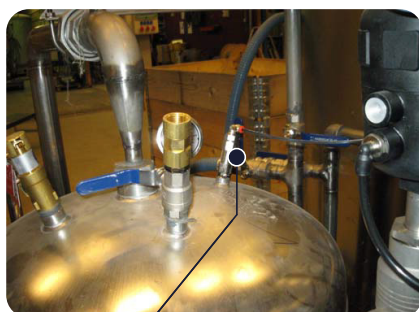
We have experienced damages to the air distributor in the electric cabinet caused by water penetration on some vessels. This has been caused by leakage of the non-return valve no. 137 on the circulation tank no. 52, see picture no. 1.

Picture 1.
Non-return valve ¼" (no. 137)
Article no. 16101

In order to avoid and correct this problem, Marinfloc recommends that the non-return valve is checked for leakage and replaced if necessary. Marinfloc also recommends that an extra non-return valve is added to the hose after the air adjustment valve no. 136 for extra safety, see picture no. 2.

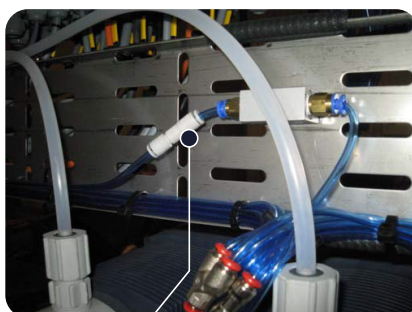
Picture 2.
Non-return valve 4 mm
Article no. 47206

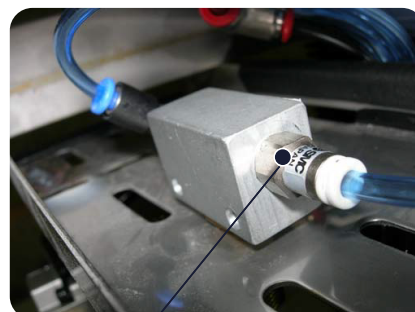
Picture 3.
Non-return valve 4 mm with thread
Article no. 47207

If your CD unit is not equipped with this 4 mm non-return valve for hose or with thread, see picture no. 3, Marinfloc AB will supply one free of charge ex. Works Varekil, Sweden
