## Cloud Hill Wind Farm

### Technical Appendix 13.1: Abnormal Load Route Assessment

Route Access Survey  
360700 Rev 0.1

Cloud Hill Wind Farm – Routes A & B

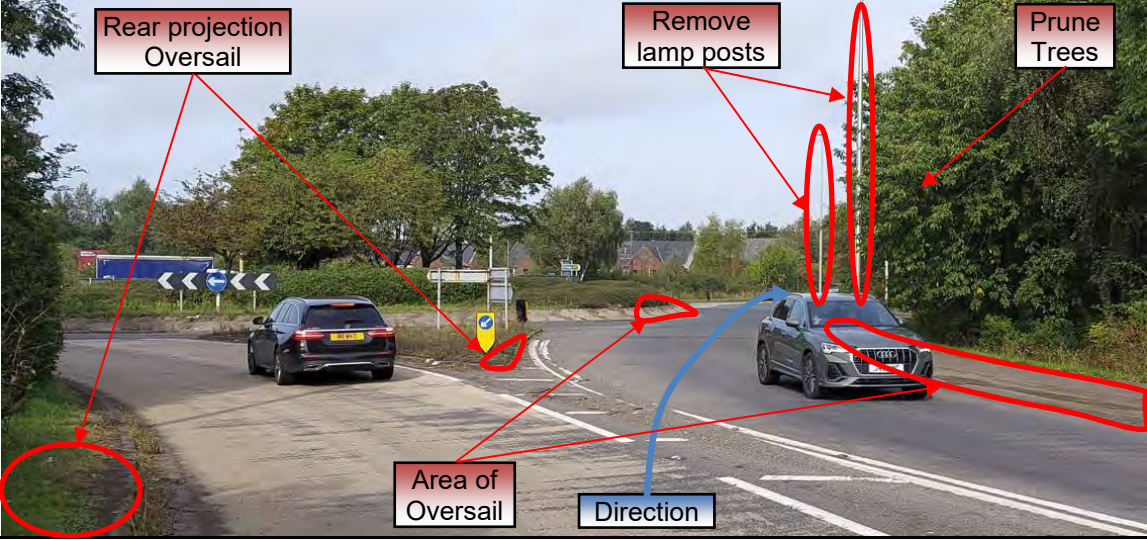
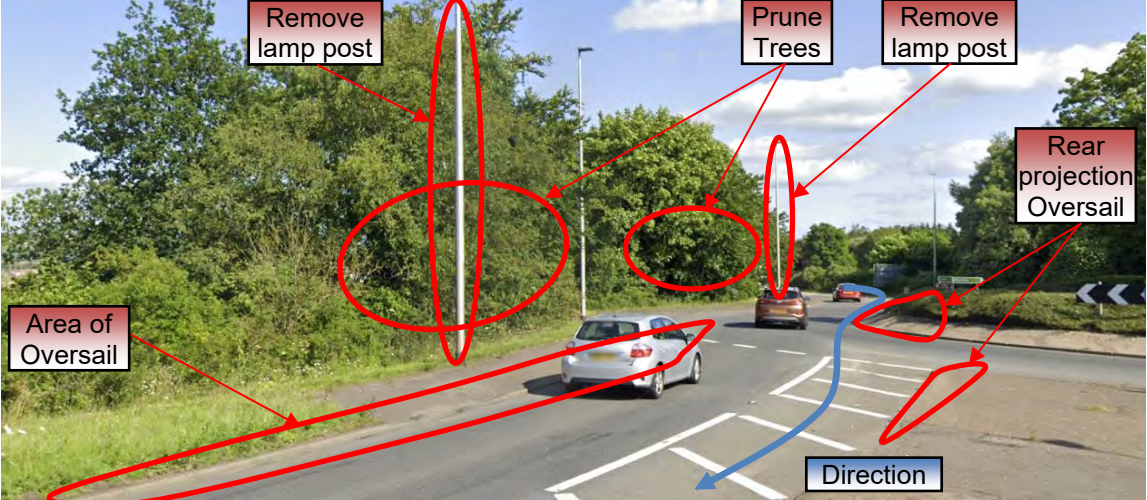
| <p>Swept path analysis indicates that the loaded vehicle will oversail on both sides of the road whilst negotiating the roundabout.</p> <p>The load will oversail on the offside. Two lamp posts are to be removed and trees will require pruning.</p> <p>The rear projection will oversail the nearside prior to the roundabout. Trees will require pruning. The entry and exit splitter islands and the island will incur rear projection oversail.</p> <p>Manual steering and utilisation of the full extents of the road are required to execute the manoeuvre at this location.</p> | | <p>Direction</p> <p>Aerial View of Location</p> | |
| <p>Rear projection Oversail</p> <p>Remove lamp posts</p> <p>Prune Trees</p> <p>Area of Oversail</p> <p>Direction</p> <p>Approach to Roundabout</p> | | <p>Remove lamp post</p> <p>Prune Trees</p> <p>Remove lamp post</p> <p>Rear projection Oversail</p> <p>Area of Oversail</p> <p>Direction</p> <p>Reverse View of Roundabout Exit</p> | |

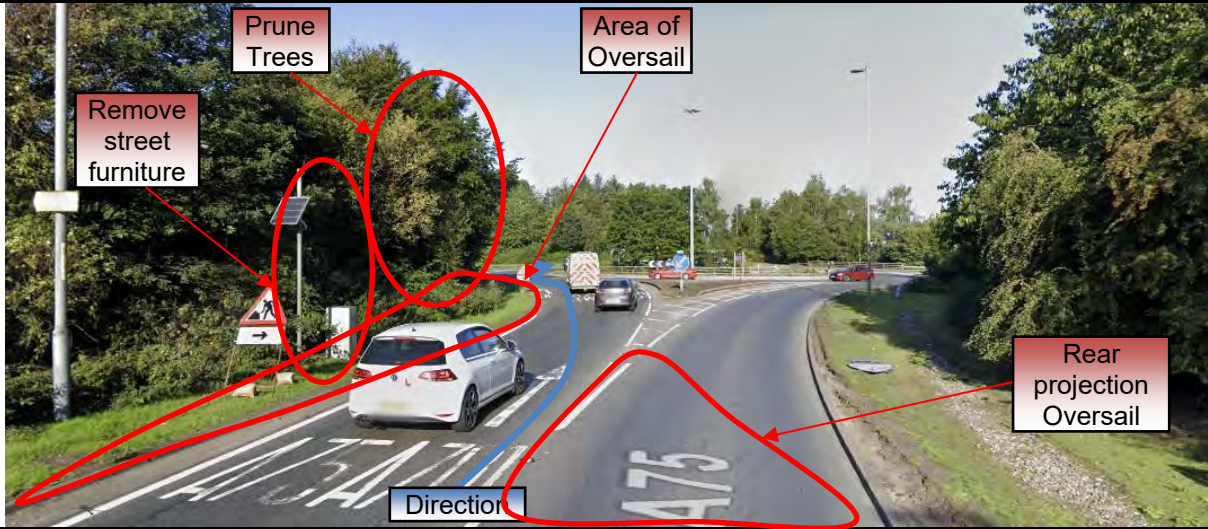
| <p>Swept path analysis indicates that road widening will be required on the nearside of the roundabout exit. A lamp post is required to be removed. Oversail occurs on the nearside of the entry and exits and the on the offside of the roundabout. A solar panel column, junction box on the nearside entry and a road sign on the roundabout are to be removed.</p> <p>Trees on the nearside entry are to be pruned. Manual steering and utilisation of the full extents of the road are required to execute the manoeuvre at this location.</p> | | | <p>Aerial View of Location</p> | | |
| <p>Approach to Bloomfield Roundabout</p> | | | <p>Bloomfield Roundabout</p> | | |

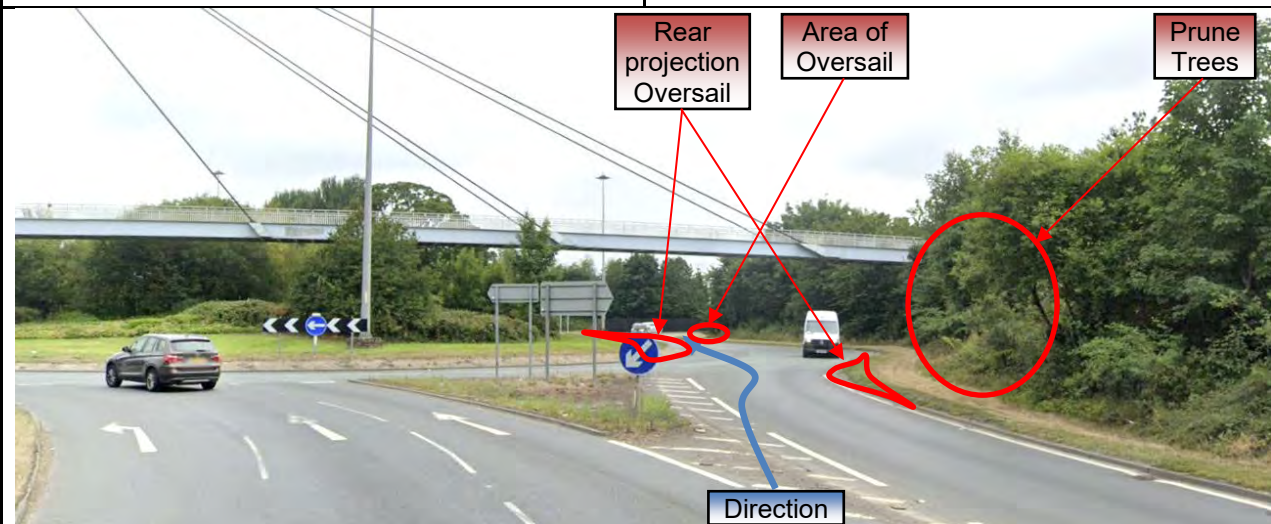
| <p>Swept path analysis indicates that road widening is required on the exit splitter island to allow the vehicle to join the left hand carriageway. The fence on the splitter island is to be removed.</p> <p>The load will oversail the offside of the entry and exits of the roundabout and exit splitter island. The rear projection will oversail the roundabout island prior to the exit.</p> <p>Trees are to be pruned on the offside entry of the roundabout.</p> <p>Manual steering and utilisation of the full extents of the road are required to execute the manoeuvre at this location.</p> | | <p>Direction</p> <p>Aerial View of Location</p> | | |
| <p>Rear projection Oversail</p> <p>Area of Oversail</p> <p>Prune Trees</p> <p>Direction</p> <p>Approach to Cuckoo Bridge Roundabout</p> | | <p>Road widening required</p> <p>Area of Oversail</p> <p>Direction</p> <p>Contraflow Exit</p> | | |
| <p>Road widening required</p> <p>Rear projection Oversail</p> <p>Remove fence</p> <p>Direction</p> <p>Reverse View of Exit</p> | | | | |

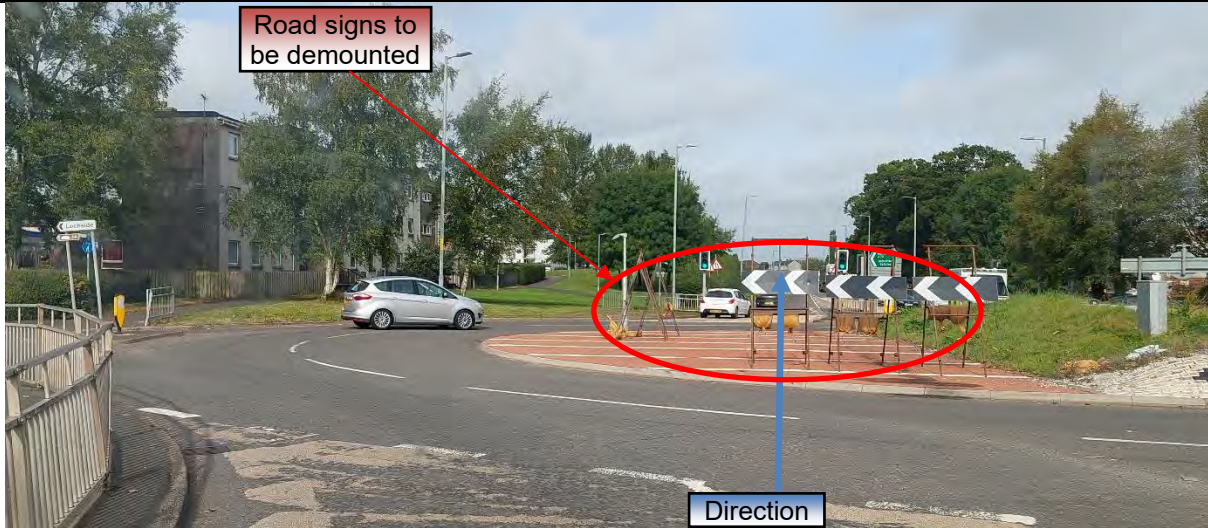
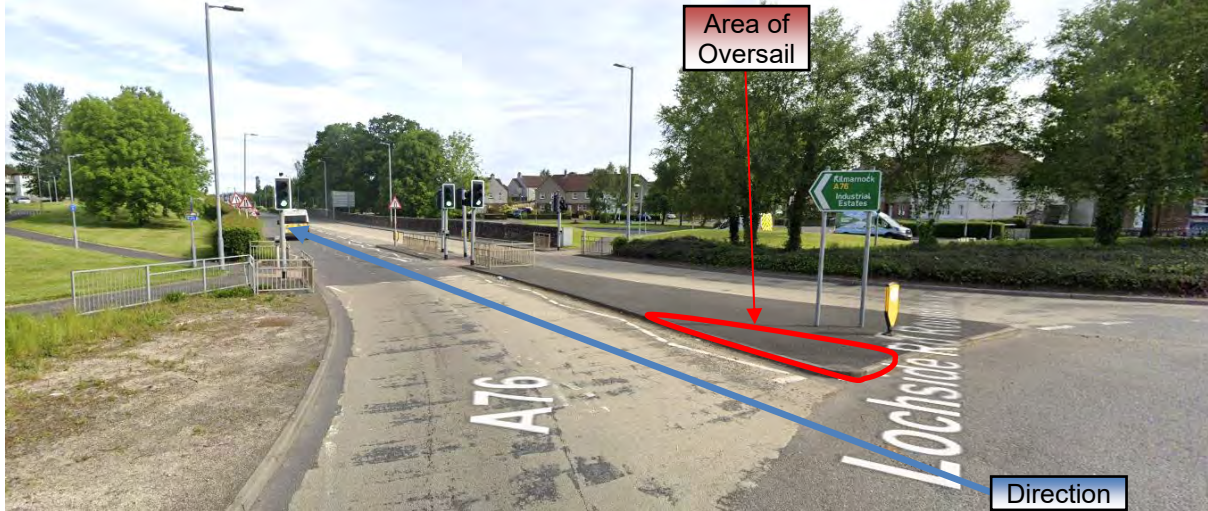
| <p>Swept path analysis indicates that the load will oversail the splitter island after the roundabout. Road signs on the widened area of the roundabout are to be demounted.</p> <p>Manual steering is required to execute the manoeuvre at this location.</p> | | <p>Aerial View of Location</p> | |

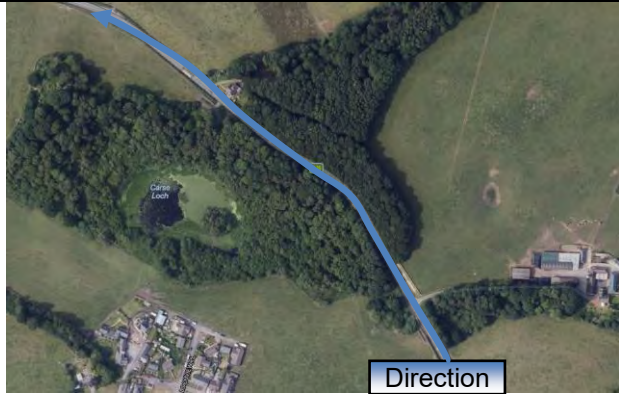
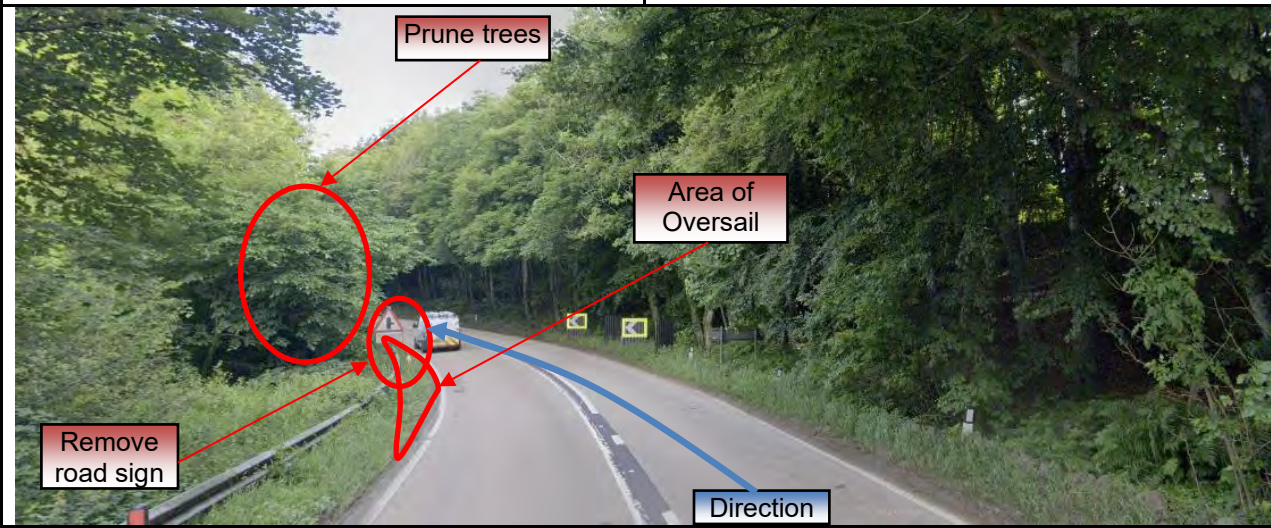
| <p>Swept path analysis indicates that the load will oversail both sides of the bend. There are no third party issues raised at this location.</p> <p>Trees/ vegetation are to be pruned on both sides of the bend.</p> <p>Manual steering and utilisation of the full extents of the road are required at this location.</p> <p>A topographical survey is recommended to confirm the extents of any modifications required at this location.</p> | | | | |

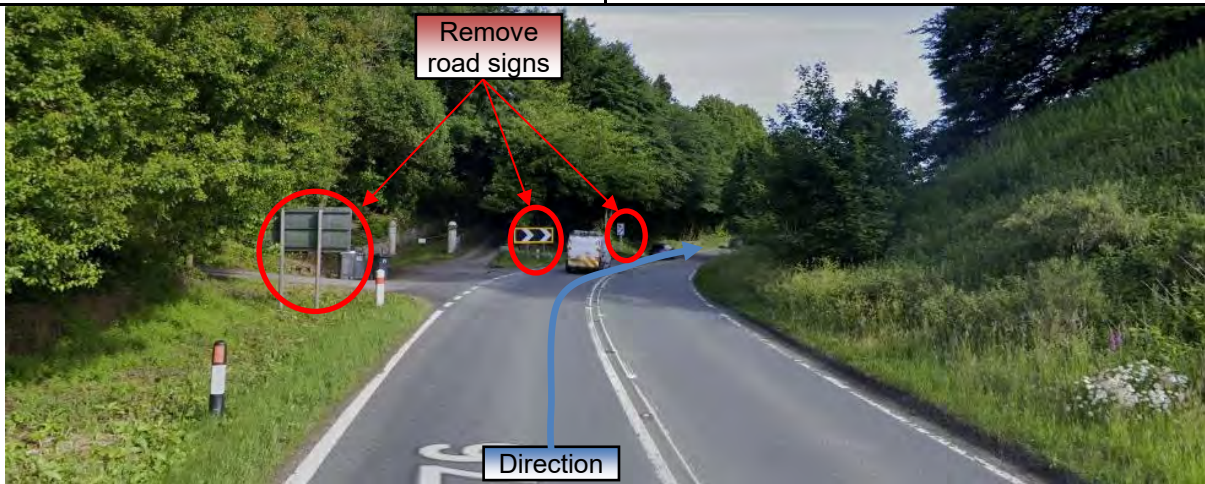
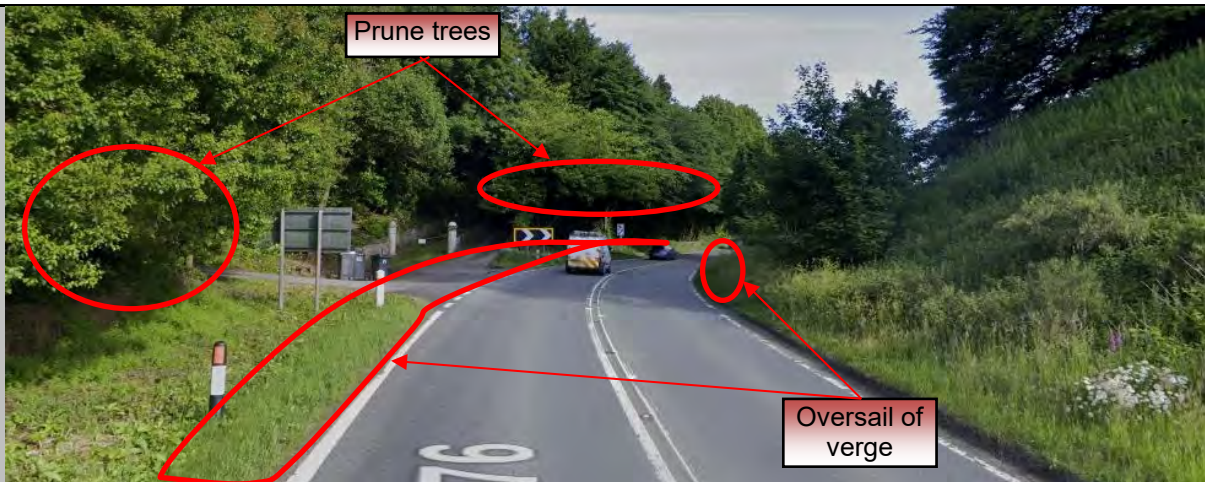
| <p>Swept path analysis indicates that the load will oversail both sides of the bend. There are no third party issues raised at this location.</p> <p>Three road signs on the nearside to be removed.</p> <p>Trees/ vegetation are to be pruned on the nearside of the bend.</p> <p>Manual steering and utilisation of the full extents of the road are required at this location.</p> | | <p>Direction</p> <p>Aerial View of Location</p> | | |
| <p>Remove road signs</p> <p>Direction</p> <p>Right Bend</p> | | | | |
| <p>Prune trees</p> <p>Oversail of verge</p> | | | | |

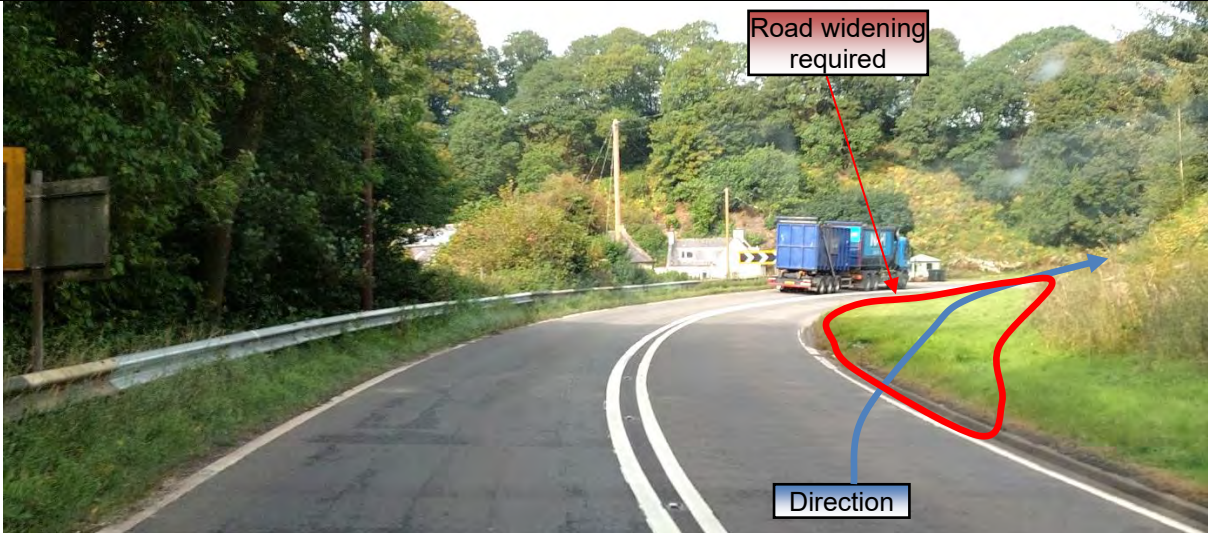
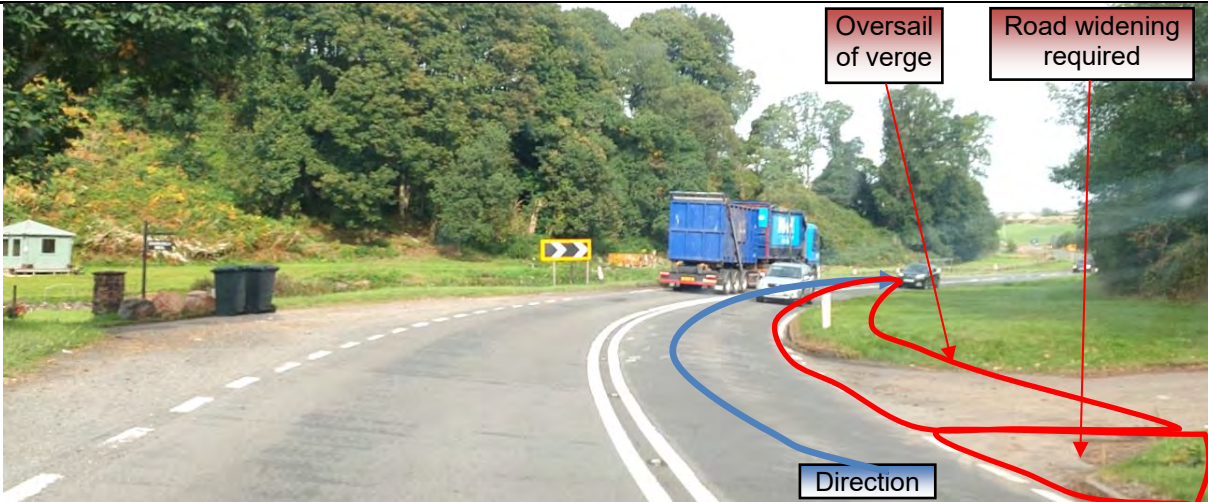
| | | <p>Road widening required</p> <p>Direction</p> <p>Approach to Left Bend</p> | |
| | | <p>Oversail of verge</p> <p>Road widening required</p> <p>Direction</p> <p>Exit of Bend</p> | |

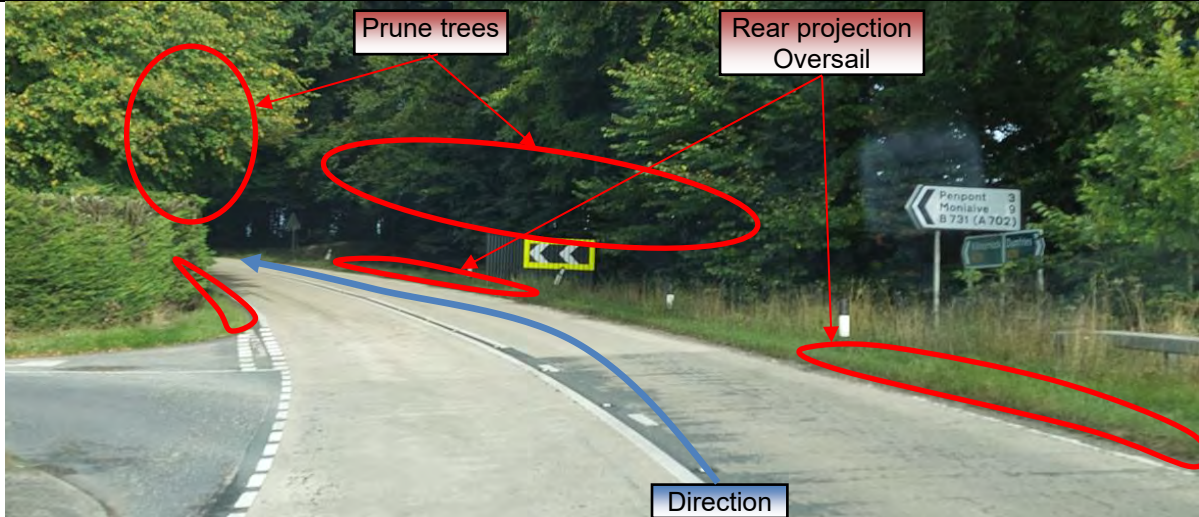
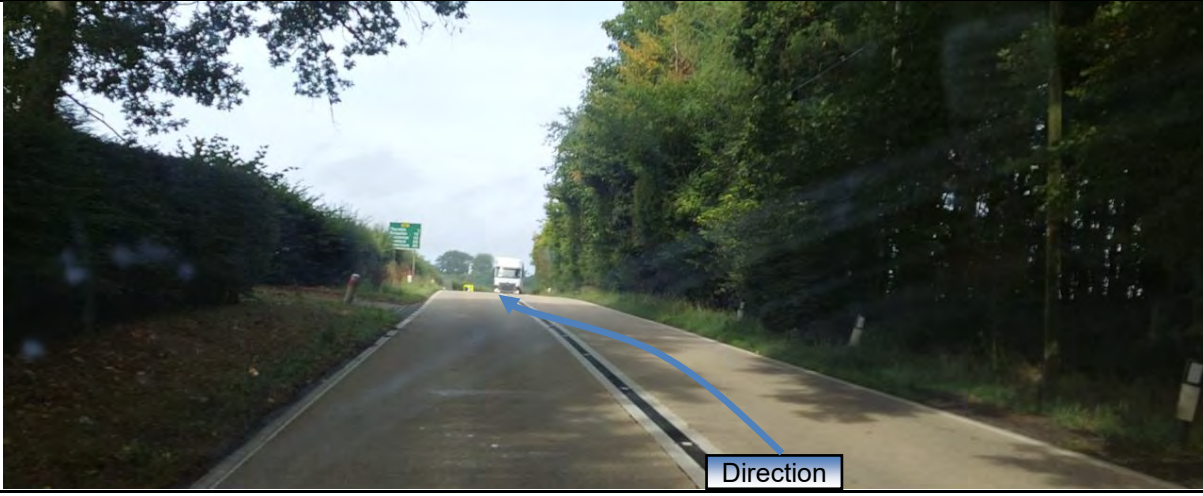
| <p>Swept path analysis indicates that the load will oversail both sides of the bend. There are no third party issues raised at this location.</p> <p>Trees/ vegetation are to be pruned on both sides of the bend.</p> <p>Manual steering and utilisation of the full extents of the road are required at this location.</p> | | <p>Aerial View of Location</p> | |

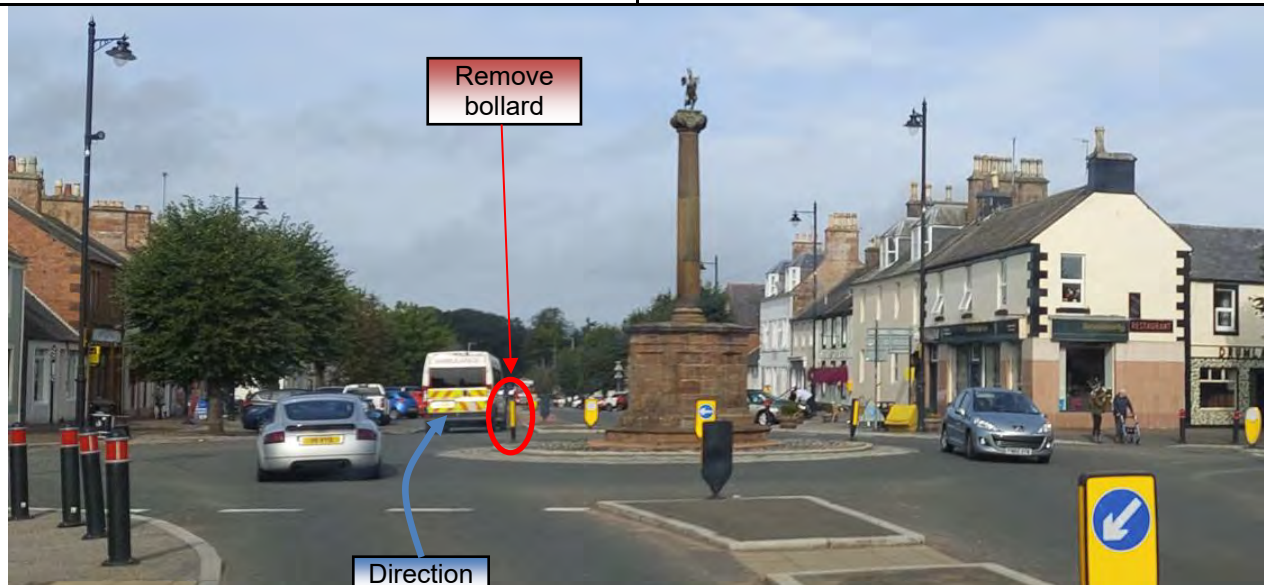
| Swept path analysis indicates that the bollard on the offside is to be removed. | | <p>Direction</p> <p>Aerial View of Location</p> | |
| <p>Remove bollard</p> <p>Direction</p> <p>Roundabout</p> | | | |

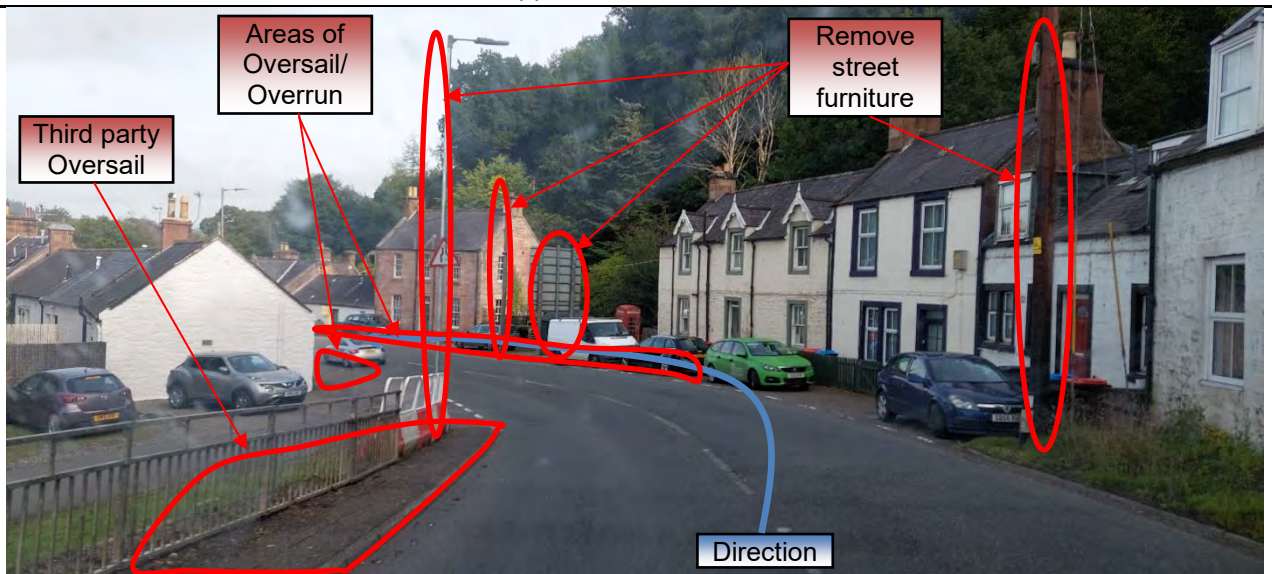
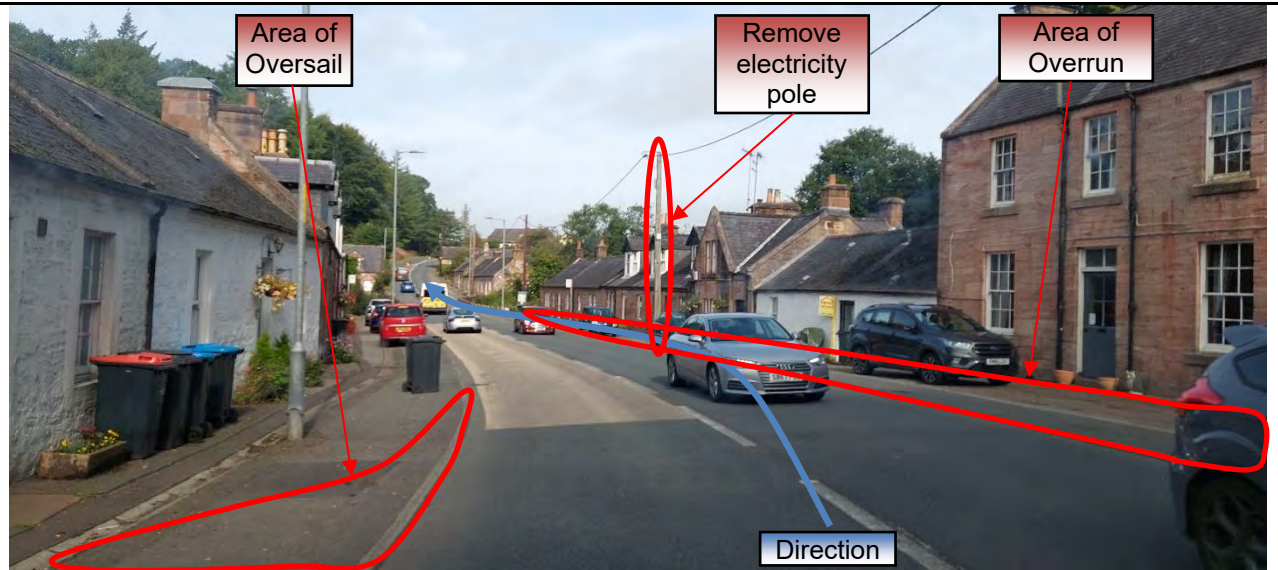
| <p>Swept path analysis indicates that third party land is required on the nearside to allow the load to oversail on the approach to the left bend. A lamp post and safety fence are required to be removed. Oversail will occur on both sides of the bend. Street furniture is required to be removed where indicated.</p> <p>Vegetation is to be removed on the offside prior to the bend.</p> <p>Parking restrictions are required both sides after the bend.</p> <p>Manual steering and utilisation of the full extents of the road are required at this location.</p> | | <p>Direction</p> <p>Aerial View of Location</p> | |
| <p>Remove safety fence</p> <p>Third party Oversail</p> <p>Prune vegetation</p> <p>Oversail of verge</p> <p>Direction</p> <p>Approach to Left Bend</p> | | <p>Third party Oversail</p> <p>Areas of Oversail/Overrun</p> <p>Remove street furniture</p> <p>Direction</p> <p>Left Bend</p> | |

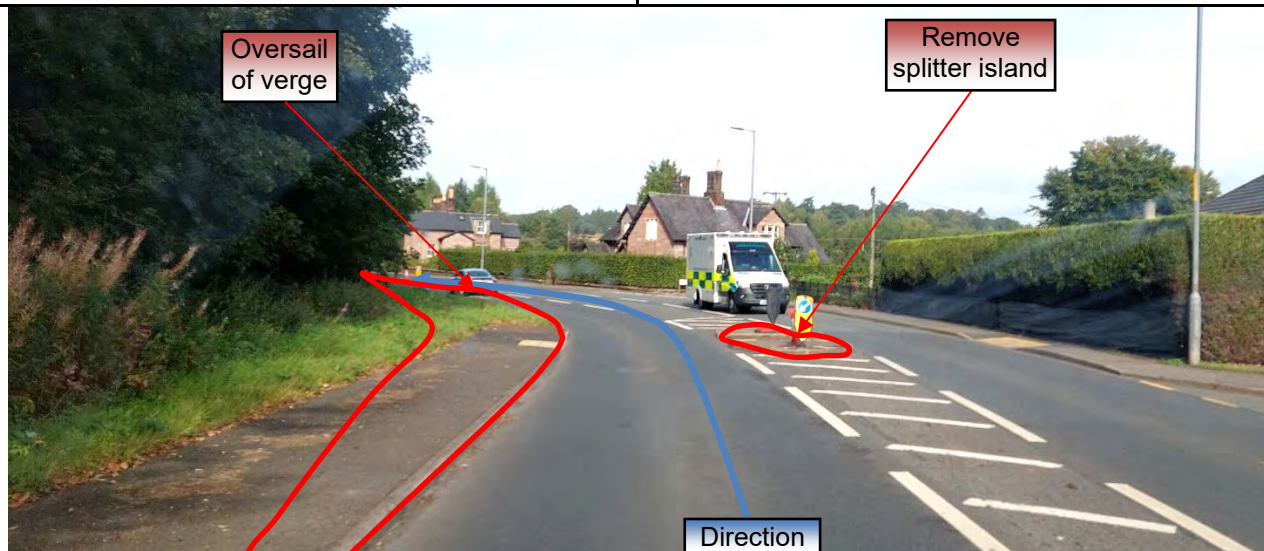
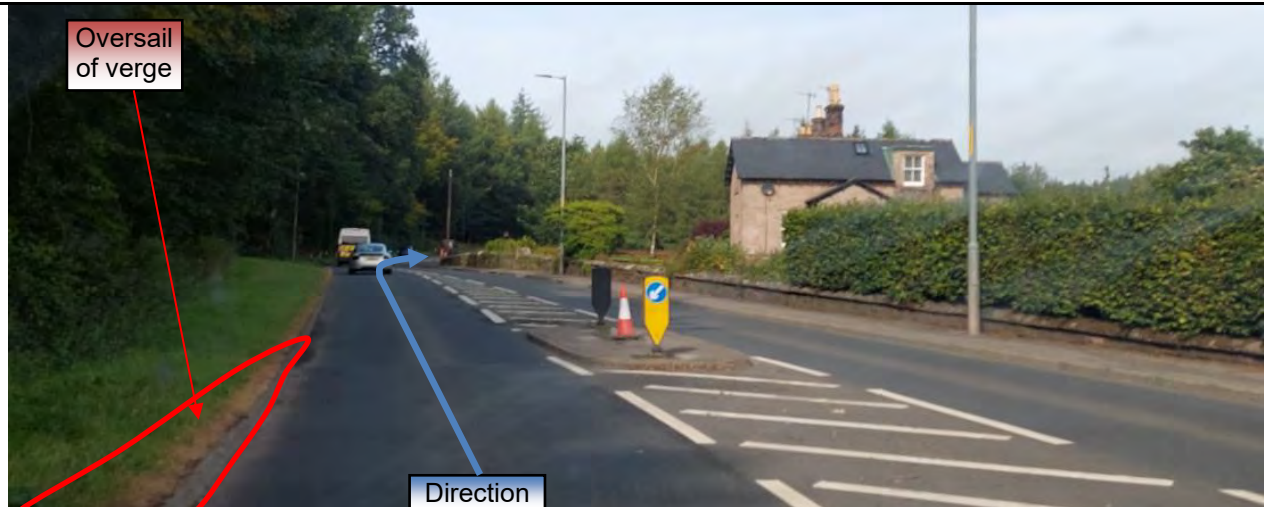
| <p>Swept path analysis indicates that the splitter island before the bend is to be removed to avoid more extensive road widening on the nearside. The load will oversail the verge on the nearside and the rear projection will oversail the footpath on the offside.</p> <p>No third party issues are raised at this location. Manual steering &amp; utilisation of the full extents of the road will be required to navigate at this location.</p> | | <p>Direction</p> <p>Aerial View of Location</p> | | |
| <p>Oversail of verge</p> <p>Remove splitter island</p> <p>Direction</p> <p>Approach to Left Bend</p> | | | | |
| <p>Oversail of verge</p> <p>Direction</p> <p>Splitter Island 20</p> | | | | |

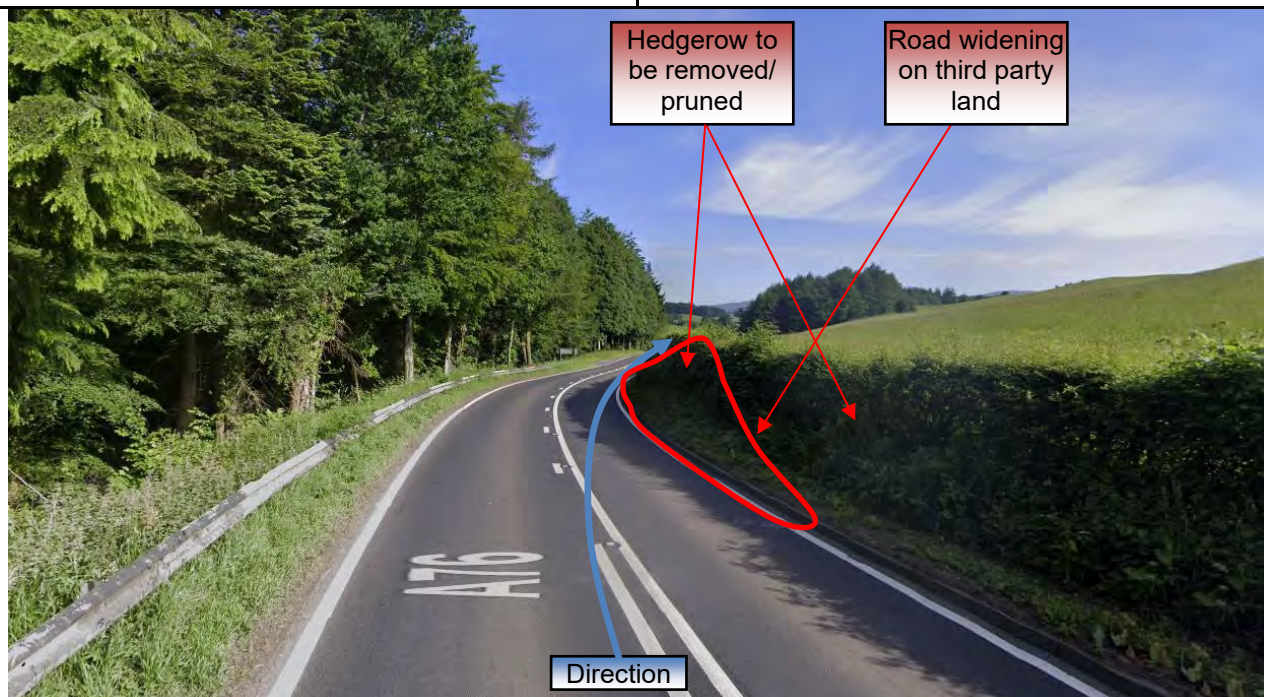
| <p>Swept path analysis indicates that third party land is required on the offside to widen the road to avoid rear projection oversail in the wood on the nearside.</p> <p>The hedgerow on the offside is to be removed/ pruned where necessary.</p> <p>Manual steering &amp; utilisation of the full extents of the road will be required to navigate at this location.</p> | | <p>Direction</p> <p>Aerial View of Location</p> | |
| <p>Hedgerow to be removed/ pruned</p> <p>Road widening on third party land</p> <p>Direction</p> <p>Right Bend</p> | | | |

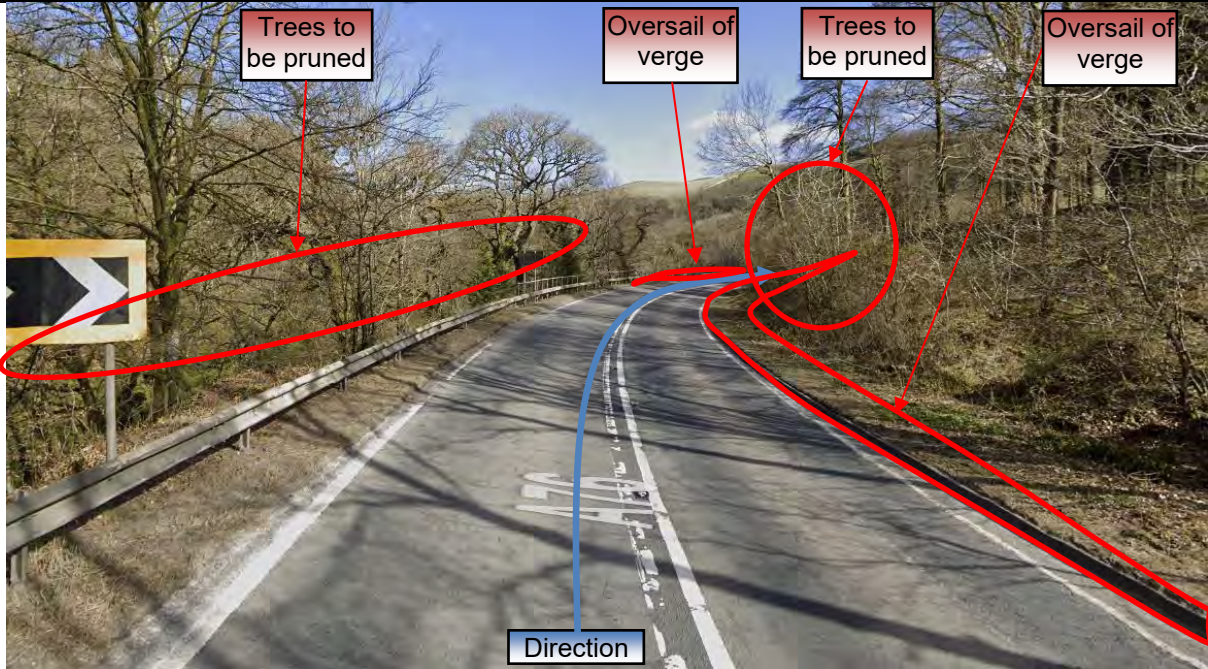
| <p>Swept path analysis indicates the loaded component will oversail both sides of the bend. Trees are to be pruned on both sides of the road. Manual steering &amp; utilisation of the full extents of the road will be required to navigate at this location.</p> | | <p>Direction</p> <p>Aerial View of Location</p> | | |
| <p>Trees to be pruned</p> <p>Oversail of verge</p> <p>Trees to be pruned</p> <p>Oversail of verge</p> <p>Direction</p> <p>Right Bend</p> | | | | |

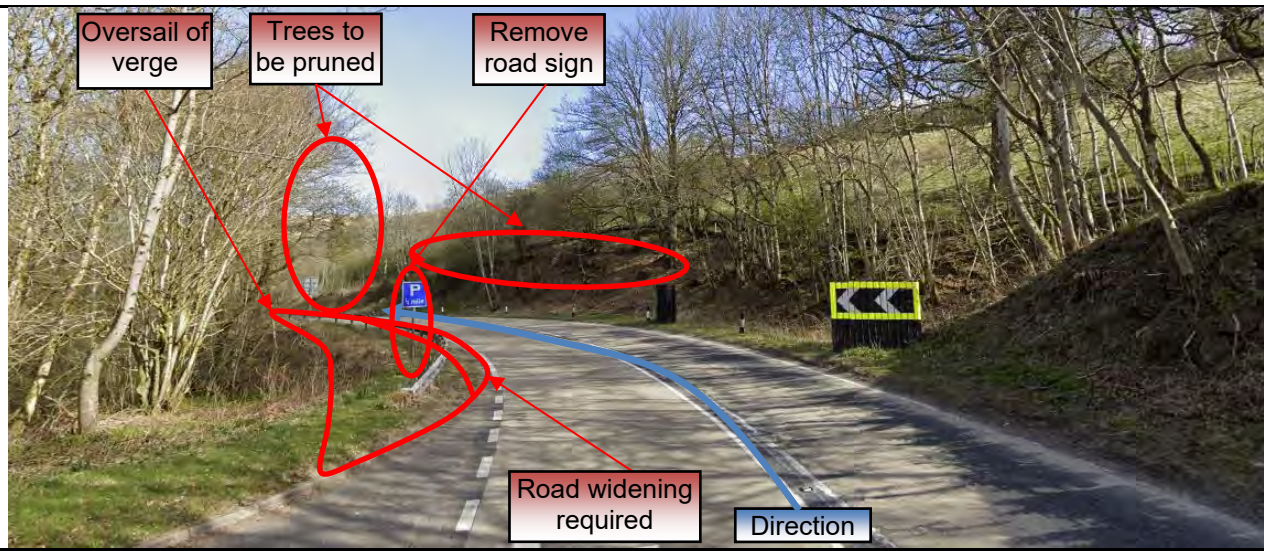
| <p>Oversail of verge</p> <p>Trees to be pruned</p> <p>Remove road sign</p> <p>Road widening required</p> <p>Direction</p> <p>Left Bend</p> | | | |

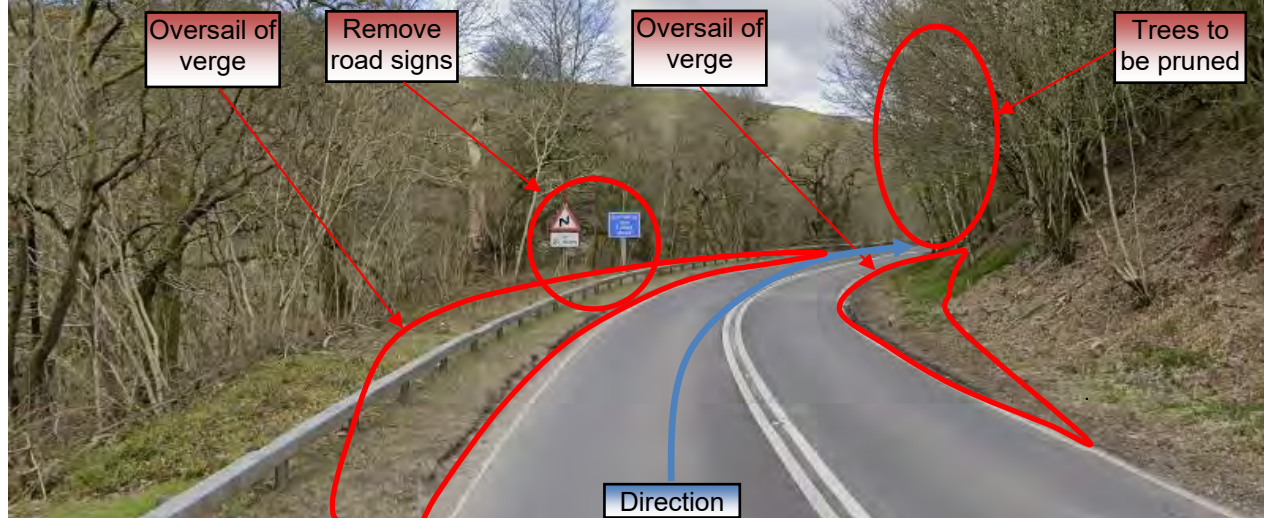
| <p>Oversail of verge</p> <p>Remove road signs</p> <p>Oversail of verge</p> <p>Trees to be pruned</p> <p>Direction</p> | | | | |

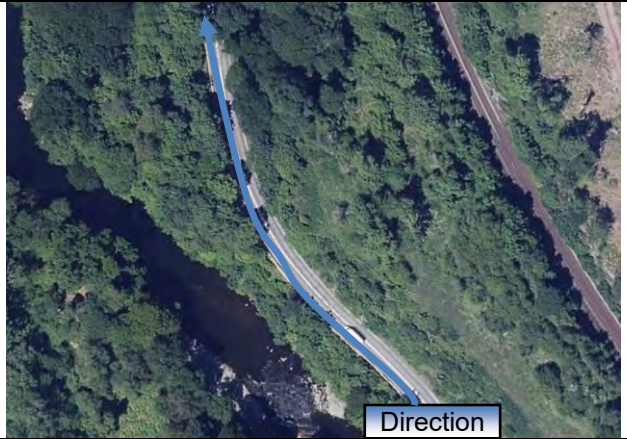
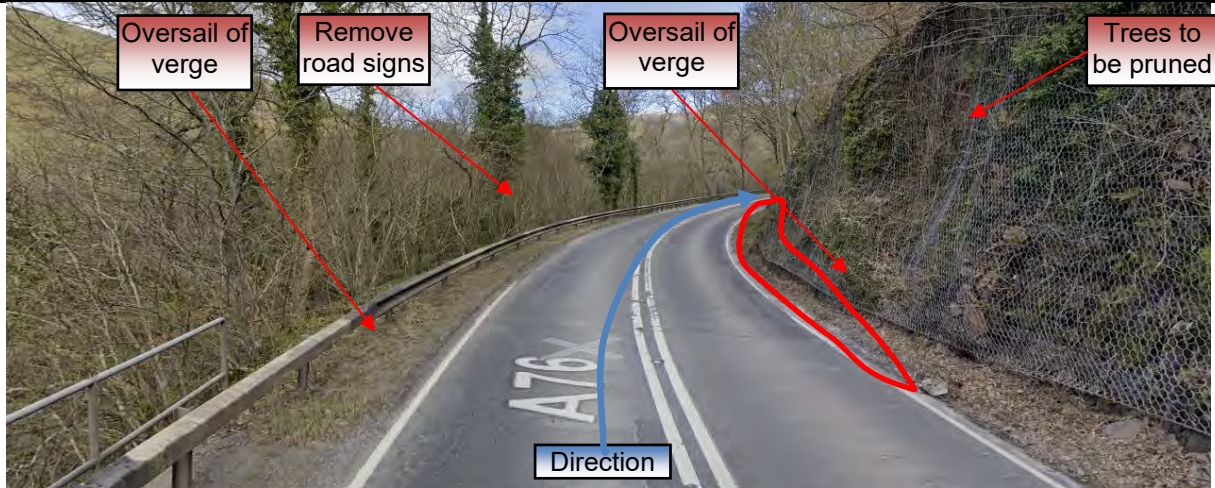
| <p>Swept path analysis indicates that third party land is required on the nearside to allow the rear projection to oversail.</p> <p>The loaded component will oversail both sides of the bend. Trees are to be topped/ removed on the nearside and pruned on the offside.</p> <p>Manual steering &amp; utilisation of the full extents of the road will be required to navigate at this location.</p> <p>A topographical survey is recommended to confirm the extents of any modifications required at this location.</p> | | <p>Direction</p> <p>Aerial View of Location</p> | |

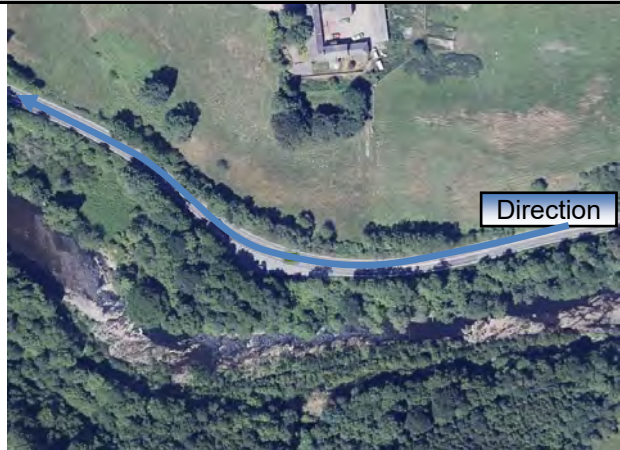
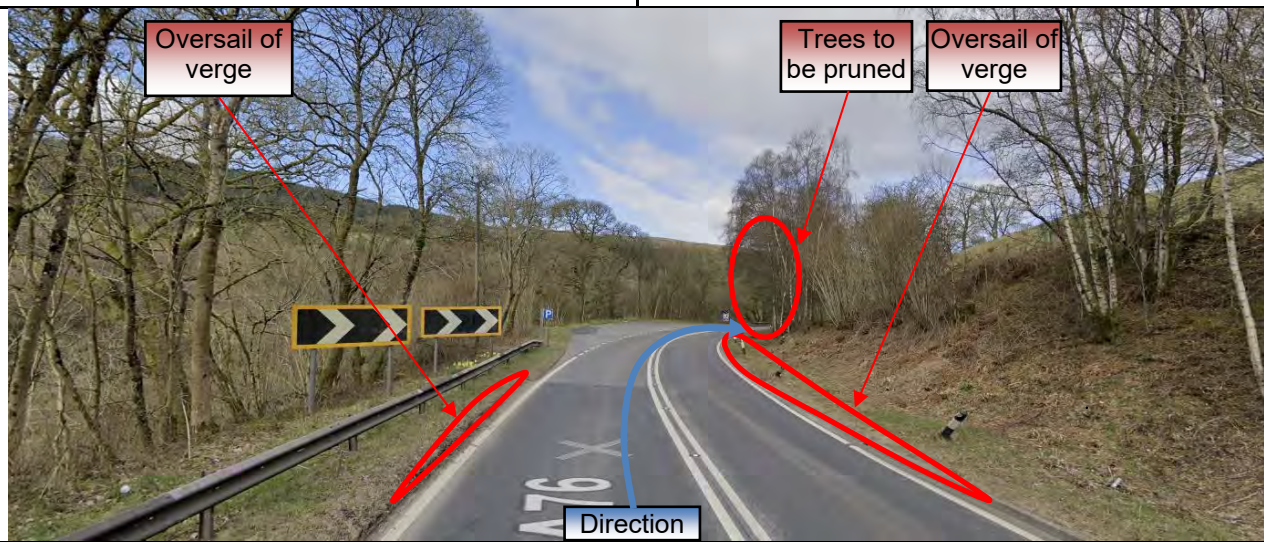
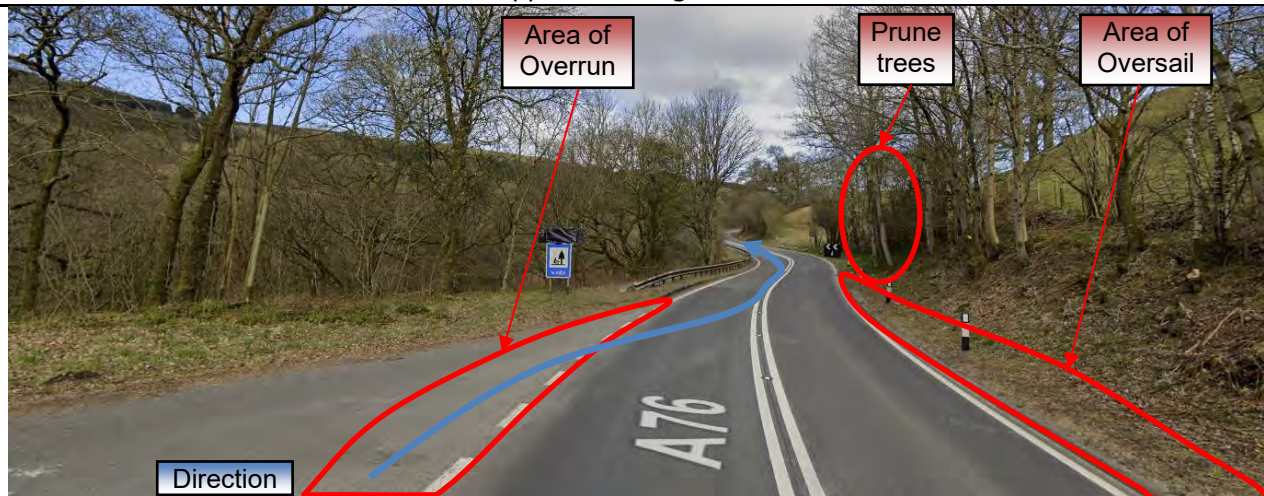
| <p>Swept path analysis indicates that the loaded component will oversail both sides of the bend. Trees are to be topped/ removed on the nearside and pruned on the offside.</p> <p>Manual steering &amp; utilisation of the full extents of the road will be required to navigate at this location.</p> <p>A topographical survey is recommended to confirm the extents of any modifications required at this location.</p> | | | |

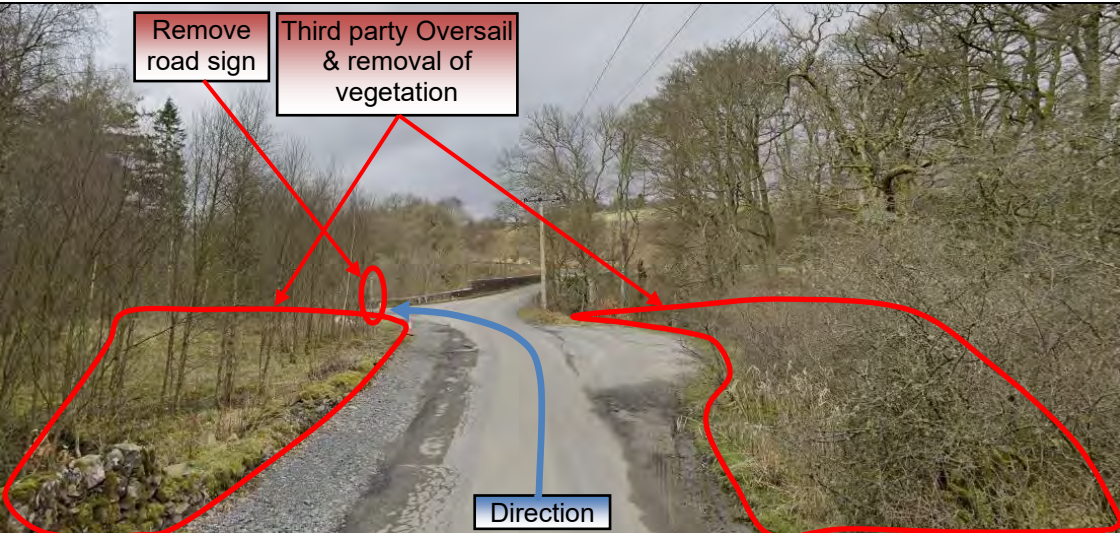
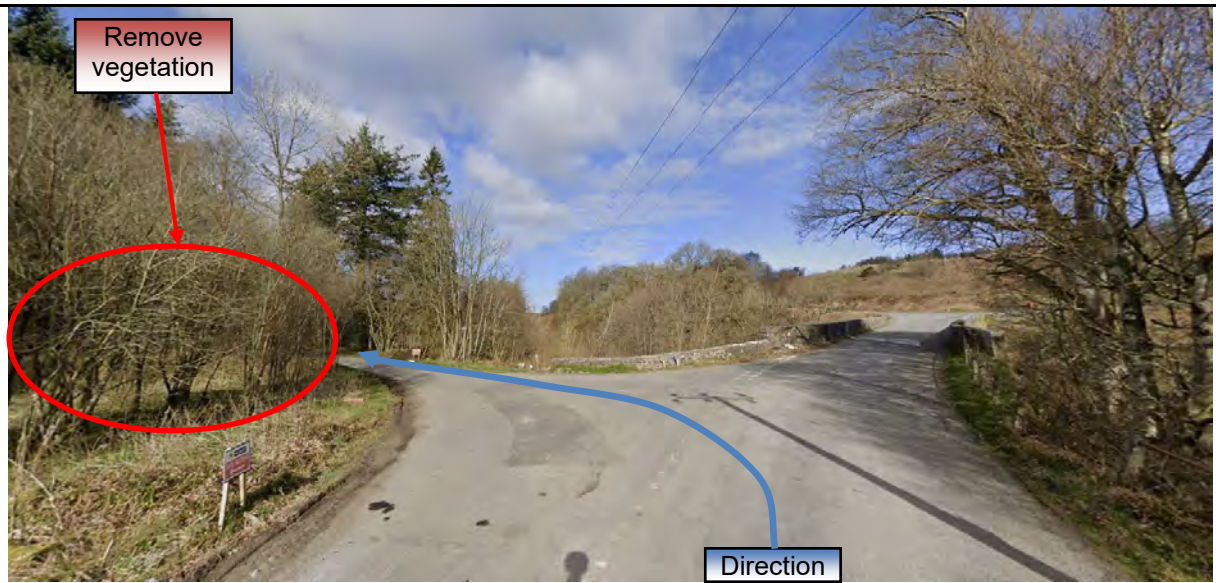
| <p>Swept path analysis indicates that third party land is required on both sides of the road to allow for oversailing. Trees/ vegetation are to be removed on both sides of the road.</p> <p>A service pole on the offside of the road and a road sign on the nearside are to be removed.</p> <p>Manual steering is required to navigate the bend at this location.</p> <p>The road is to be upgraded where necessary to meet the manufacturer's specification.</p> | | <p>Direction</p> <p>Aerial View of Location</p> | |
| <p>Remove service pole</p> <p>Third party Oversail &amp; removal of vegetation</p> <p>Direction</p> <p>View on Road</p> | | <p>Remove road sign</p> <p>Third party Oversail &amp; removal of vegetation</p> <p>Direction</p> <p>'Street View' of Left Turn</p> | |

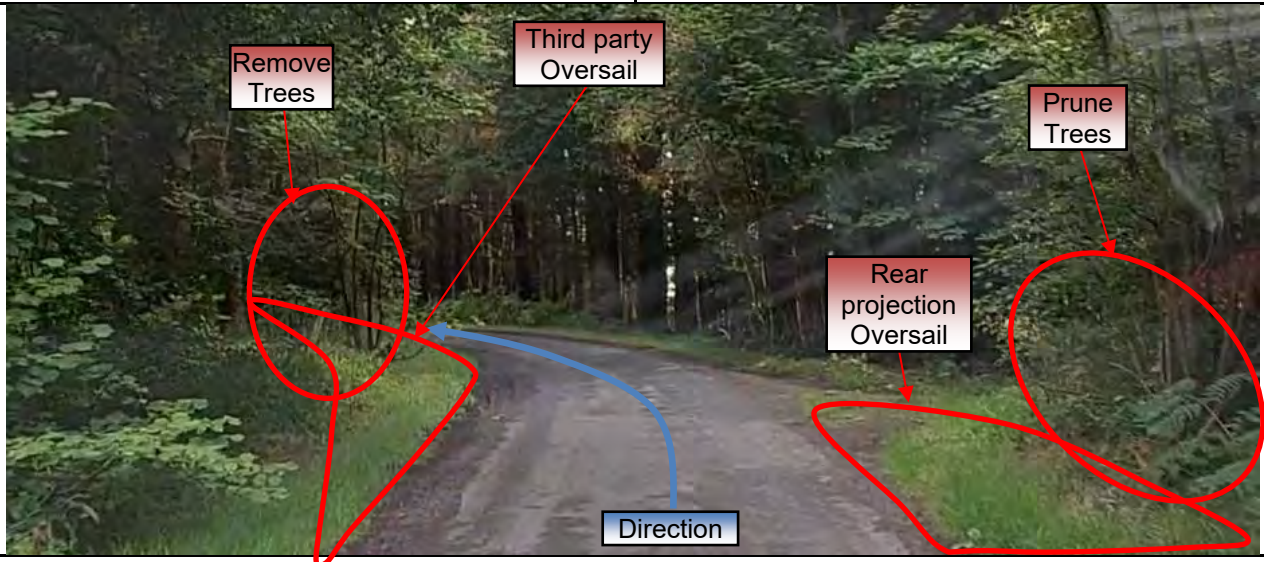
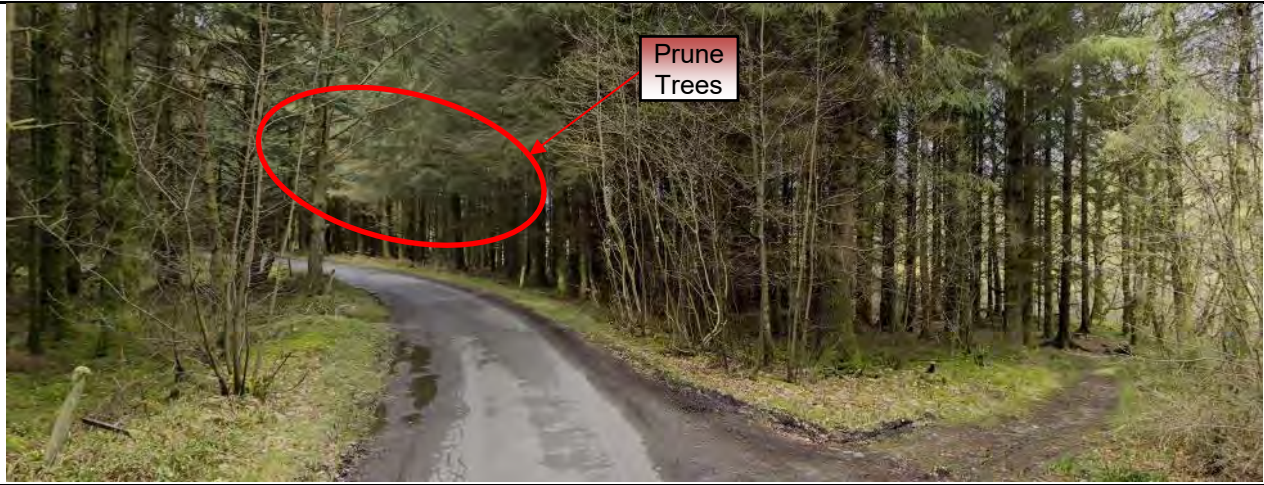
| <p>Visual inspection indicates that Third party land is required on the nearside of the bend to allow the load to oversail. Trees on the nearside are to be removed.</p> <p>Tree pruning is required on the offside, prior to the bend to allow the rear projection to oversail.</p> <p>Tree pruning is required on both sides of the road after the bend.</p> <p>Manual steering is required at this location.</p> | | <p>Aerial View of Location</p> | | |
