## Cloud Hill Wind Farm

### Technical Appendix 13.1: Abnormal Load Route Assessment

Route Access Survey  
360700 Rev 0.1

Cloud Hill Wind Farm – Routes A & B

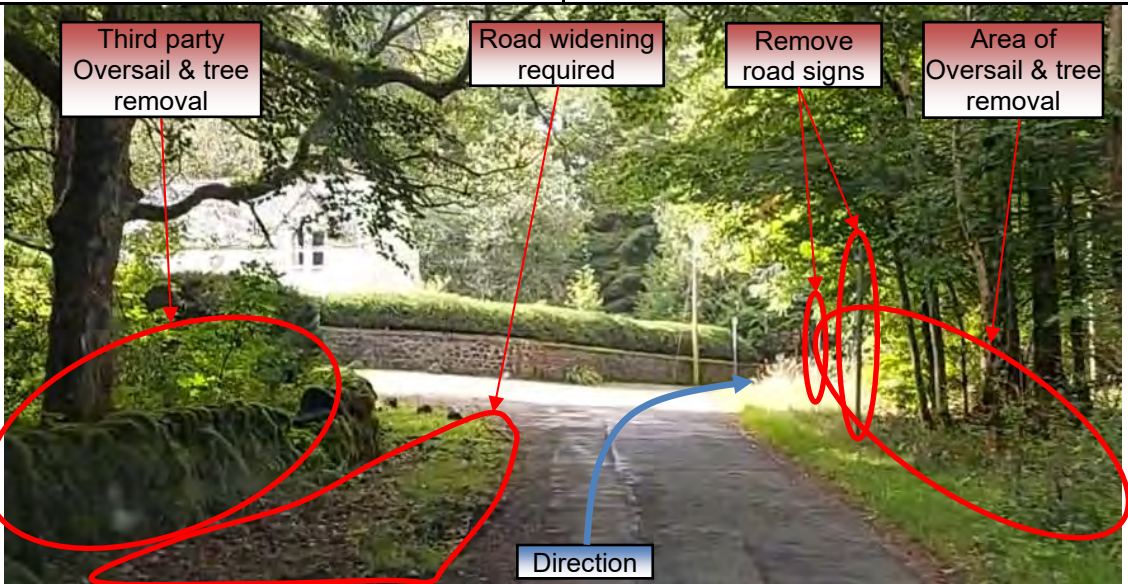
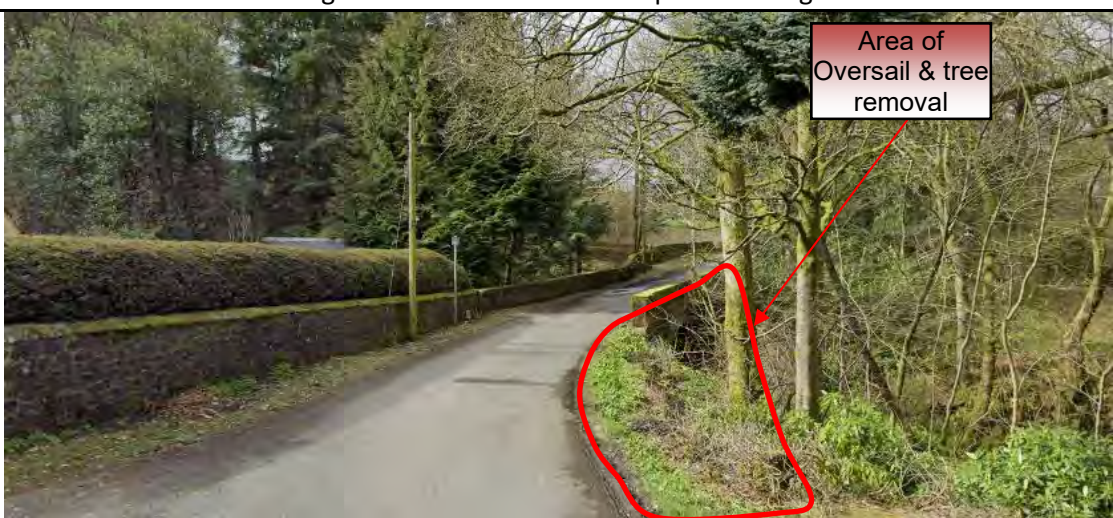
| <p>Visual inspection indicates that third party land is required on the nearside, prior to the junction on the nearside, to allow the rear projection to oversail. Trees in the area of oversail are to be removed.</p> <p>Road widening is required on the nearside of the road.</p> <p>The load will oversail on the offside of the verge. Trees in this area are to be removed.</p> <p>Two road signs on the offside are to be removed.</p> <p>Manual steering is required at this location.</p> | | <p>Direction</p> <p>Aerial View of Location</p> | |
| <p>Third party Oversail &amp; tree removal</p> <p>Road widening required</p> <p>Remove road signs</p> <p>Area of Oversail &amp; tree removal</p> <p>Direction</p> <p>Right bend on unnamed road prior to bridge</p> | | <p>Area of Oversail &amp; tree removal</p> <p>Street View - bridge on unnamed road</p> | |

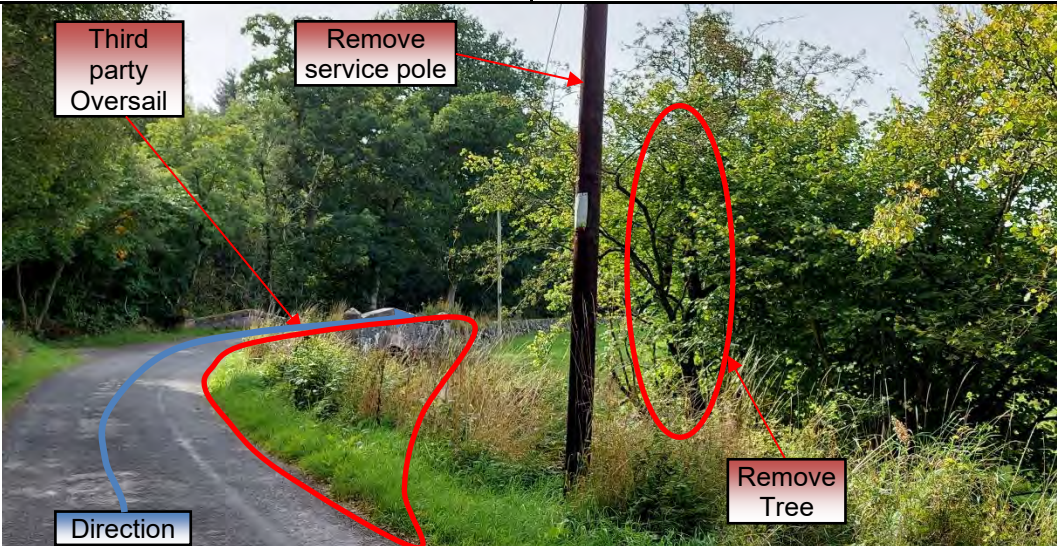
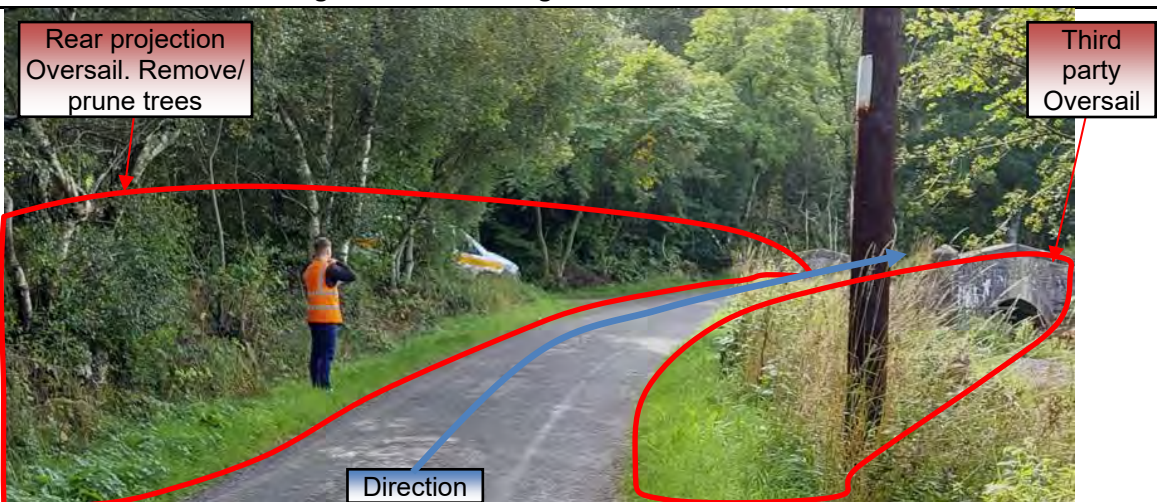
| <p>Visual inspection indicates that third party land is required on the offside of the bend to allow the loaded component to Oversail.</p> <p>The rear projection will oversail the verge on the nearside of the road prior to the bend.</p> <p>A service pole and a tree on the offside are to be removed.</p> <p>Manual steering is required at this location.</p> | | <p>Direction</p> <p>Aerial View of Location</p> | |
| <p>Third party Oversail</p> <p>Remove service pole</p> <p>Remove Tree</p> <p>Direction</p> <p>Right bend onto bridge on unnamed road</p> | | <p>Rear projection Oversail. Remove/prune trees</p> <p>Third party Oversail</p> <p>Direction</p> <p>Right bend onto bridge on unnamed road</p> | |
