Fractured Foot - Struck by Towed Water Bowser Tow Hitch			
Number	2023-13	Date	30/07/2023
<b>Summary:</b> Recently on a UK Construction Site The IP was preparing a water bowser trailer for connection to a forward tipping dumper truck. As the IP raised the hitch of the browser using the jockey wheel extender, the jockey wheel clamp slipped and the hitch fell to ground level on the IP's foot. He felt pain in his foot and was sent to the local A&E department. <b>Outcomes:</b> It was found that the IP had a hairline fracture of his Metatarsal bone. <b>Incident Classification:</b> L2 – LTI – 31 Days			
<div><div>

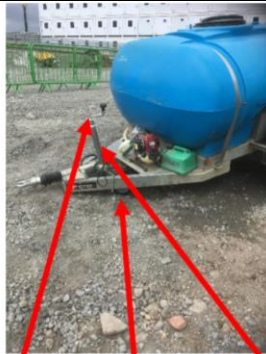
Jockey wheel handle</div><div>

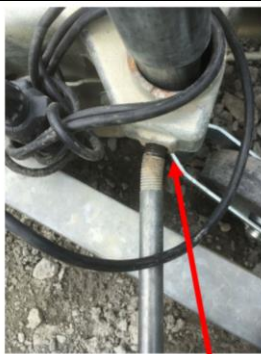
Jockey wheel support tube</div><div>

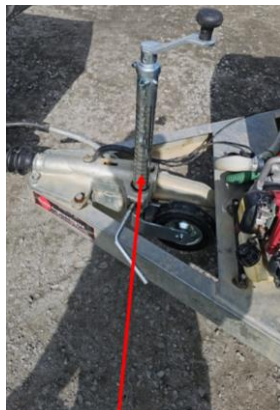
Replacement ribbed support tube</div>

<p>Immediate/Direct Cause</p> <ul style="list-style-type: none"><li>Equipment failure namely the jockey wheel clamp friction pad.</li></ul> <p>Contributory Causes</p> <ul style="list-style-type: none"><li>Although not a direct contributory cause all Towed Mobile Plant should be issued with a HZI Plant Sticker and the documented inspection associated with that process retained.</li><li>Although this type of clamp is used successfully on many thousands of trailers, the replacement jockey wheel assembly had a ribbed support tube. This design may reduce the risk of the front bracket falling if the friction pad fails.</li></ul> <p>Root Cause</p> <ul style="list-style-type: none"><li>Unforeseen component failure - failure of the human / machine interface.</li></ul>		<ul style="list-style-type: none"><li>Check all items of Towed Mobile Plant for serviceability. If necessary take the weight off the jockey wheel (without placing anyone in the line of fire) to inspect support tube screw clamp and the friction pad</li><li>Ensure all items of Towed Mobile Plant are issued with a Plant Sticker and retain the associate inspection document</li><li>If any defective or worn components are identified in the checks, the "ribbed support tube" jockey wheel is the preferred replacement. It is not mandatory to use this type however due to the very low risk of failure of the original type.</li></ul> <div>
