Near Miss: Baldwin Crane Hire – Fall from Height

Number NERF- 2020714 - 01

Date 14.07.2021

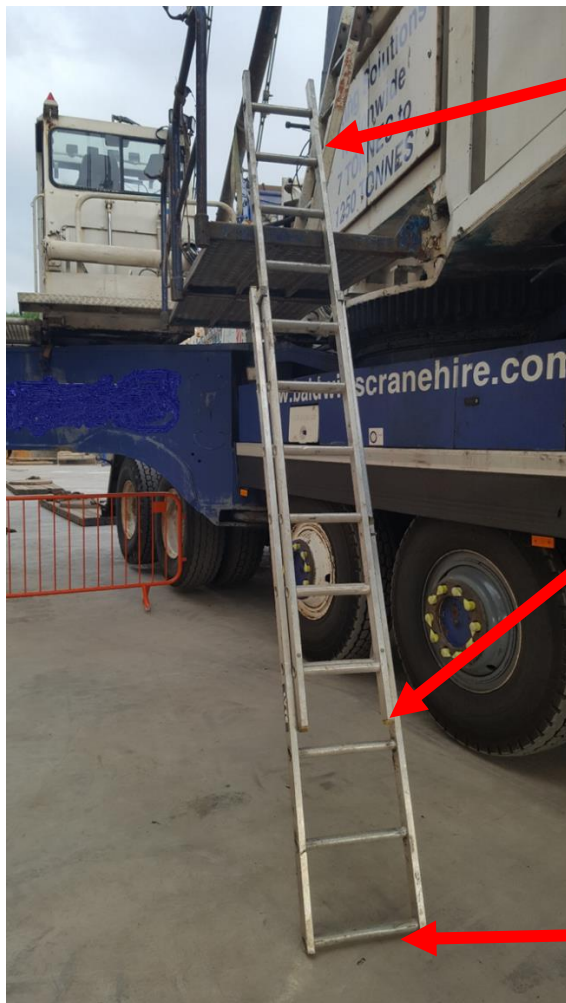
The Ladder was not secured at the top.

The Ladder was not Footed at the base

The Ladder was modified and the rubber feet had been cut off

- The modification to the ladder was the main contributing factor in the accident, followed closely by the ladder not being secured at the top or footed at the bottom

- All mobile cranes will have their ladders inspected, with some form of a recorded inspection register in place.
- Ladders will be securely fitted at the top and footed at the bottom when they are being used.

- Any defective/modified ladders will not be allowed on a HZI project.
- Task supervision will ensure all ladders are compliant.
- HZI corporate team to look at setting an age limit on mobile cranes.
