Proposed CSCOA funding not to exceed \$10,000

Proposed Projects – Photos, July 2022

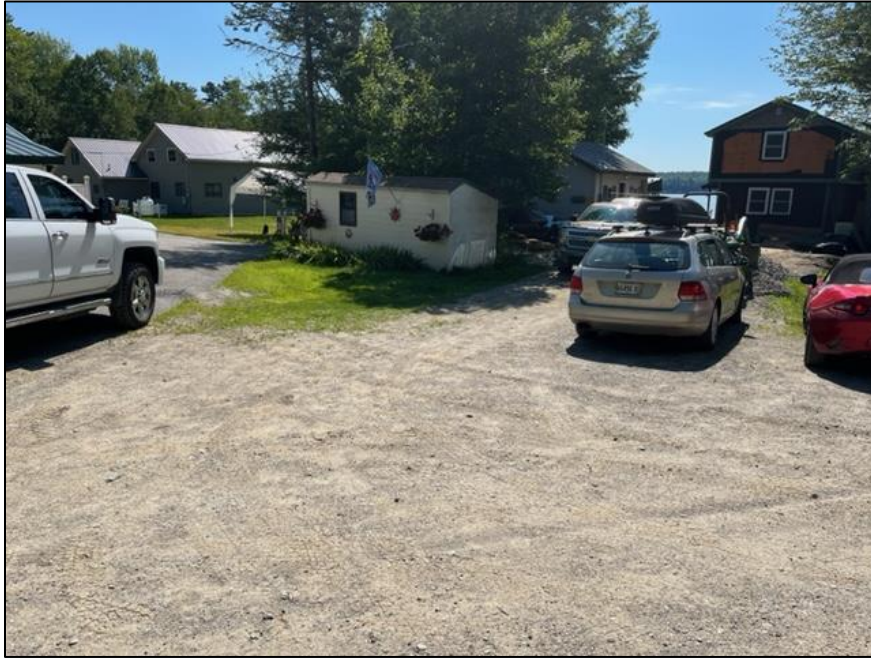
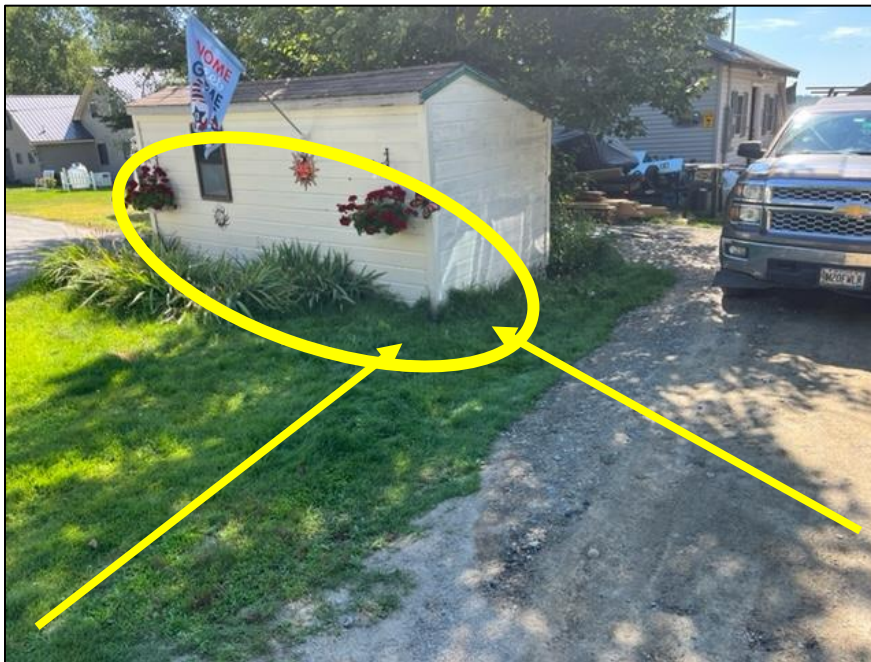
Lemay Road – Discussed new culverts and plunge pool to collect outfall.

Suggested fix: Relocate existing shed and install 10'x20' rock lined plunge pool in location where shed is currently located. Install new 12" diameter culvert (approx. 100' in length) from ditch across road that will outlet in new pool. Excavate and replace crushed/clogged culvert coming in from south and outlet into new pool. Pool should outlet into ditch that runs behind shed/garage toward lake and pool outlet should be stabilized with rock as it enters ditch.

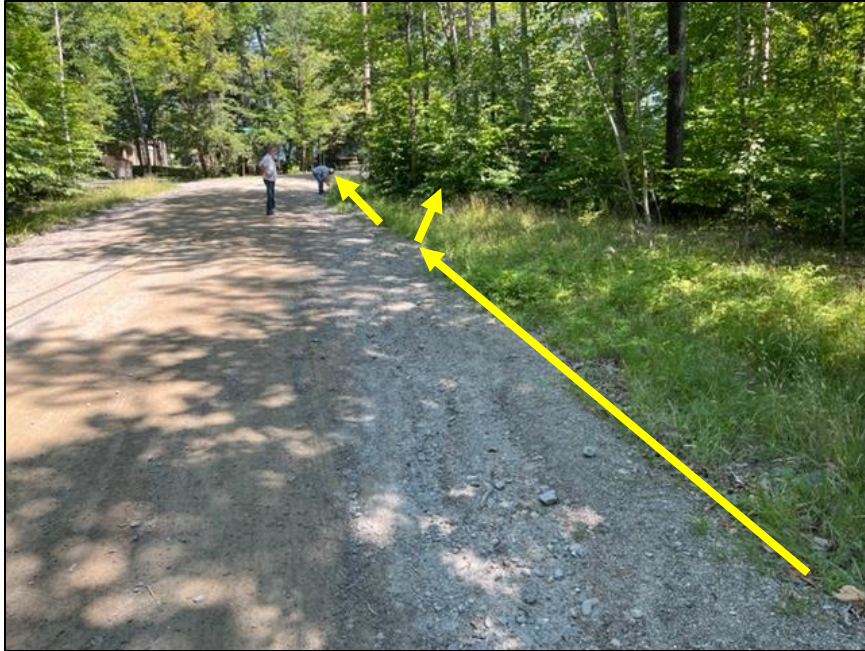
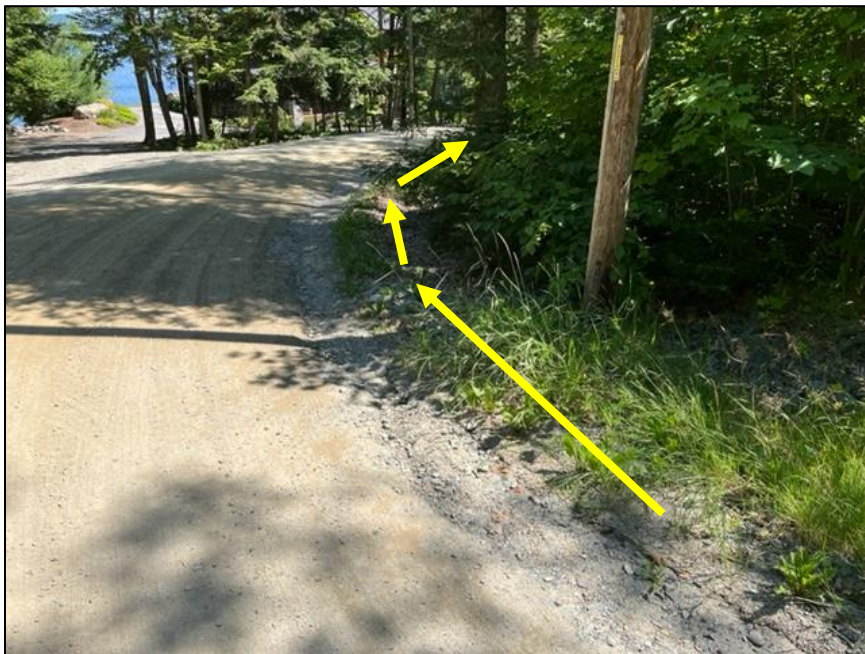
Cedar Rest Road – Road has become very wide near corner. Lack of surface crown causing shoulder erosion and water not getting off surface/shoulders.

Suggested Fix: Install sufficient surface gravel above corner at Pole # 85 to obtain $\frac{1}{2}$ " per foot crown. Install ditching along grass line on right side leading to turnout as shown in photo.

Begin new ditching beyond new turnout and around outside of Pole # 85. New ditch will tie into existing ditch around corner and beyond Pole.

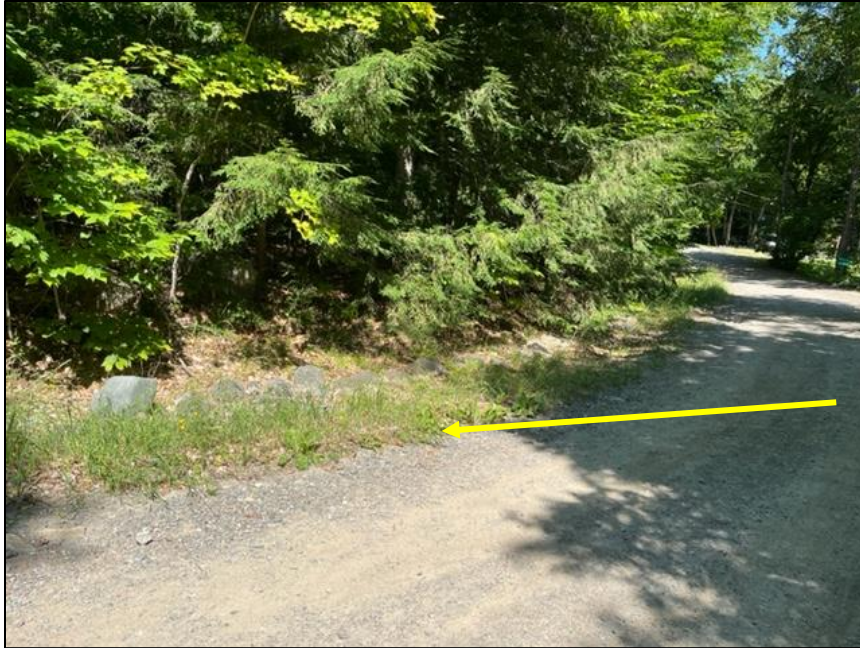
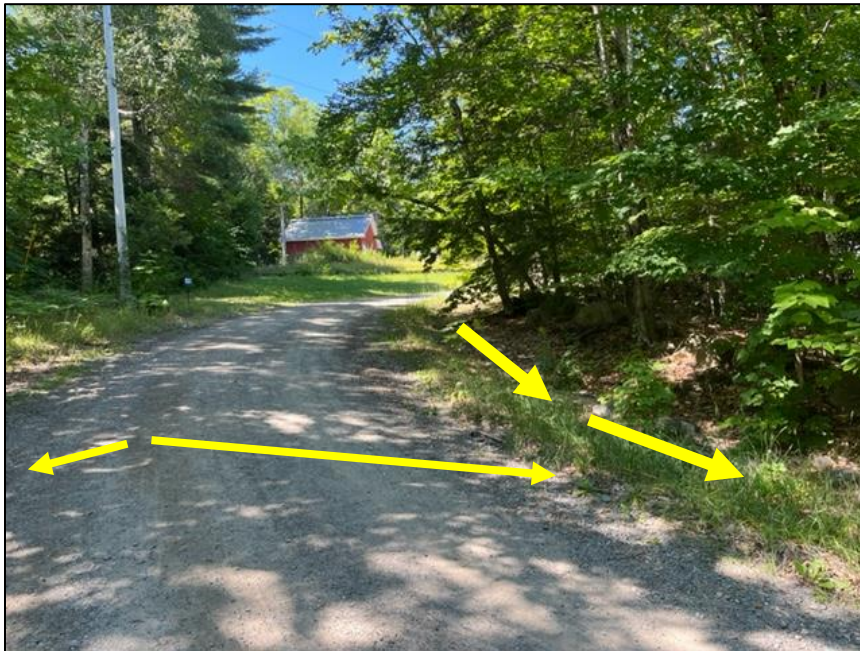
Lower Abbot Drive – Culvert at Pole # 15 has failed. Replace with a 24" diameter HDPE (lower priority).

At the sharp corner (pictured) the insloped ditch is very shallow and has significant sediment accumulation. Shoulder berms are present, and the road is lacking proper shaping to move water to existing ditching.

Suggested Fix: Remove shoulder berms, add surface gravel to super-elevate toward ditch around corner between flagging. Reestablish capacity in ditching and install riprap in ditch 180'.

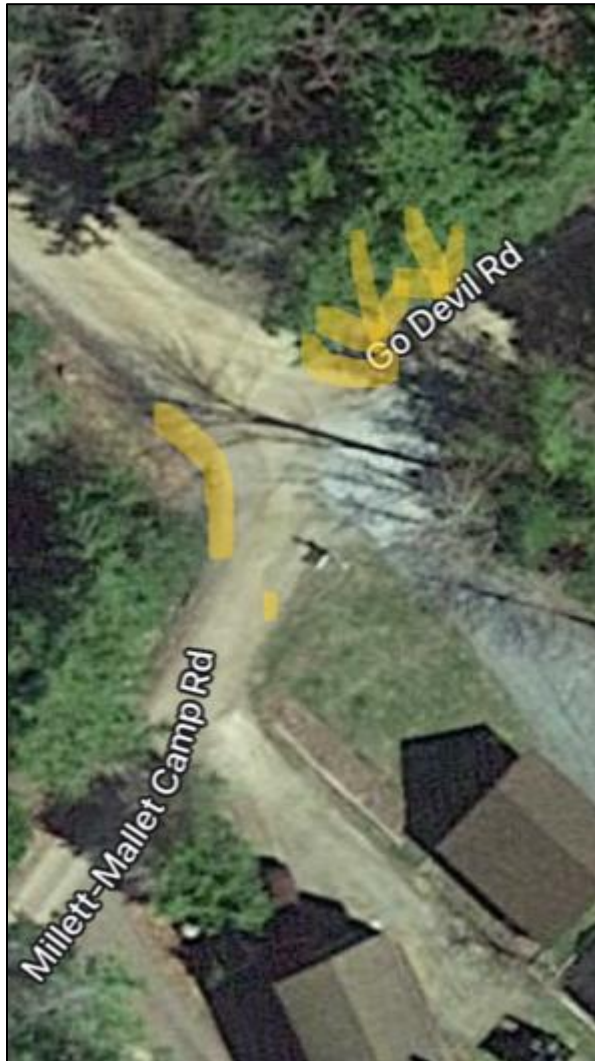
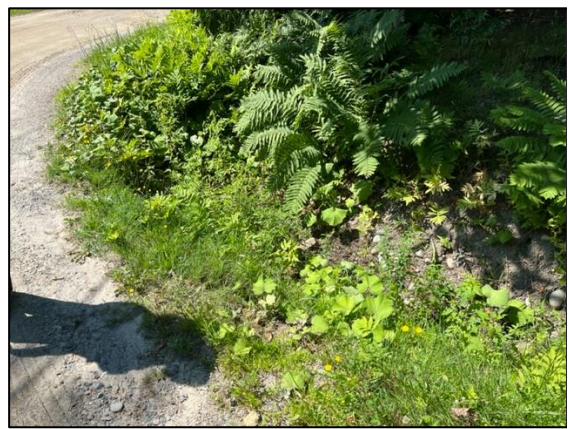
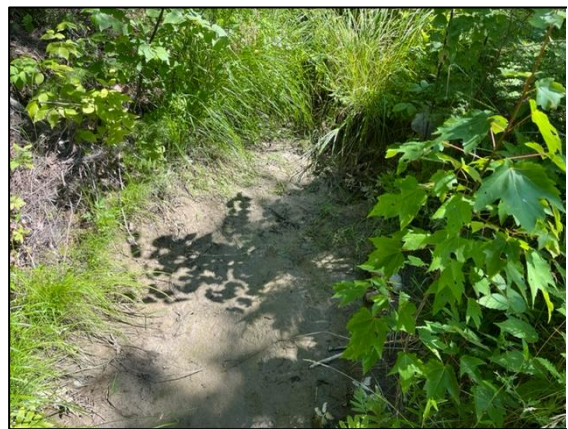
Go Devil Intersection/Corner

Photos showing the two culvert inlets at the Go Devil intersection. Both locations are full of sediment accumulation. Install small plunge pools at both locations to intercept sediment before culvert/lake. Both pools should be stabilized with 4-6" riprap. Be sure that both culverts have sufficient riprap stabilization around both inlet and outlet ends.

Install plunge pools at both culvert inlets on north side of road corner. Pole # 5125 install rip rap around ditch corner and armor culvert inlet on north side of road.

On south side of intersection, armor ditch uphill of culvert inlet for 20' (in front of leach field) and around inlet of culvert.
