Salzburger Lokalbahn | AT

Hands-on training and efficient troubleshooting

/ LIFE CYCLE SERVICES

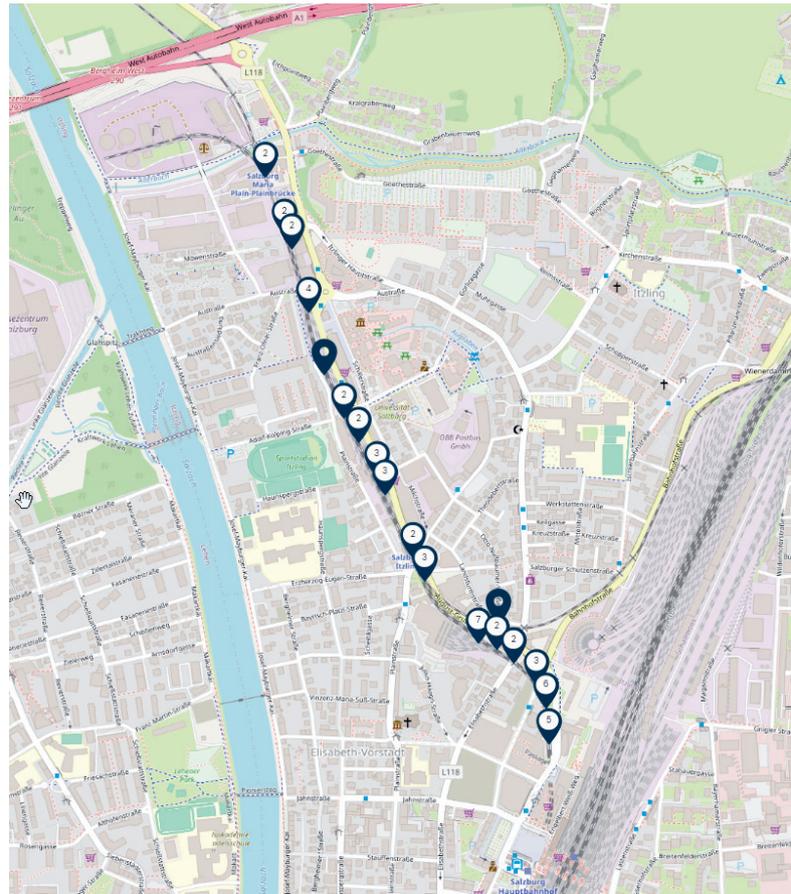
GPS positions of wheel sensors via Motion application

The project was supported by Frauscher's cloud-based application, Frauscher Insights Motion. By providing structured checklists, the app helped streamline the servicing process and enabled thorough documentation of all systems. Serial numbers, sensor positions, current values, and GPS coordinates of the wheel sensors were recorded and are now digitally available for future service deployments.

SLV received a detailed report covering all components, their status, and the measures taken. Operators using the Motion application also gain access to GPS data for future reference.
