## TEST REPORT

No. : GZMR240701935301

Sample Name : Collaborative robots  
Model No. : Product Name: CR5AP; Model Name: DT-CR050A-0P  
Manufacturer : Shenzhen Yuejiang Technology Co., Ltd.  
Other Information : FACTORY:Rizhao Yuejiang Intelligent Technology Co., Ltd.  
Trade Mark:DOBOT

### Summary of Results:

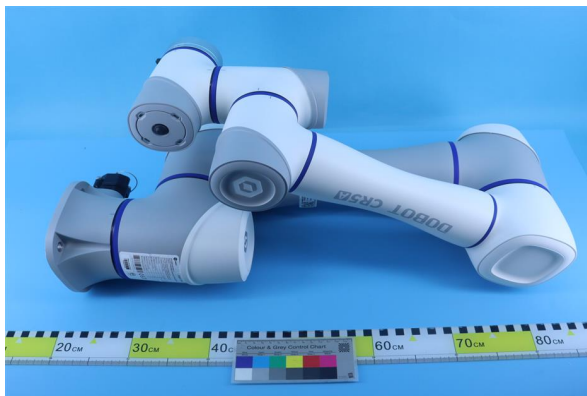
Original Sample-Sample A

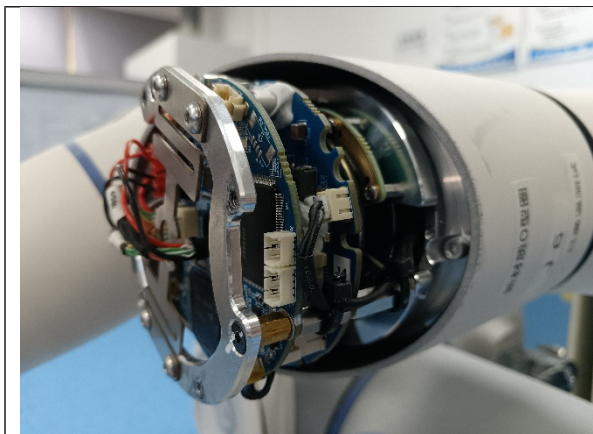
After Test-Local Part

| Specimen | Result | Client's requirement | Conclusion |
|---|---|---|---|
| A-1 | 1.No visible ingress of water.<br>2.The robotic arm was connected to the computer normally and could be active by controlling computer. | 1.No visible ingress of water.<br>2.The robotic arm is connected to the computer normally and can be active by controlling computer. | Pass |

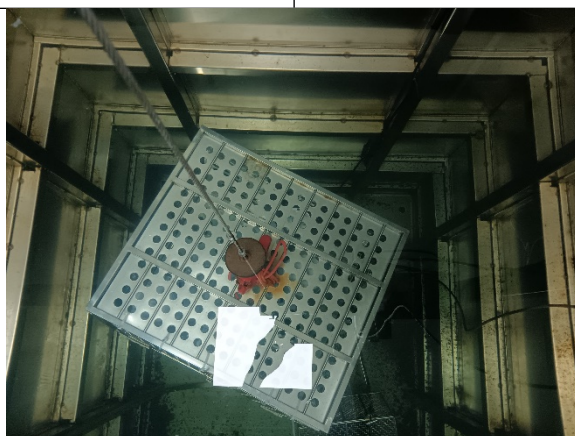
During Test-Sample A

Depth: 1m

Test duration: 72h

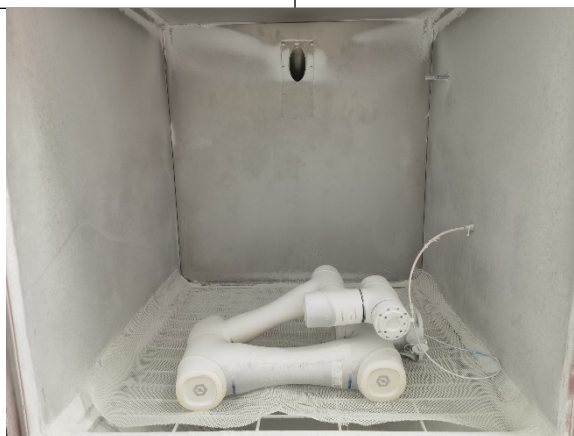
During Test-Sample A

Test Dust: Talcum powder

Dust Concentration: 2 kg/m<sup>3</sup> chamber volume and be kept in suspension during the test

Test Duration: 8 hours
