**Cultural Heritage Study
Ireland's Eye
North County Dublin**

**Dr Clare Crowley, Courtney Deery Heritage Consultancy
On behalf of Fingal County Council**

January 2017

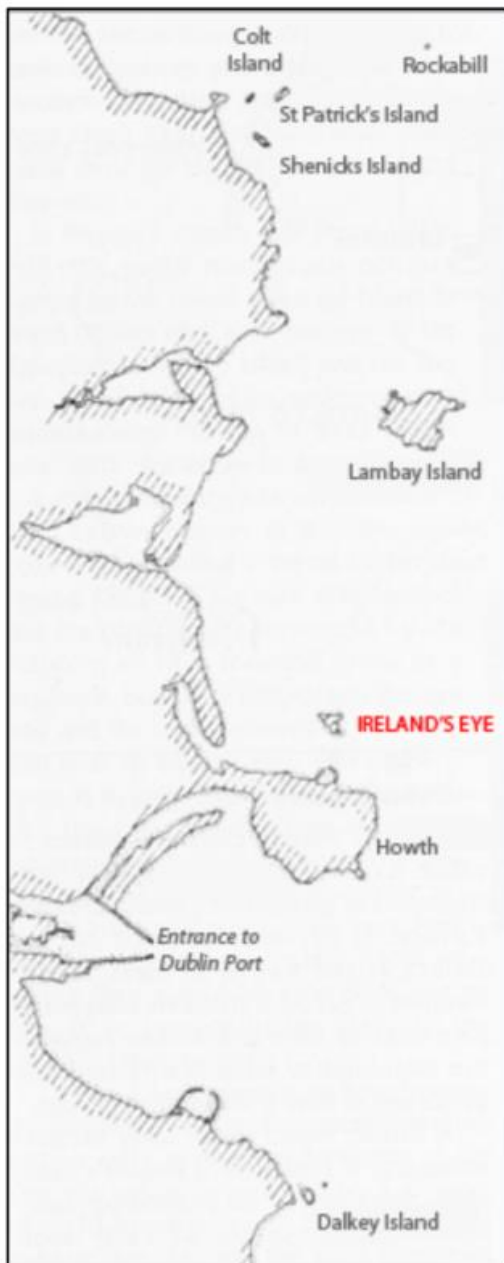
Figure 2 Dublin's Islands (after Cooney 1990)

There is direct evidence for prehistoric maritime activity in the seas around Ireland's Eye, albeit not on the island itself. Ireland's Eye is just one of a network of small islands off the coast of Dublin (Figure 2), within easy reach of the mainland and of each other, with Dalkey Island and a nearby islet (the Muglins) on the south side of Dublin Bay, Lambay Island c. 9km north of Ireland's Eye, and the Skerries islands further north again (Colt, St Patrick's, Shenick, Rockabill and Red Island; the latter now a headland). This grouping of Dublin islands included the nearby Howth peninsula, which was an island during the prehistoric period (it is now joined to the mainland by a sandy isthmus at Sutton Cross), as well as Clontarf Island (a small island of sand and gravel now under the East Wall area). There is an abundance of evidence to suggest that Dublin's coastline – both mainland and islands – was used by Mesolithic people, hunter-gatherers who were exploiting maritime resources; this includes significant Late Mesolithic activity in the form of middens at both Dalkey and at Sutton / Howth Head (RMP DU015-024) and Late Mesolithic fish traps identified in estuarine mud from the River Liffey (Mitchell 1956; Liversage 1968; Woodman *et al.* 1999, McQuade & O'Donnell 2007). Analysis of lithics collected from Lambay Island also revealed definite evidence for the use of the island in the Late Mesolithic period, with strong indications that it was used from the Early Mesolithic (c. 7000 BC) onwards (Dolan & Cooney 2010). At a time when Ireland was densely wooded, boats provided the most efficient means of transport into the interior, via rivers and lakes, while coastal and island hopping would have been the easiest way to communicate in coastal areas.

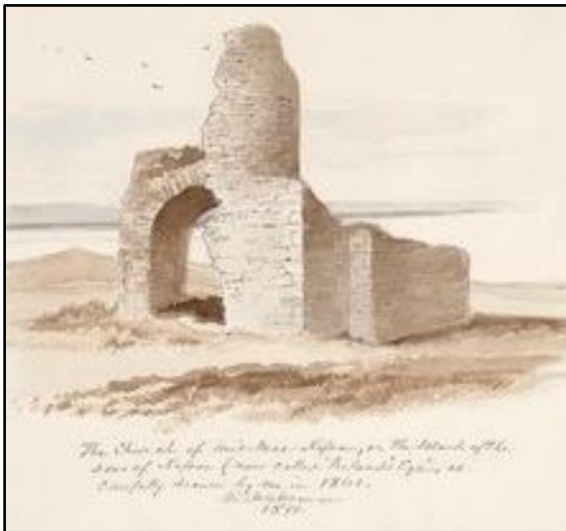
Figure 4 'Base of Round Tower of St Nessian', George Victor Du Noyer, June 1843 (RSAI Library)

The church, which survives currently in its reconstructed form to gable height, is a nave and a chancel construction, aligned ENE-WSW. The chancel is tied into the nave and has a vaulted roof from which rises the partial remains of a round turret (this has been interpreted by some as the remains of a round tower); the sketches by Petrie (1828), Du Noyer (1841) and Wakeman (1843) all show a large portion of the turret still in situ (Figures 4-6). The sketches produced by the antiquarians also demonstrate the degree to which the ruins degraded in the first half of the 19th century and also the extent of the subsequent reconstruction. By the time Wakeman visited in 1843, the whole of the west gable had disappeared, as had the east window and parts of the east wall, along with much of the south walls of the chancel and nave (Figure 5).

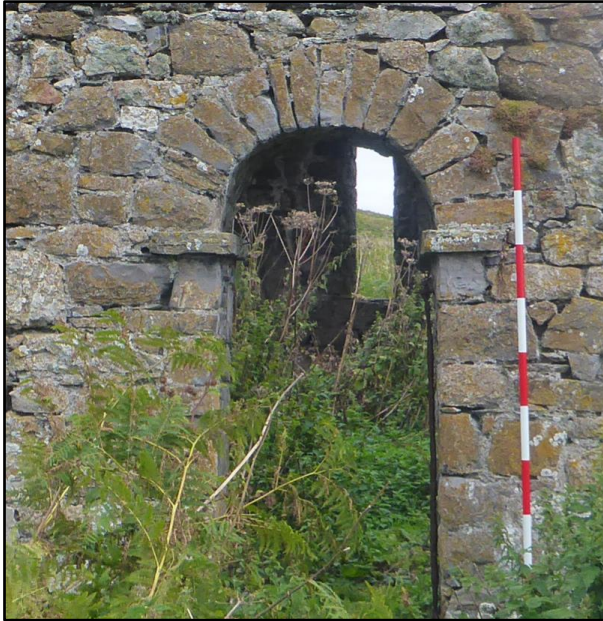
Plate 1 St Nessian's Church,
doorway in east wall

The ensuing restoration works can be seen – still crisp and obviously quite recently completed – in the two photographs taken towards the end of the century (Plates 2 & 3). The turret is, by this time, gone and its base partly or wholly reconstructed along with the east gable wall and window. In addition, the north wall, which is shown on Wakeman's and Du Noyer's sketches with no openings, is now pierced with two small windows (one each in the nave and chancel). More subtle differences include the impostes on the doorway (the projecting blocks embedded in the wall which serve as the base for the lowest voussoir of the arch); as Cochrane (1893) observed, these are now formed of rough hammered flagstones, whereas Petrie's earlier sketch had shown them as chamfered along their bottom edges (Plate 1, Figure 8).

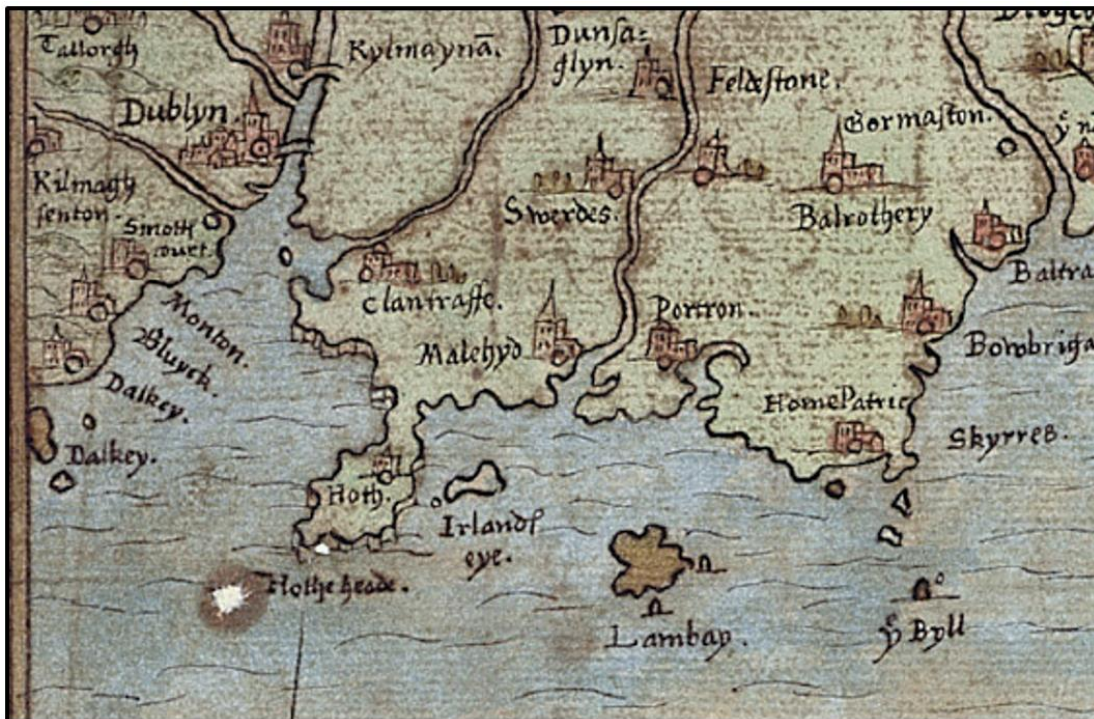
Figure 17 Map of the coast of Ireland from Dublin to Carrickfergus c. 1580

A more detailed map was drawn of the coast of Ireland from Dublin to Carrickfergus c. 1580 (Figure 17); it depicts all of the Dublin islands, including Ireland's Eye, which is located just north of 'Hothe heade' (the island is named and shown in roughly the right shape).

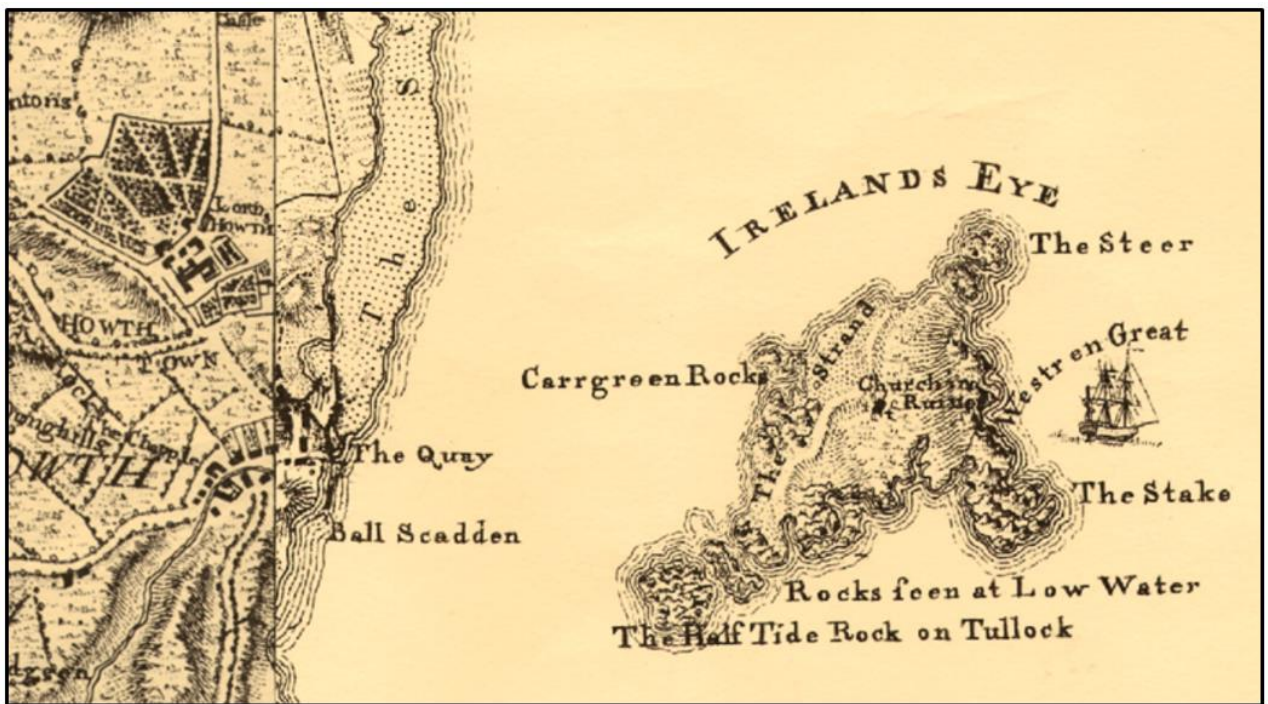
Figure 19 Rocque's map of County Dublin, c. 1760

John Rocque's map of the county of Dublin (Figure 19) was issued in 1760 and provides substantially more detail than the Down Survey maps of the previous century. It depicts the island off the coast of Howth, showing the then small quay and village of Howth, as well as Howth Castle and demesne. Of the island itself, Rocque depicts not only the main landmass but also the many rocks that litter its coastline, naming 'The Steer', 'Carrgreen Rocks', 'Westren Great' and 'The Stake'. He also notes 'The Half Tide Rock on Tullock' (islet) and indicates that the depicted rocks around the coastline are representative of low tide. The map shows the long beach on the sheltered western side of the island ('The Strand') – Carrigeen Bay – and shows St Nessans's Church (annotated 'Church in Ruins'). The tall ship depicted on the eastern side of the island is no doubt indicative of the busy maritime traffic within these waters.

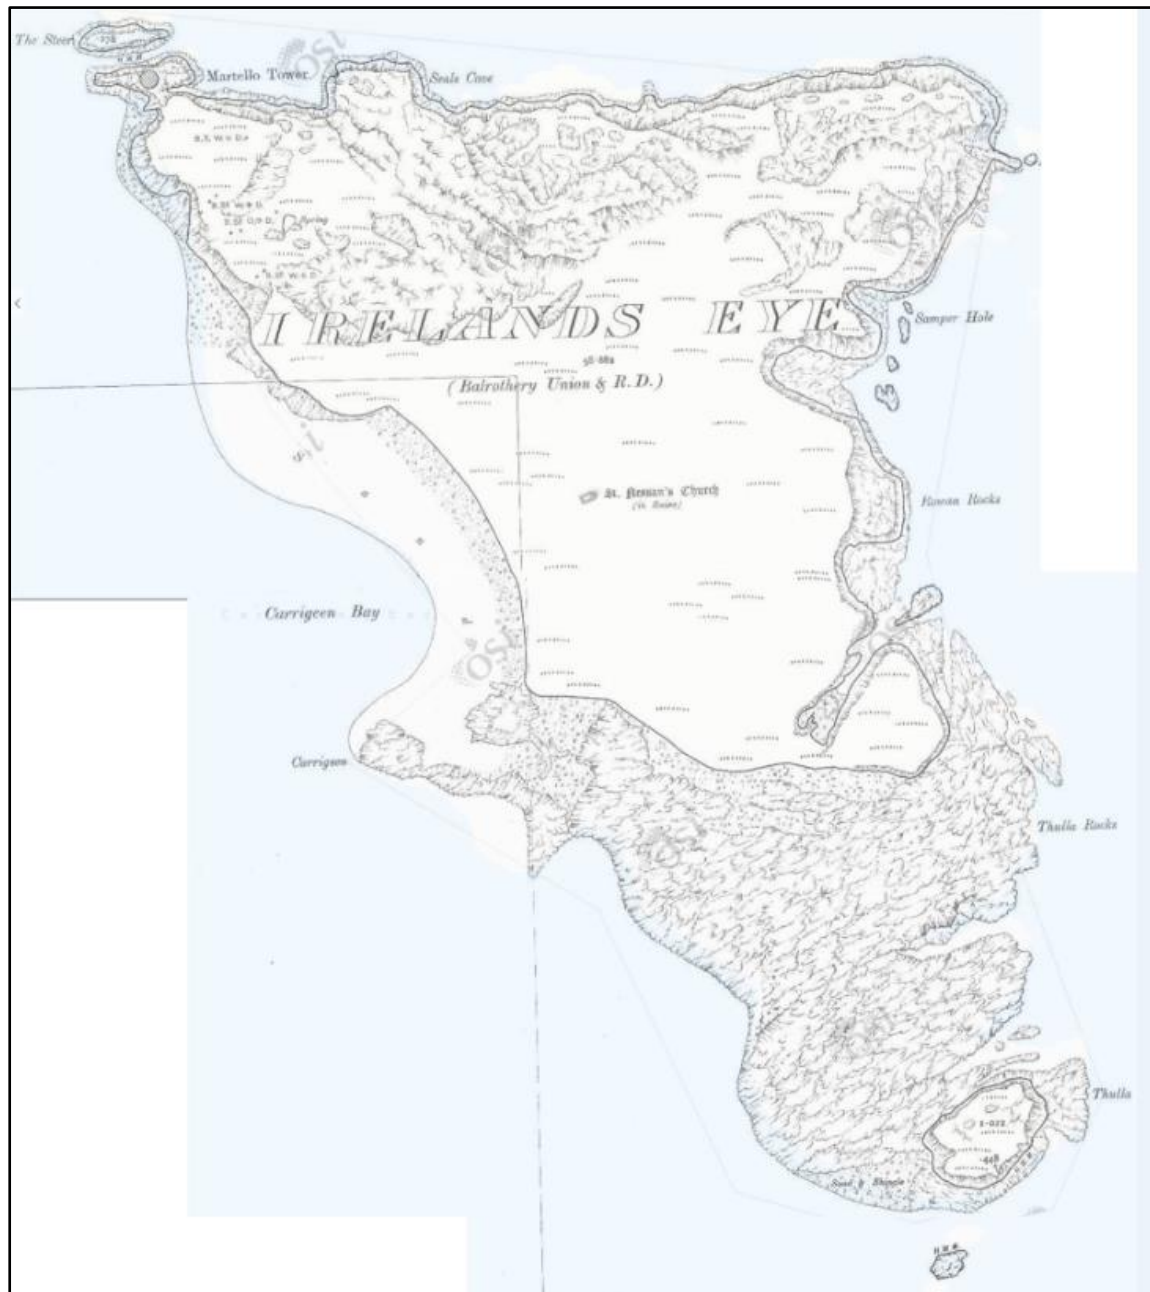
Figure 22 Ordnance Survey 25-inch map, 1906-9

This topography is more clear on the 25-inch OS map (Figure 22), with the smaller scale allowing for additional details, such as the scrub grass across the island, the sand on Carrigeen Bay giving way to small cobbled coves further north towards the Martello Tower, and the sand and shingle marked to the south at Thulla. There are some other features noted on this edition mapping, including the plan outline of the nave and chancel structure of St Nessian's Church (which is annotated 'in ruins'; Figure 21), the War Office boundary stones associated with the Martello Tower (Figure 30; Section 6.3), and the location of the natural spring.

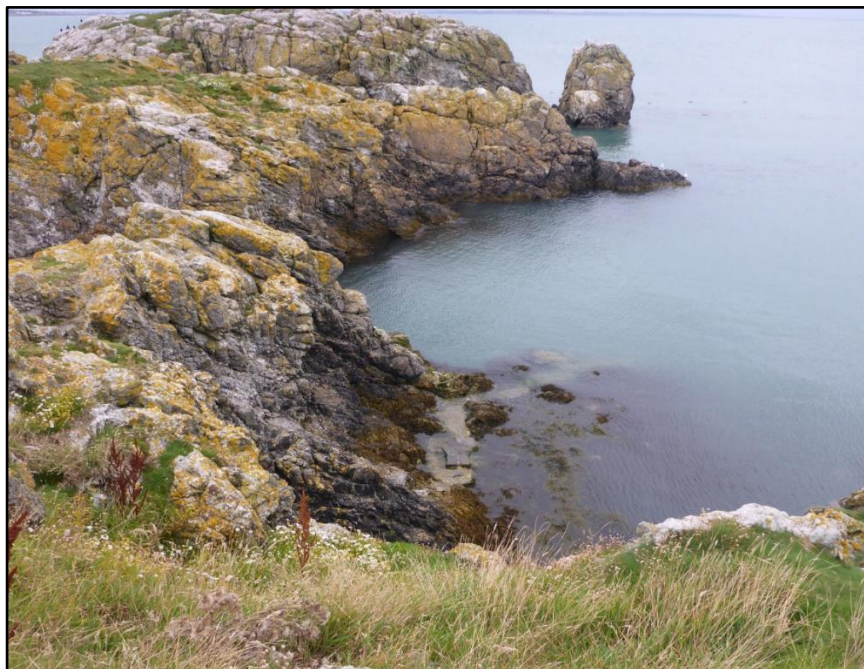
On the eastern side there is evidence of rocks being cut or shaped to create steps to allow easier access up the cliff-side from the water's edge (Plates 7 & 8). This is a much more elaborate landing place compared to the western side, and the steps cut into the steep cliff would have necessitated a considerable amount of effort to achieve. It seems unlikely that local fishermen would invest the requisite time and energy, simply to facilitate the occasional and seasonal tourist visitor. More probable is that the steps were cut to create a new landing place that would allow direct and easy access to the Martello Tower at the beginning of the 19th century. The construction of the tower would have required the delivery and unloading of substantial amounts of heavy material, but given the somewhat precarious nature of the landing place, it seems unlikely (though not impossible) that it could have been used for this purpose. It may well have been created during this initial stage to serve the tower once built, perhaps for those times when the tides rendered the western landing point unusable. A concrete platform has been added at the base of the steps to allow a more sure footing from the boat to the steps.

Plate 7 View down to eastern landing place from cliff-top

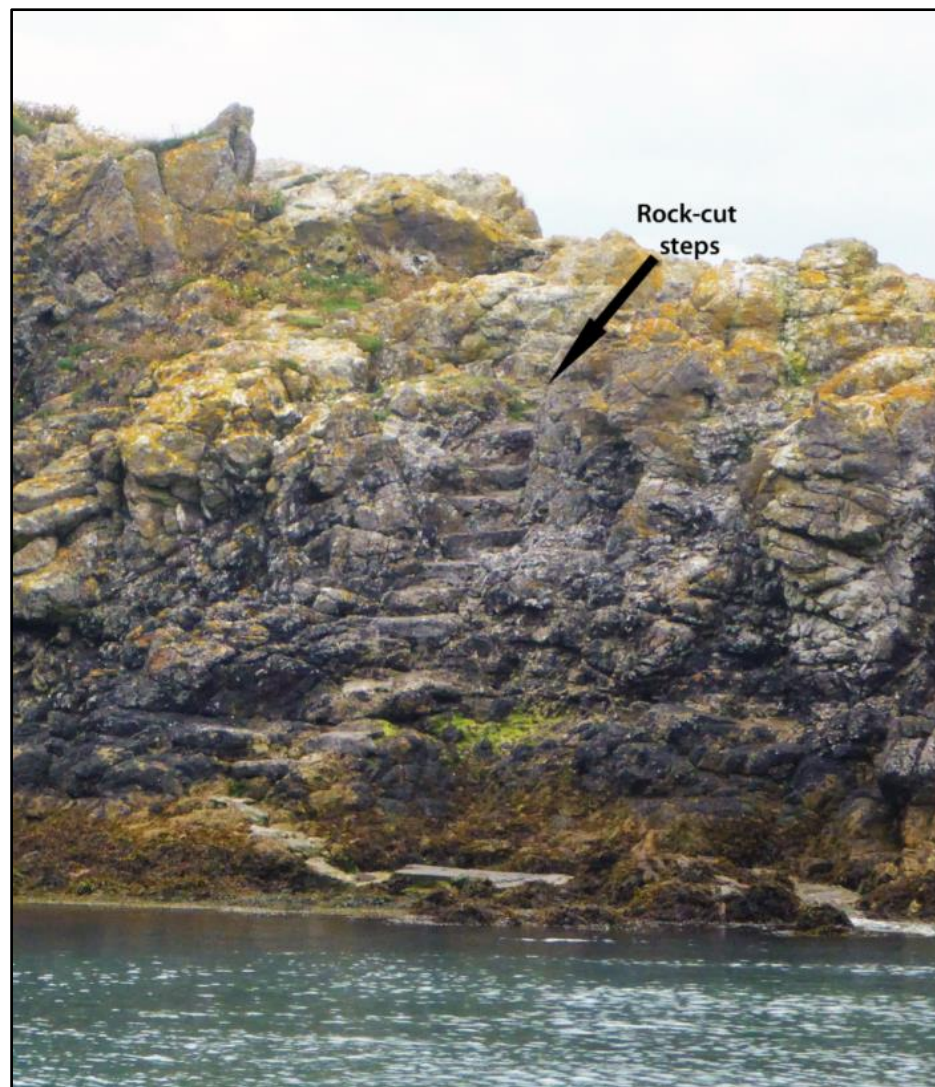
Plate 8 Rock cut steps down to eastern landing

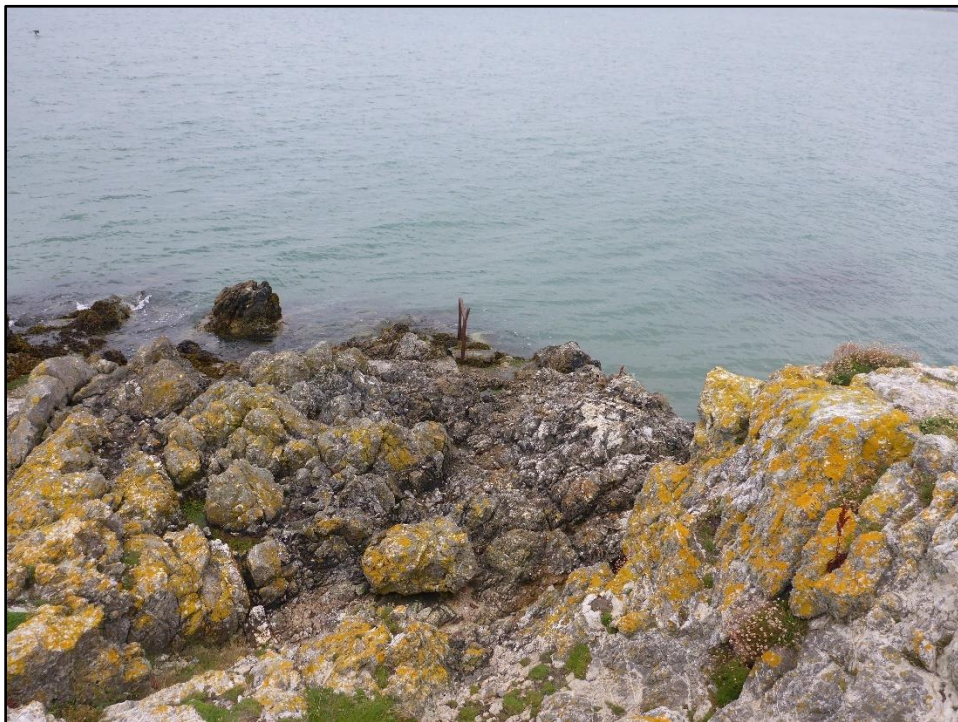
Plate 9 Iron railing at western landing place

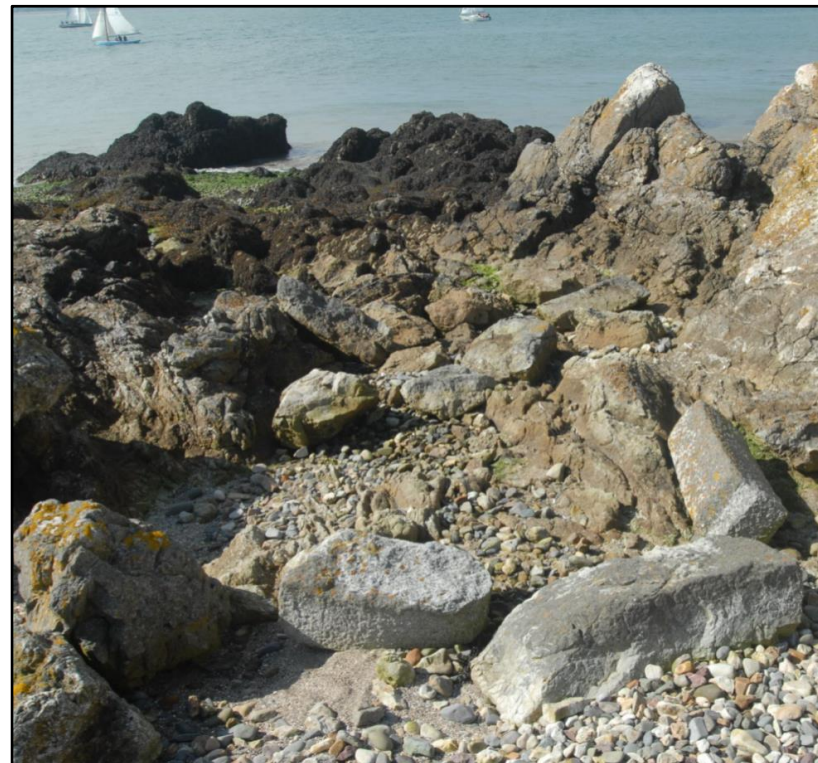
Plate 10 Cut-stones on shoreline, west of Martello Tower (Photo courtesy of Jason Bolton)

Bolton has previously observed three large granite stones that were left over from the construction of the string course and box machiolation on the Martello Tower still lie on the cobbled beach below the structure (Bolton *et al.* 2012; Plate 10). These were not visible at the time of the inspection, as they lie below the high-tide mark.

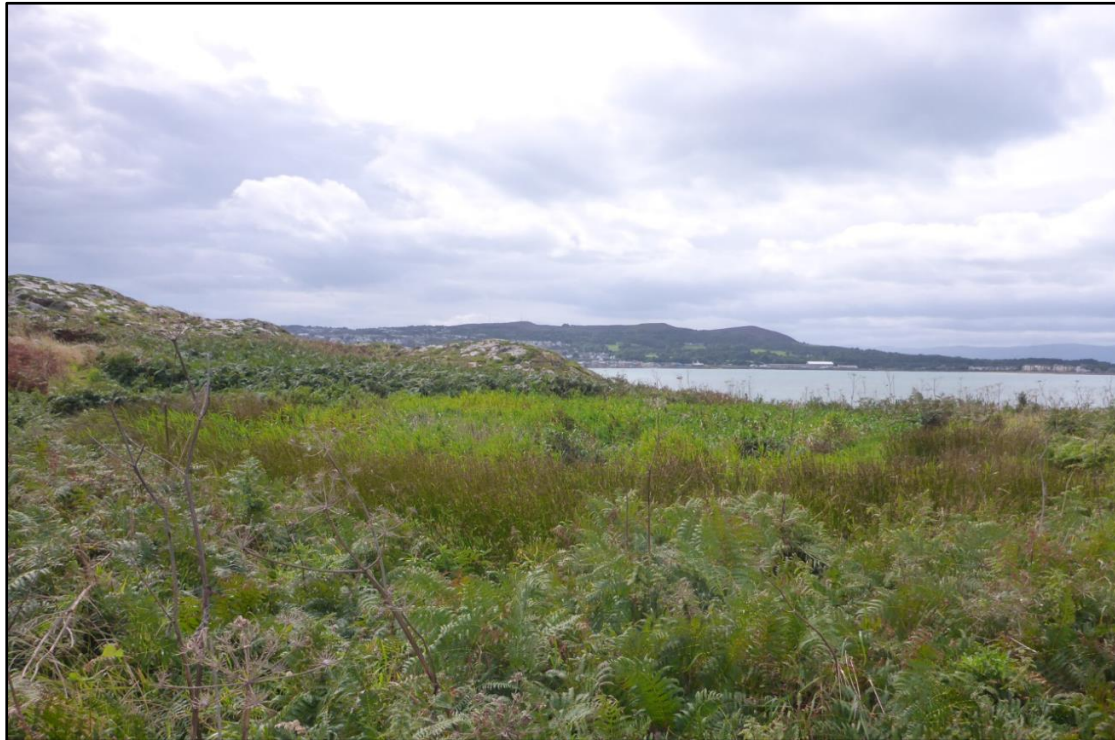
Plate 12 Natural spring in the northwest quadrant of the island, facing south (the spring is visible in the image as a large area of light green vegetation ringed with brown).

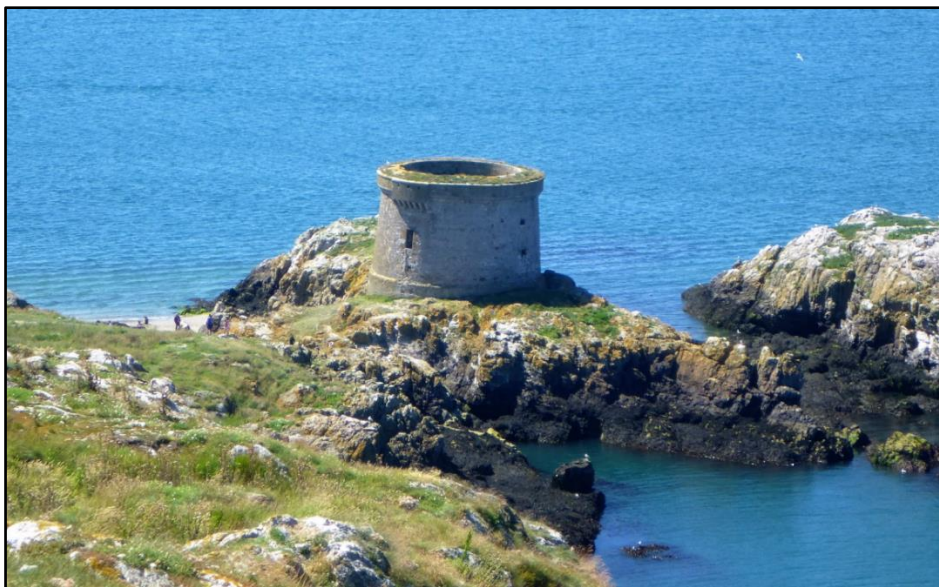
The Martello tower (RMP DU015-016; RPS No. 589) is by far the most prominent and the best preserved of the archaeological monuments on the island. It stands proud on a natural rise, on the rocky promontory at the north-western tip of the island (Plates 13 & 19). The views from the tower site are impressive and were undoubtedly even better from the now inaccessible rooftop.

Plate 13 Martello Tower, facing northwest

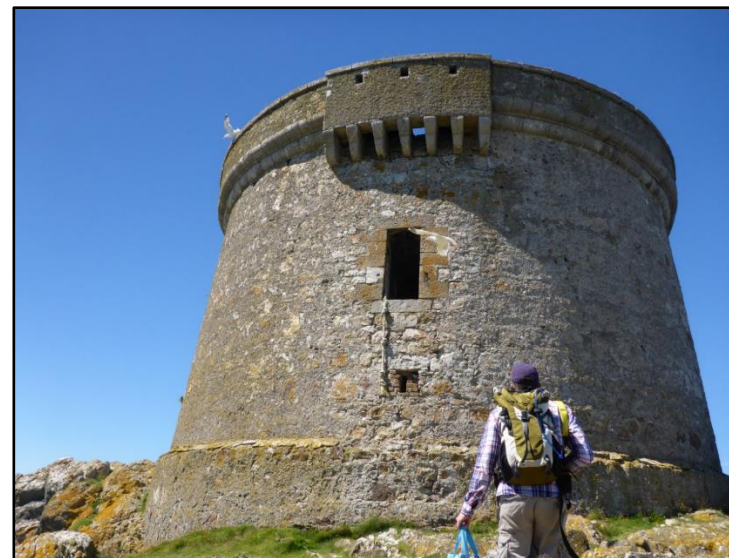
The raised doorway on the south side of the tower was designed to deter attackers (much like the early medieval round towers that still stand on some of the Irish ecclesiastical sites) and access today can only be gained by climbing the rope that hangs from the stone door-jamb (Plate 14). In addition to the doorway, there are small opes on the east and west sides, as well as a small opening with brick insertions beneath the doorway (possibly a later, partial repair). The interior of the tower has been lime-washed and the graffiti on it is evidence of past visitors to the island (such as D. Quinn, who etched his name into the wall in 1940, presumably at a time when the floor was still in place; Plate 16). The original wooden flooring at first-floor level has been removed (the raised doorway provides an entrance to this level), though the remains of the timber supports can still be seen in the wall. This has left the undercroft exposed and revealed a large iron storage chest still in situ, as well as the random-rubble stone partition walls that divided the area into three small spaces (Plate 15). Where the limewash has eroded from the roof of the tower, the brick-construction of the slightly domed top can be seen (this doming is not visible from the outside as it is hidden behind the parapet walls).

Plate 14 Martello Tower, facing north, showing raised doorway and machiolation

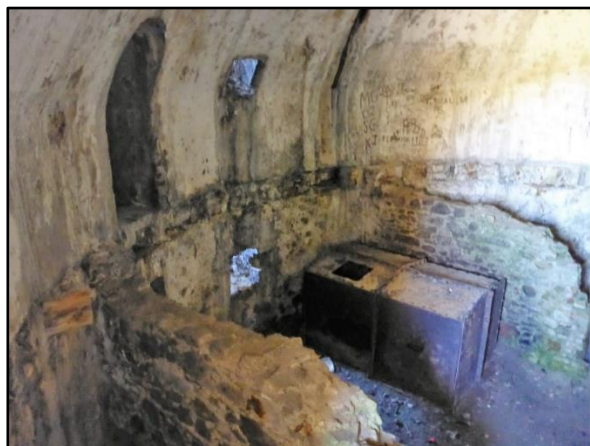
Plate 15 View of interior of tower, showing metal trunk and walls dividing undercroft

pierce the walls, means that the interior of the structure is at least partially open to the elements. There has already been some damage to the internal fabric of the tower, where the flooring at first floor level is gone and graffiti litters the walls. Damp was reported as a particular problem for the tower in the first half of the 19th century; in the 1820s the window frames were broken and by 1829 it was reported that ‘the damp is fast injuring the floor’ (Bolton 2008). Continual exposure to the elements now could lead to further damage to the structure. As the monument is still roofed and is currently structurally sound, it is imperative that it is not allowed to advance further into a state of dereliction.

It is also recommended, as a minimum requirement, that the Martello Tower be made weather-tight by replacing the door and window glazing, to protect the monument from further deterioration. Despite access to first floor level being only possible by climbing a rope attached to the inside of the stone door-jamb, the graffiti inside the tower is an indication that the structure is vulnerable to vandalism; replacing the door would allow access to the interior to be controlled if that is deemed necessary. Proposals to replace the door and windows or for any other repairs or works to the tower should only be undertaken following consultation with the National Monuments Service and Architectural Heritage Advisory Unit of the DAHRRGA and under the supervision of a conservation architect.

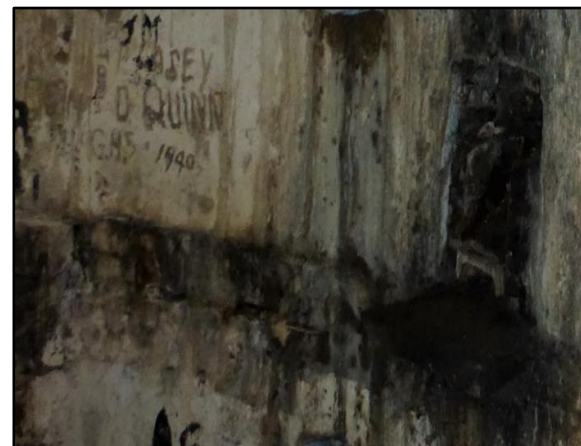
Plate 16 Interior of tower, showing graffiti above original floor level

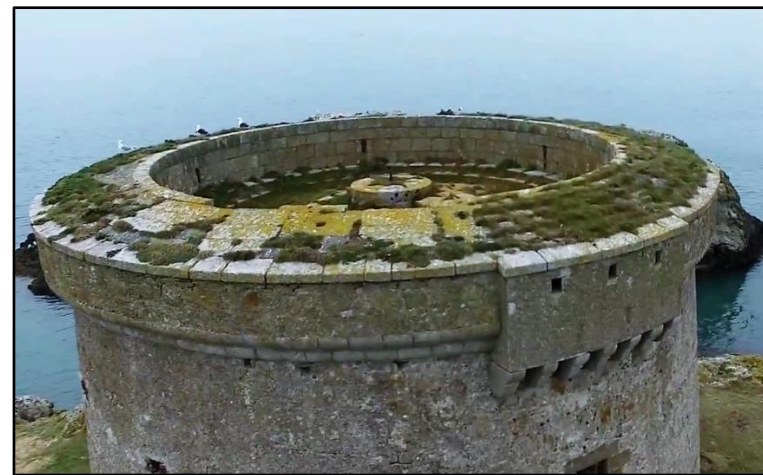
Plate 18 View of tower roof from Drone footage (courtesy of Ken Doyle, Ireland's Eye Ferries)

Vegetation growth is not as big a problem on the exposed rock outcrop that houses the Martello Tower. That being said, the drone imagery provided by Mr Doyle shows grasses and lichen growing on the rooftop and in the roof space (only some lichens types can cause damage; expert advice should be sought). The original door into the Martello Tower is no longer present, and this fact, when added to the presence of the small unglazed opes that

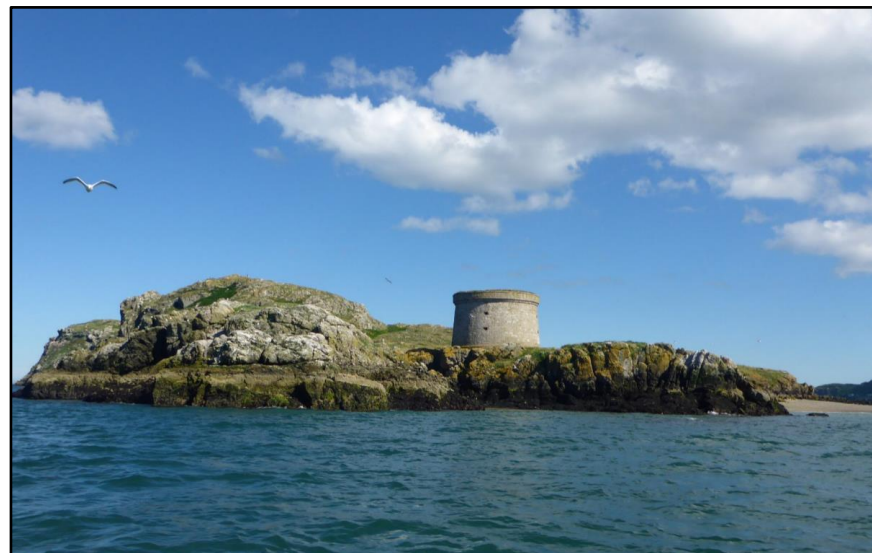
Plate 19 View of Martello Tower, facing south

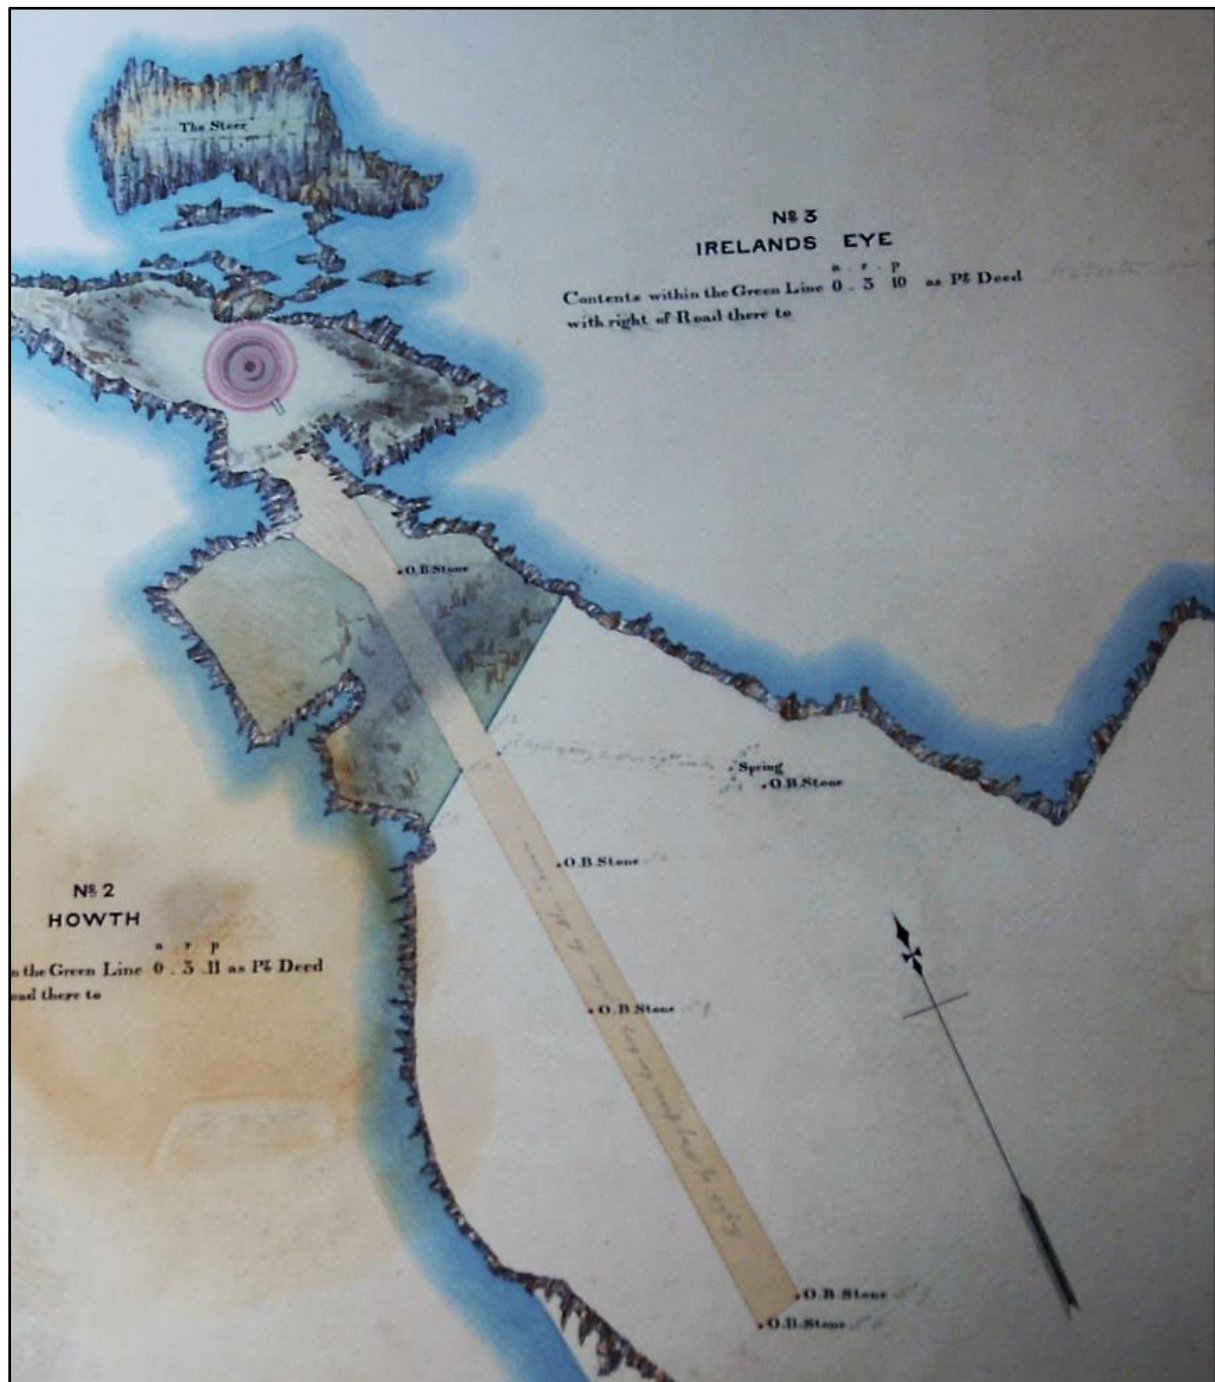
The site of the tower is one of the least changed in Dublin – no doubt owing to its remoteness – and its original layout can still be discerned by the placement of the Board of Ordnance and later War Office boundary stones that marked its land extents and rights-of-way. The War Office re-surveyed the land extents associated with all of the Martello Towers after they took over in 1855/6, usually removing the original boundary stones and replacing them with granite ones. They also appear to have increased the overall number of stones at the sites so that the boundaries were more clearly marked on the ground. That this is the case at Ireland's Eye is apparent from a comparison of an 1848 plan of the site now held in Kew Archives (Ref. MPH 1-662; Figure 29), which shows six boundary stones (marked 'O. B. Stone'), and the 25-inch OS map of 1906-9, which shows nine (Figure 30).

Figure 29 Board of Ordnance Plan, 1848, showing locations of boundary stones (National Archives, Kew)

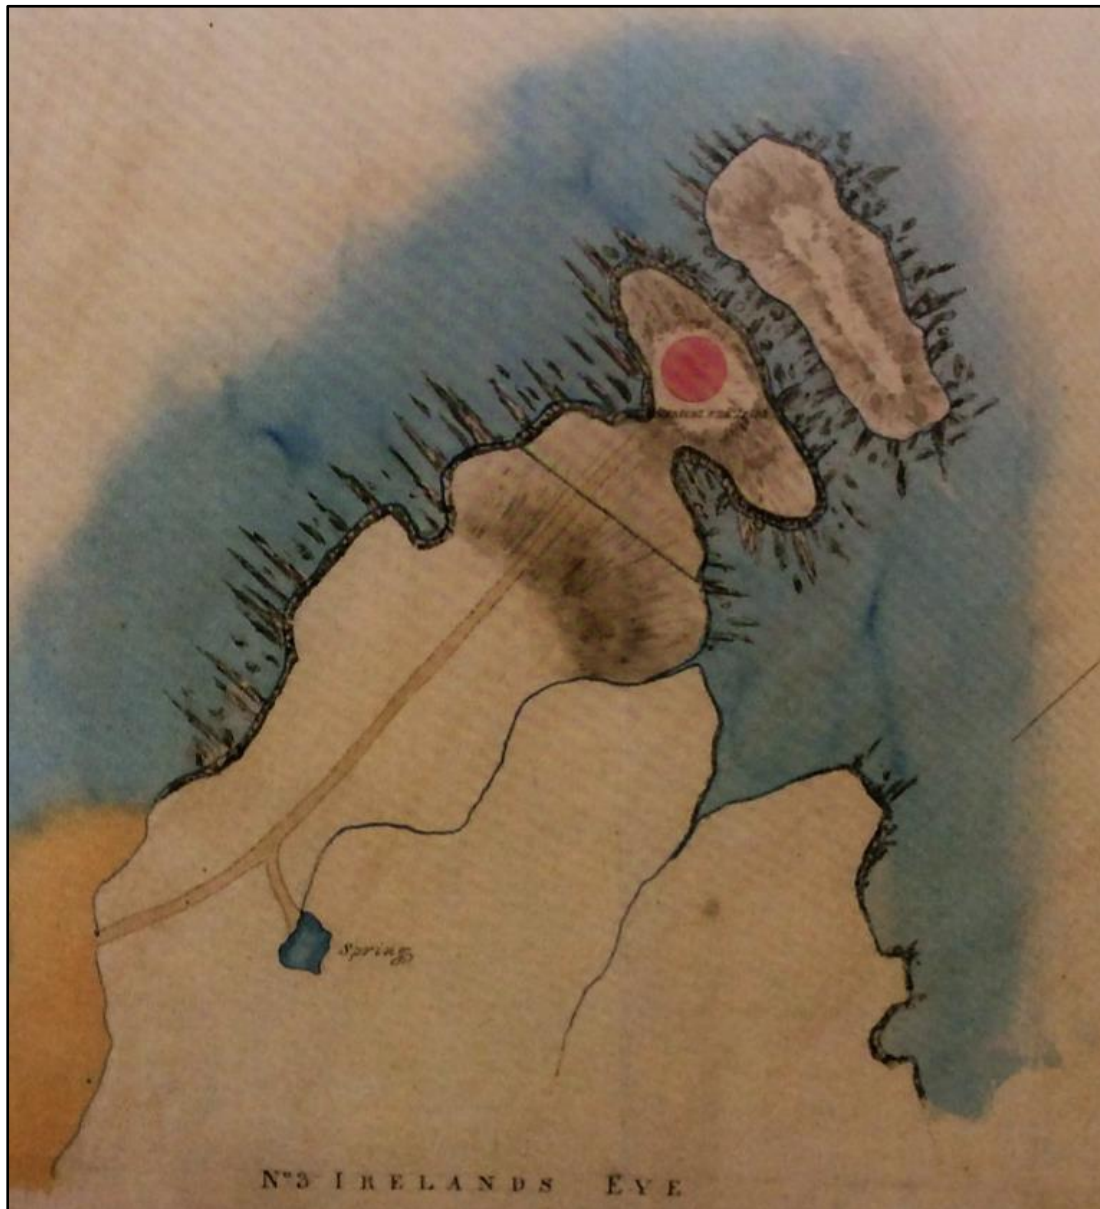
The earlier plan (Figure 31) depicts an access route running from the beach at Carrigeen Bay to the tower, annotated as the 'right-of-way from landing place to tower', with a pathway way diverging east / northeast to the spring (also annotated as a right-of-way). One of the boundary stones is shown at the spring, on its southern side, with the others demarcating the main access route (a pair of stones mark the beginning of the pathway close to the beach, two stones are staggered along the midway point, one to the east and one to the west, and a third is located close to the tower). Although a line is drawn on the map to indicate the Board of Ordnance lands (this area is coloured in, showing grass and scrub, with the lands outside it left blank), there are no stones marking the boundary. In contrast, the 25-inch OS map edition of 1906-9 depicts nine boundary stones: three parallel pairs aligned along the access route which runs northwest from beach to tower; one each to the north and south close to the cliff-side, marking the extent of the Board of Ordnance lands; and one at the spring.

Figure 31 Board of Ordnance Plan, c. 1805, showing rights of way to Martello Tower (Botlon *et al.* 2012)

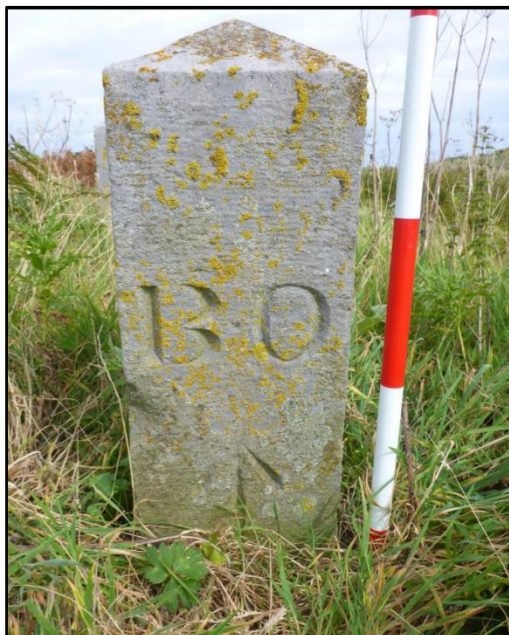
Plate 20 Original limestone Board of Ordnance boundary stone

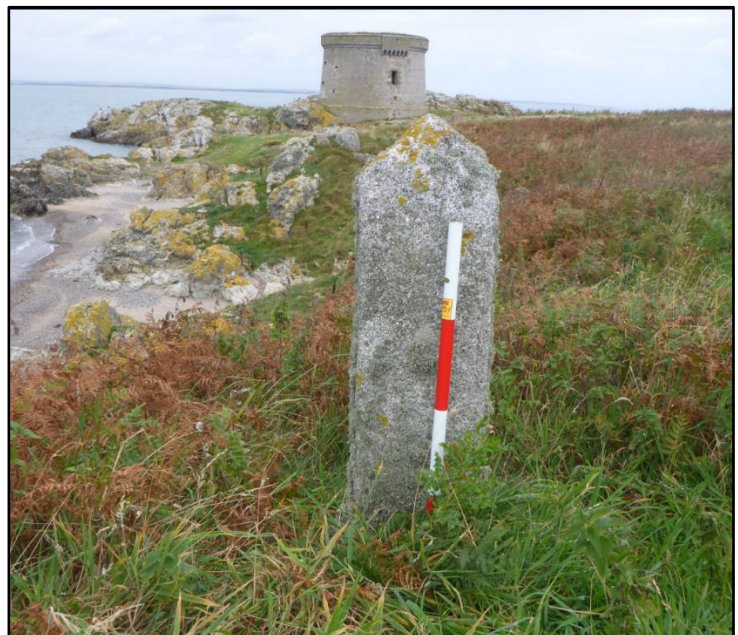
Plate 21 Granite War Office replacement boundary stone, with Martello Tower in background

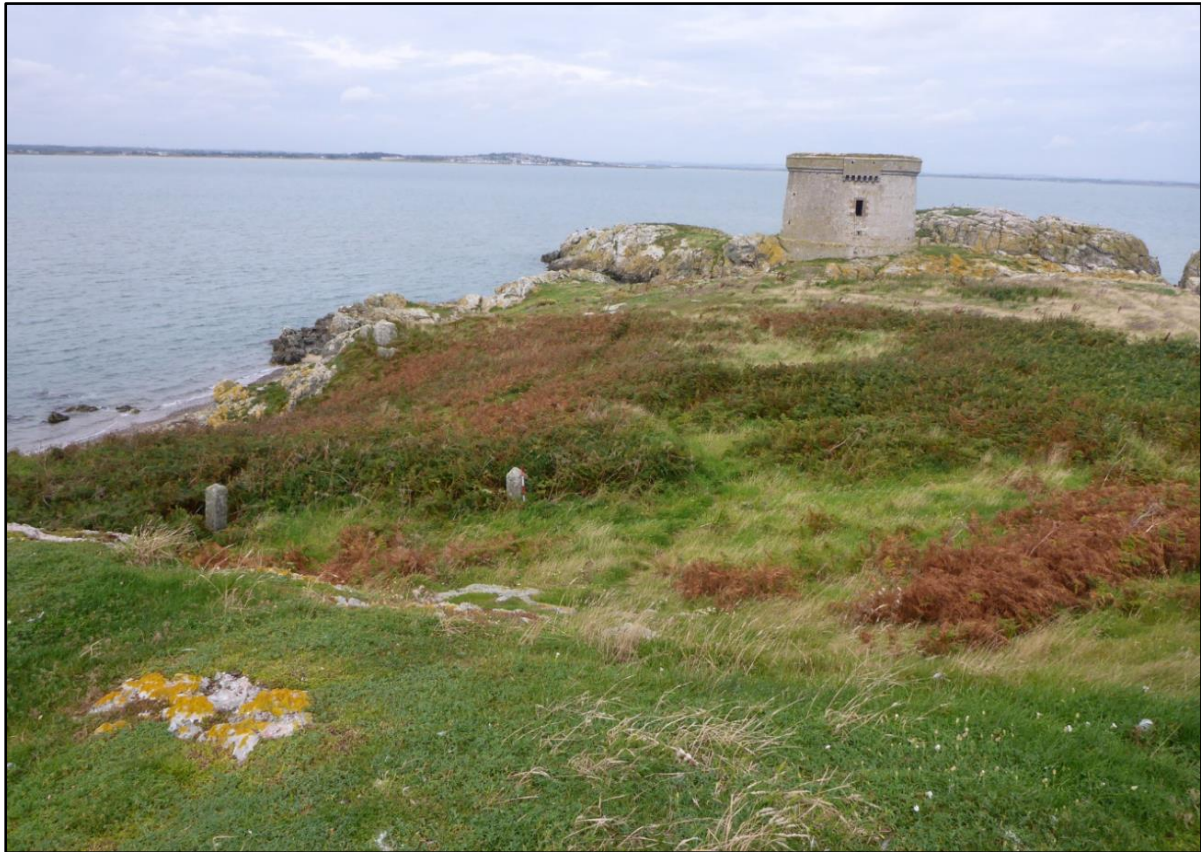
Plate 22 View from rock outcrop showing level ground to south of Martello Tower containing boundary stones (visible to left) and possible promontory fort site (SMR DU015-133)

There were no visible traces of the features identified by Casey (1999) on aerial photography as a possible promontory fort (SMR DU015-133; Plate 22). The abundant protruding natural rocks and the overgrown nature of the site make it difficult to discern any patterns on the ground. This small headland is fairly level, however, with a large section of rising rock outcrop forming a natural boundary between it and the rest of the island, and the natural spring located just beyond it. The relatively level area between the Martello Tower and the rock outcrop measures approximately 90m by 50m or c. 0.45 hectare (coastal promontory forts can vary considerably in size: e.g. on Lambay Island, the smaller of the two measures c. 75m by c. 25m or c. 0.18ha, with the larger one c. 190m by c. 85m or c. 1.6ha, while Drumanagh Fort is an expansive 13ha). Although the rock outcrop provides a natural boundary, it also allows a vantage point over the level area, which would appear to be a disadvantage from a defensive point of view. On such a small island, however, a defensive boundary may not have been required, but simply one that divided the 'fort' or settlement area from the rest of the land mass.

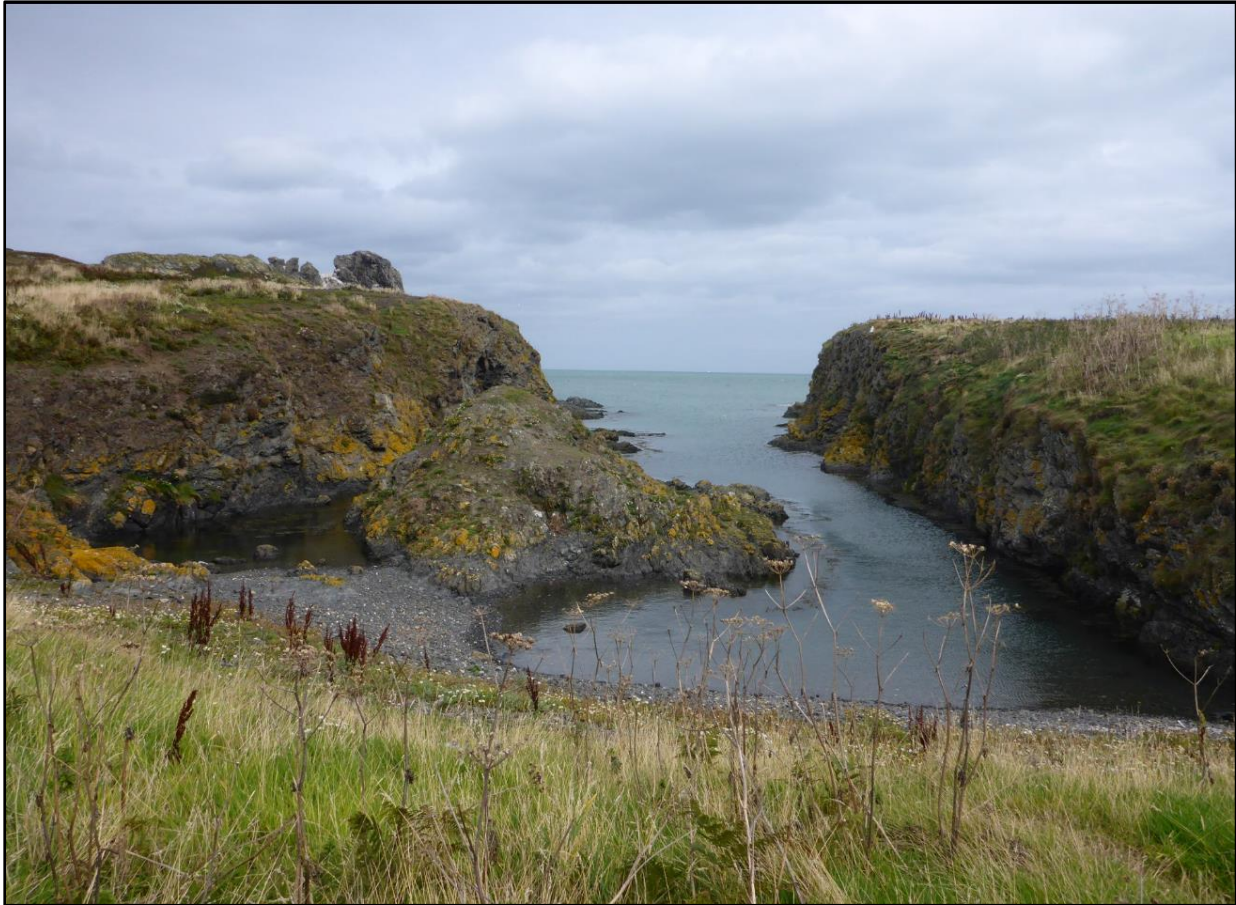
The Long Hole is an inlet located at the south-eastern end of the island, narrow at the entrance and wider towards the head, with steep cliffs on either side (Plate 23). A small, curved cobbled beach sits just beyond the low, grass-covered dunes that line the island's beaches. A large rock protrudes from the water, dividing the channel into two, with other smaller rocks visible in the water close to the beach. This little inlet has a peaceful aspect and provides

Plate 23 The Long Hole viewed from the sand dunes above the beach, facing northeast

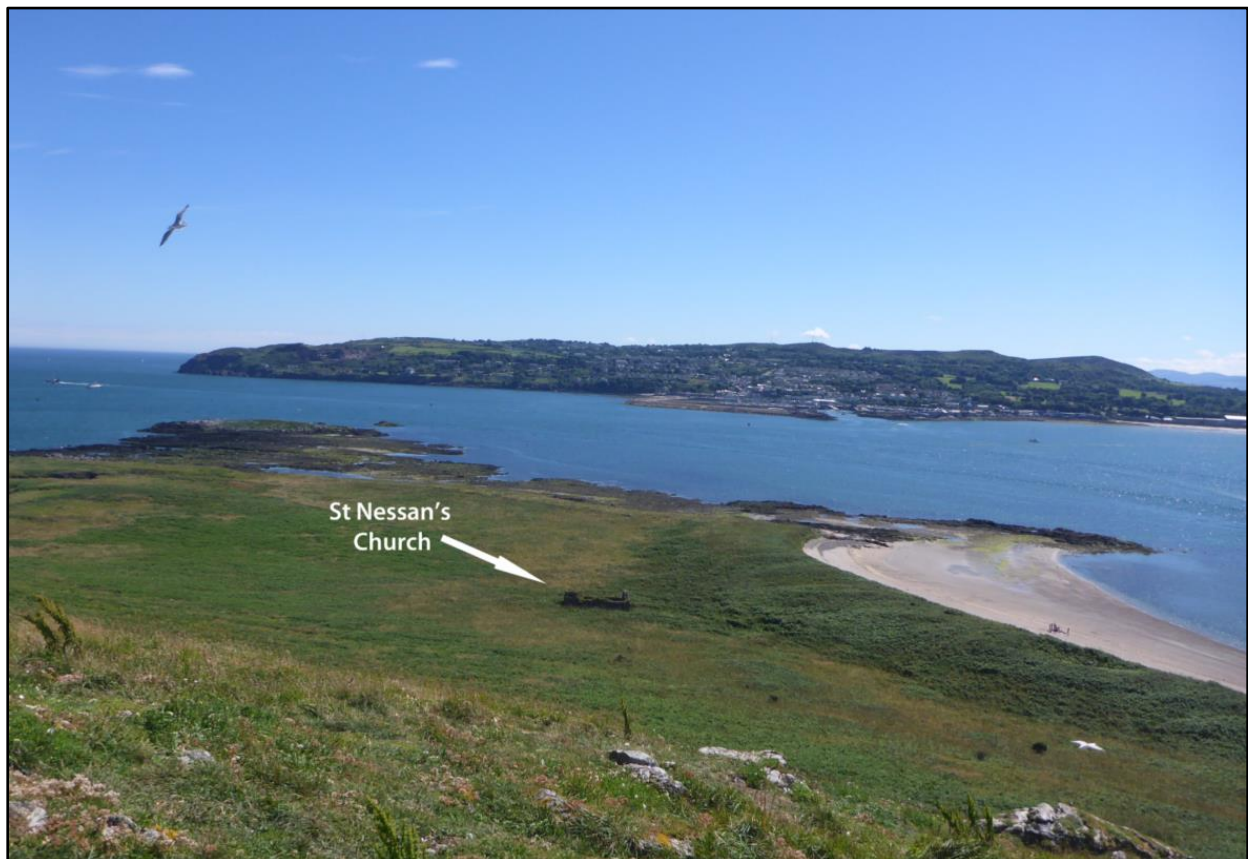
Plate 24 View of St Nessian's Church (DU016-001001), facing south towards Howth Head

Uncontrolled vegetation growth can cause considerable damage to a masonry ruin. St Nessan's Church underwent significant reconstruction in the 19th century and at present the ruins appear stable. Nonetheless, the nave of the church is un-roofed and the structure is open to the elements (a roof is a structure's greatest defence against the elements). A more immediate problem for the church, however, is the encroaching vegetation, which has begun to colonise the interior and was also evident on the chancel roof, the wall tops and the face of the north wall. While this does not appear to be a significant problem yet, the situation will require regular monitoring.

In the absence of a full condition survey, and at a minimum, it is recommended that St Nessian’s Church be monitored on a regular basis (e.g. once a year at the end of the growing season) to assess the extent of the vegetation growth in and on the structure. Should the vegetation require removal or controlling, this should only be undertaken following consultation with the National Monuments Service (DAHRRGA) and under the supervision of a conservation engineer and / an archaeologist, as deemed appropriate by the National Monuments Service.
