**Cultural Heritage Study
Ireland's Eye
North County Dublin**

**Dr Clare Crowley, Courtney Deery Heritage Consultancy
On behalf of Fingal County Council**

January 2017

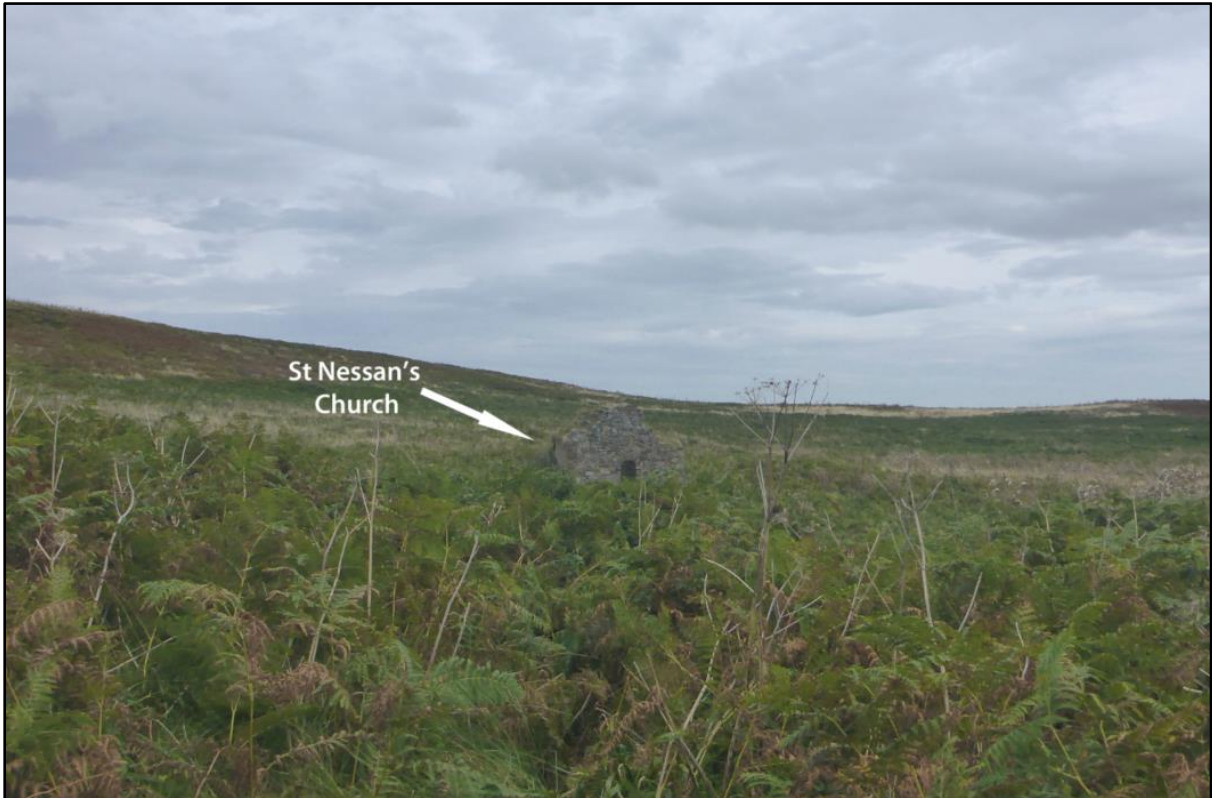
The recorded church ruins (RMP DU016-001001) occupy the most sheltered location on the island, on the leeward side of the high cliffs that dominate its north and east shores. The church site appears carefully chosen, nestled in a shallow depression in relatively low land above the beach. It has good views back towards Howth Head and the mainland, and it is surrounded by a broad sweep of land that rises gradually up from the beach at Carrigeen Bay to the cliffs (Plate 24). There is no obvious or clear pathway to accessing the ruins, with the significant overgrowth of bracken and briars making approaches from all angles difficult. The combination of the local stone used to construct the church, its location in a slight dip and the overgrowth of vegetation can make the church almost invisible in the landscape (Plate 25 & 26).

Plate 25 View east of St Nesson's Church

In the absence of a full condition survey, and at a minimum, it is recommended that St Nessian’s Church be monitored on a regular basis (e.g. once a year at the end of the growing season) to assess the extent of the vegetation growth in and on the structure. Should the vegetation require removal or controlling, this should only be undertaken following consultation with the National Monuments Service (DAHRRGA) and under the supervision of a conservation engineer and / an archaeologist, as deemed appropriate by the National Monuments Service.

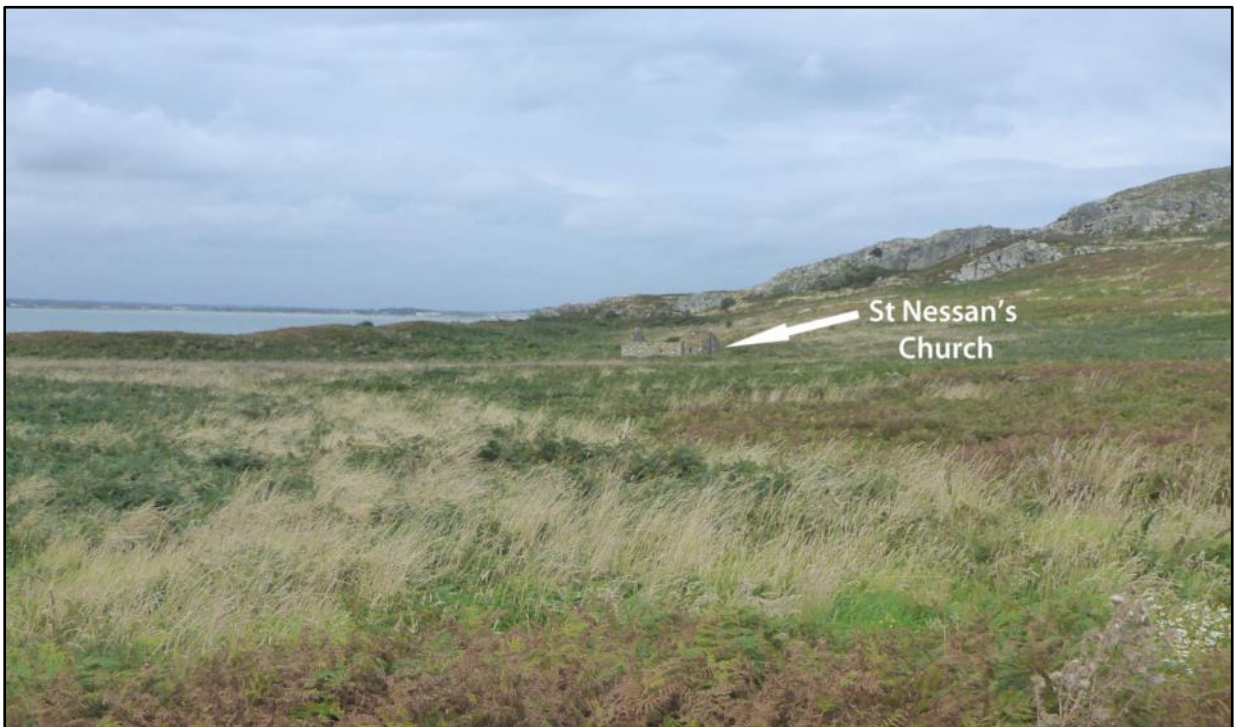
Plate 26 View north / northwest of St Nesson's Church

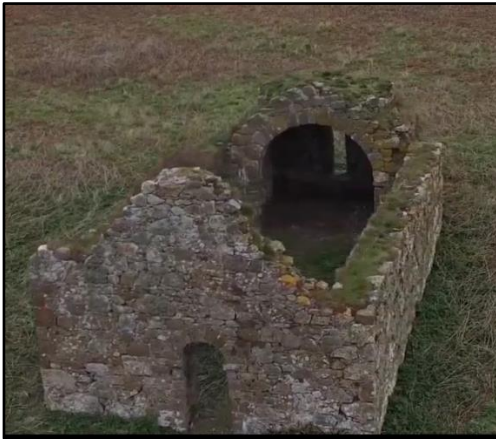
Plate 27 View east of St Nessian's Church from Drone (courtesy of Ken Doyle, Ireland's Eye Ferries)

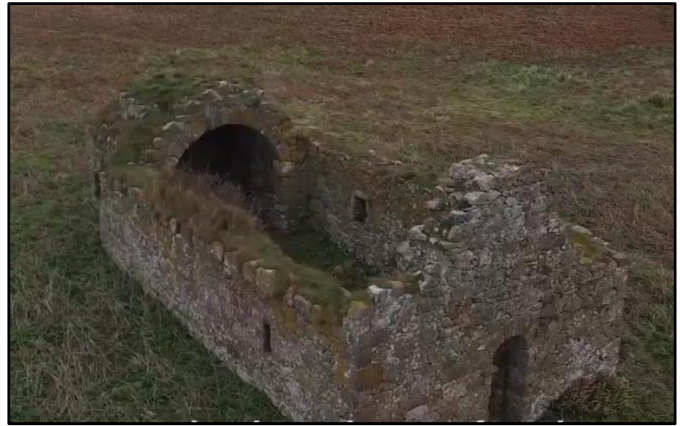
Plate 28 View southwest of St Nessian's Church from Drone (courtesy of Ken Doyle, Ireland's Eye Ferries)

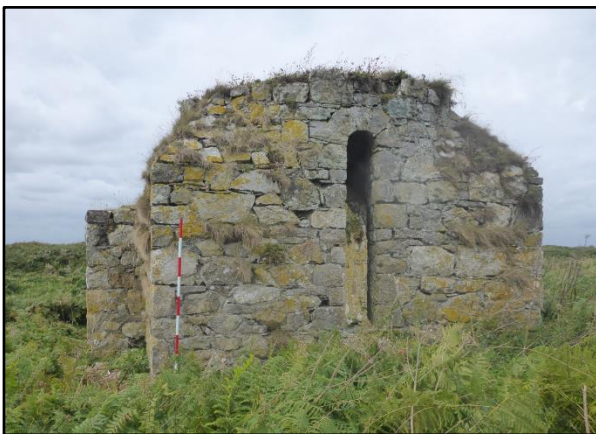
Plate 29 West gable of St Nessian's Church, showing tall arched window

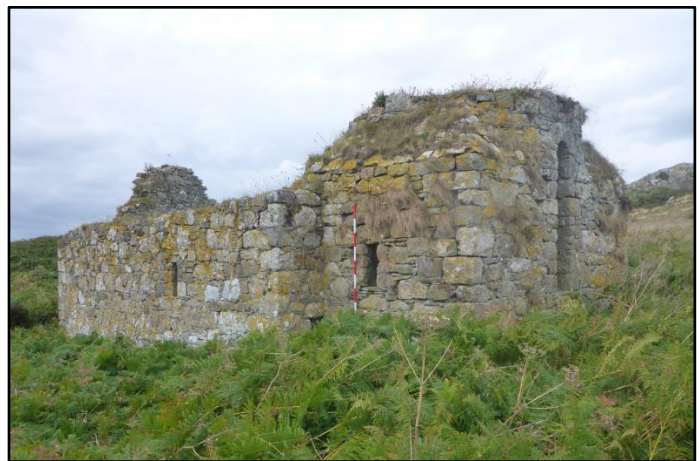
Plate 30 North walls of nave and chancel, St Nessian's Church

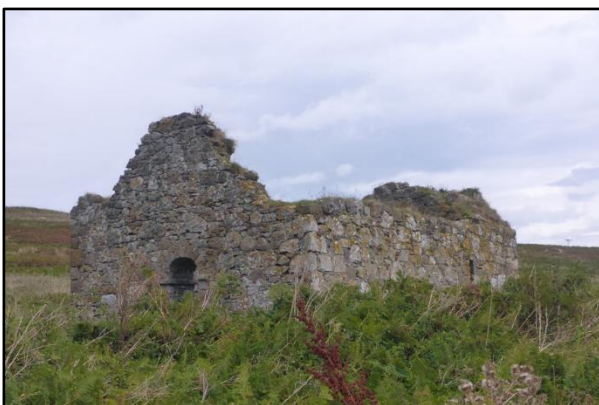
Plate 31 West gable and south wall of nave, St Nessian's Church

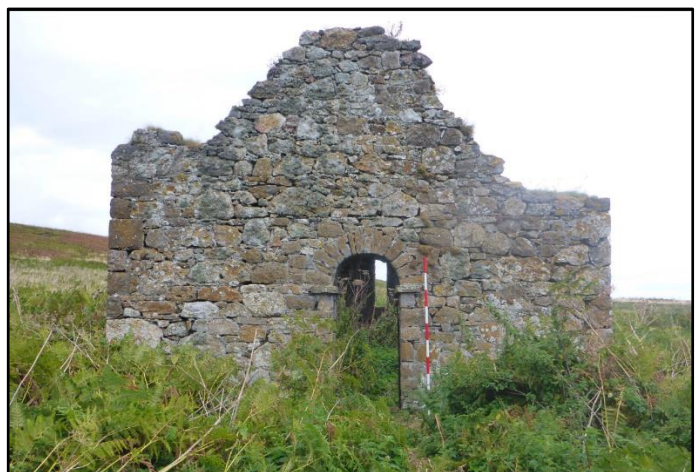
Plate 32 East gable of St Nessian's Church

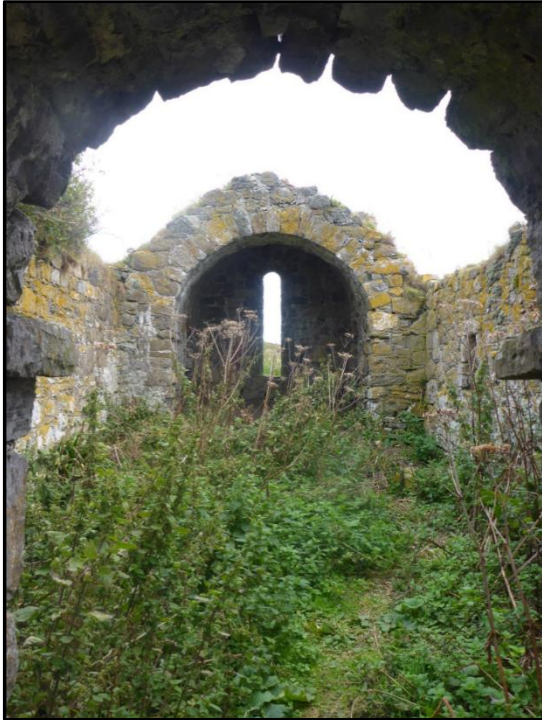
Plate 33 Interior of church: View from east doorway towards chancel

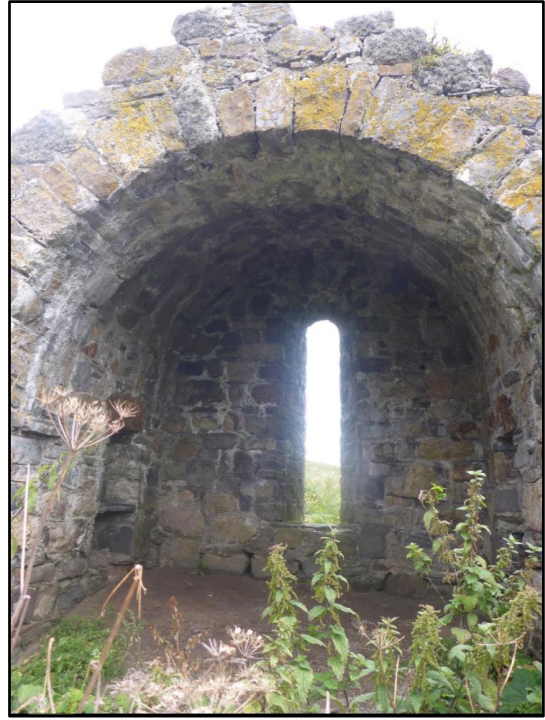
Plate 34 Interior of church: Chancel

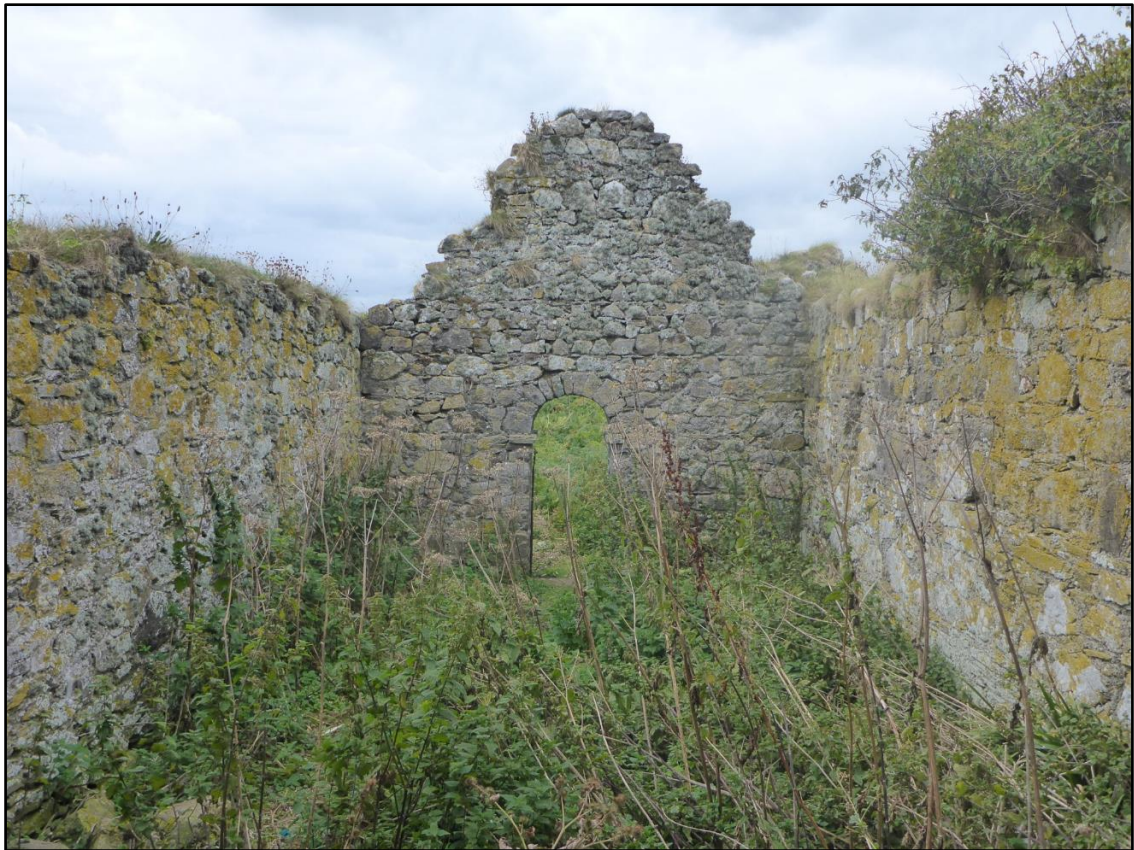
Plate 35 Interior of church: Nave

Uncontrolled vegetation growth can cause considerable damage to a masonry ruin. St Nessan's Church underwent significant reconstruction in the 19th century and at present the ruins appear stable. Nonetheless, the nave of the church is un-roofed and the structure is open to the elements (a roof is a structure's greatest defence against the elements). A more immediate problem for the church, however, is the encroaching vegetation, which has begun to colonise the interior and was also evident on the chancel roof, the wall tops and the face of the north wall. While this does not appear to be a significant problem yet, the situation will require regular monitoring.

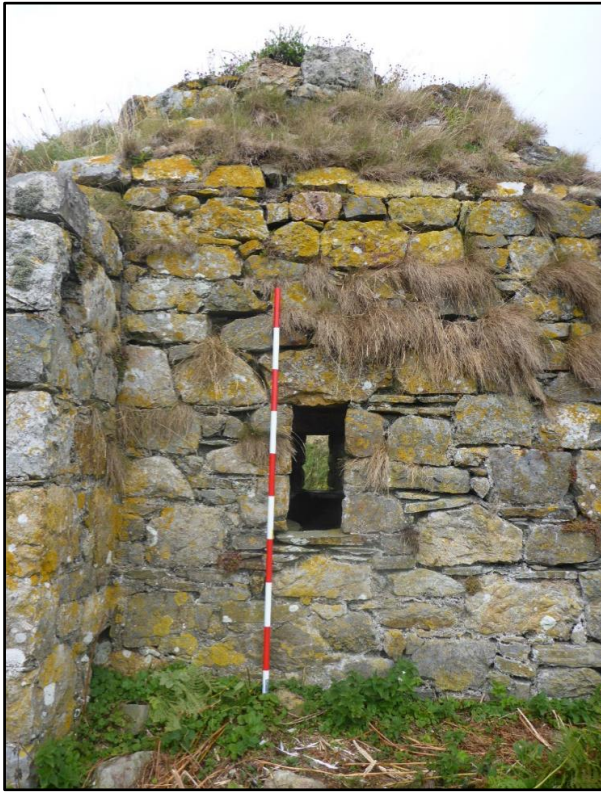
Plate 36 View through both windows of chancel from exterior, facing north

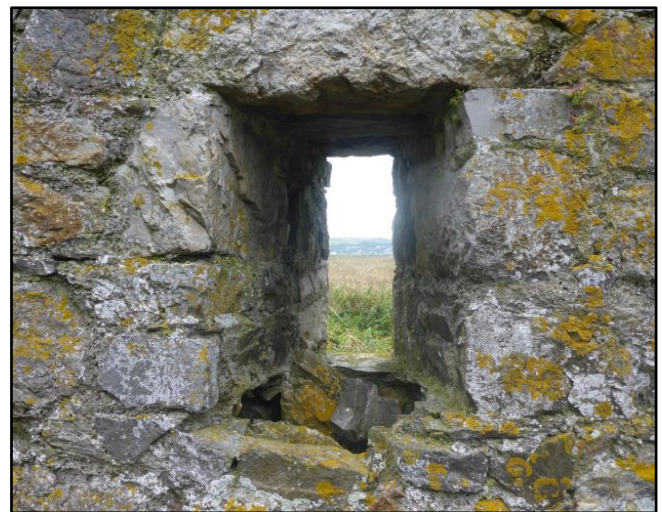
Plate 39 Interior of church: window in north wall of nave

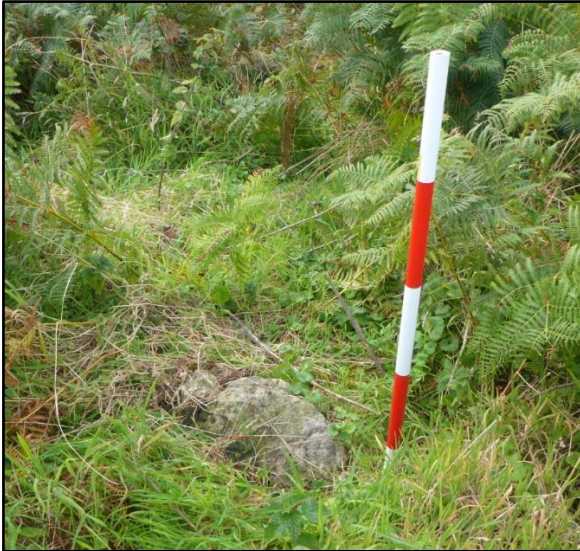
Plate 40 Stone set into ground on east side of church

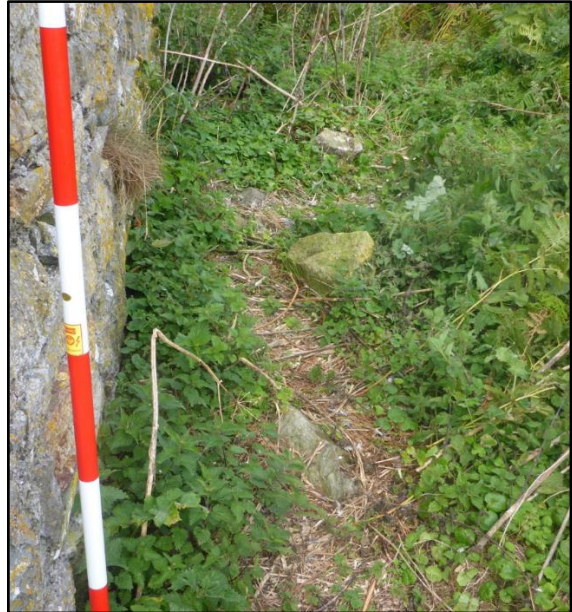
Plate 41 Stones set into ground on south side of church

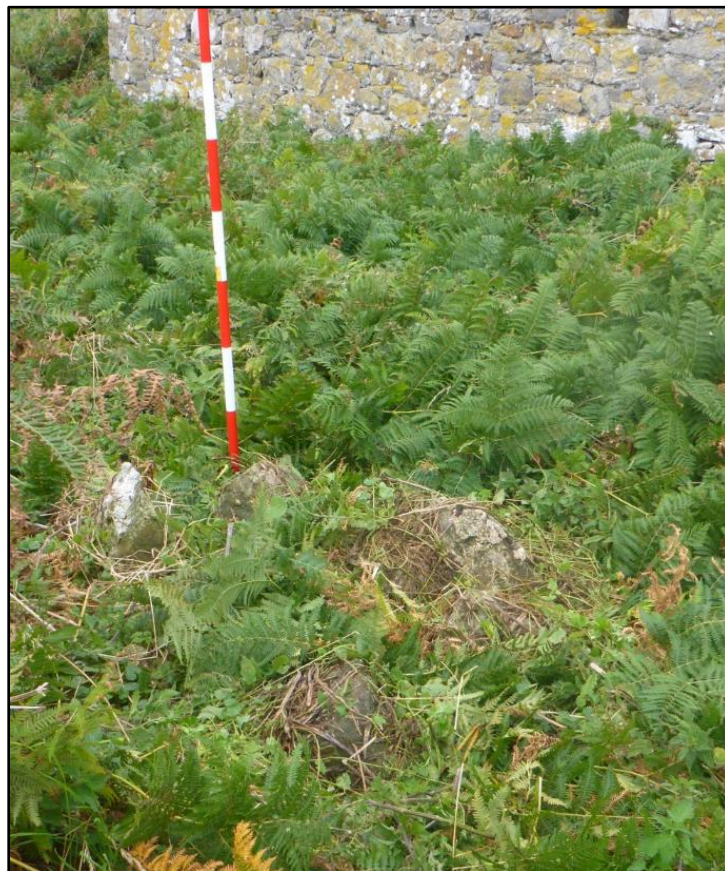
Plate 42 Stones set into ground on south side of church

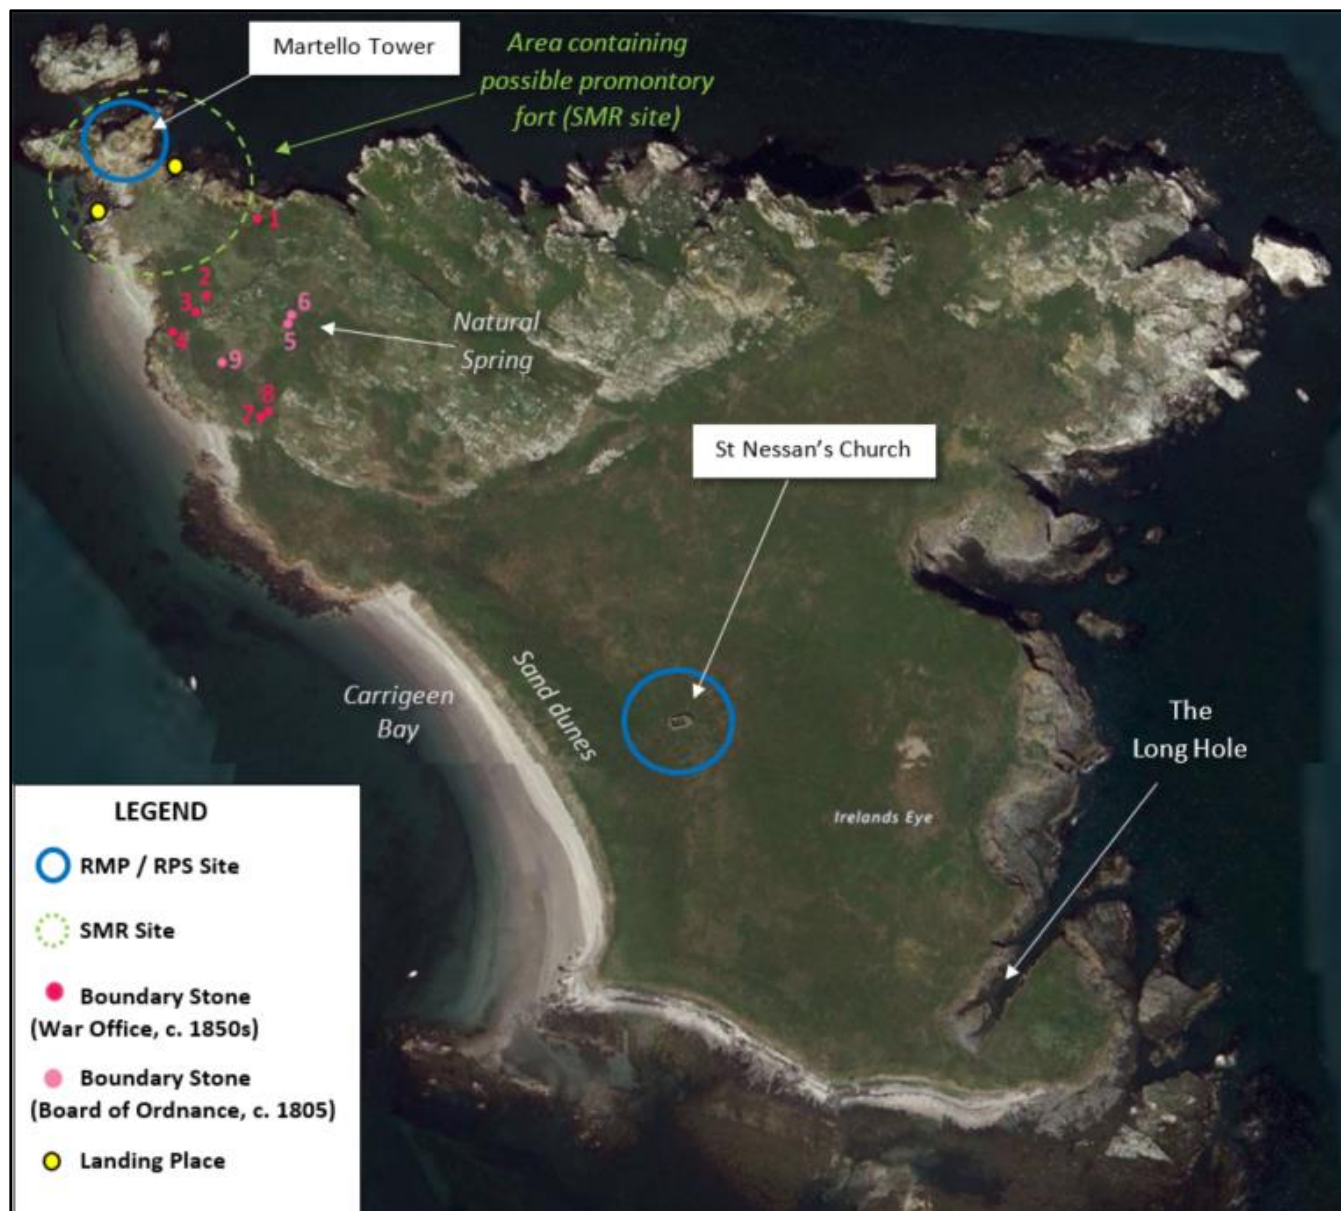
Figure 32
Aerial Photograph showing the location of cultural heritage features on Ireland's Eye

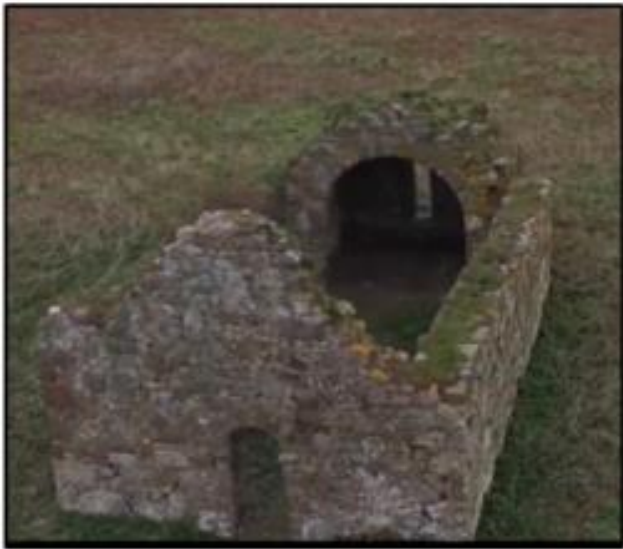
Cultural Heritage Feature	St Nessian's Church
Statutory Protection	RMP DU016-001001
Location	In the southern half of the island, on its western side, overlooking Carrigeen Bay (ITM 728698,741190)
Description	The ruined remains of a pre-Norman structure (nave and chancel) that was heavily reconstructed in the later 19 th century (Cf. Section 5.5.1). The stone structure now stands to gable height (in its reconstructed form) and is heavily overgrown with vegetation, in its interior, on its walls and in its surrounds. It appears to have changed little since the reconstruction, as evidenced by comparison with the 19 th century antiquarian drawings. Access to the church is made difficult by the dense vegetation that covers the interior of the island. This ground cover also obscures any potential archaeological features associated with the early medieval ecclesiastical settlement that may survive in the area around the church. Possible stone burial markers were noted on the south and east sides of the church. Probable associated cist burial uncovered during ploughing in the 1860s (RMP DU016-001002).

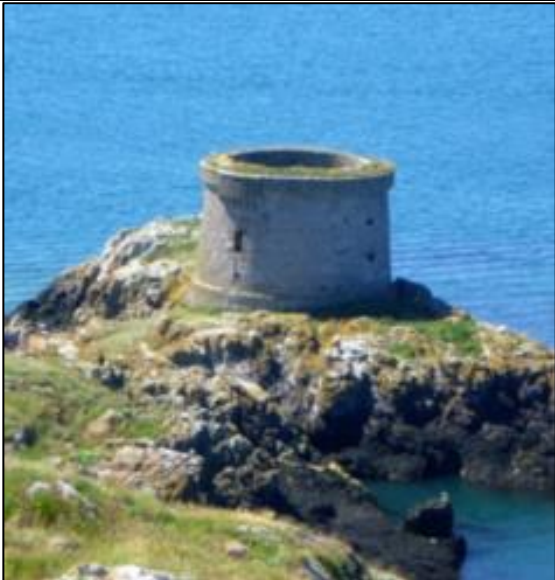
Cultural Heritage Feature	Martello Tower
Statutory Protection	RMP DU015-016 / RPS No. 589
Location	On a small rocky peninsula at the northwest tip of the island (ITM 728345,741526)
Description	A prominent structure, built c. 1805, as one of a group of towers positioned around Dublin Bay. The rendered rubble exterior is in good condition, as are the masonry elements in the machicolation, the rooftop corbels and the door frame. Inside, the original floor is gone and graffiti litters the walls. Impressive views of the structure from high points on the island and from the sea on the approach from Howth. Its relationship with the Board of Ordnance (BO) boundary stones that still stand on the island has been lost. The stones themselves (catalogued individually), which mark the extent of BO lands and the associated rights of way (from the beach and to the spring) have been almost completely obscured by vegetation overgrowth.

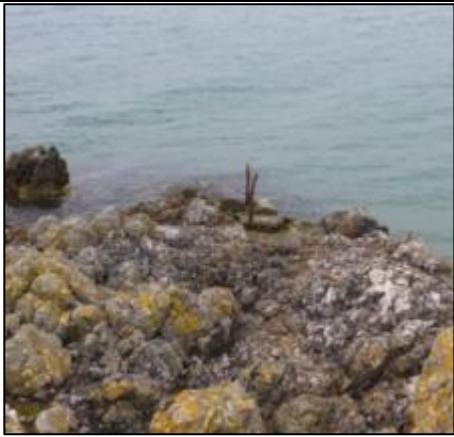
Cultural Heritage Feature	Landing Place (east)
Statutory Protection	None
Location	A small cove on the east side of the Martello Tower (ITM 728328, 741507)
Description	An iron railing set into concrete on the rocks at the high water mark is the only indication of a landing place. Appears to be a relatively late addition, perhaps early to mid-20 th century, given the use of concrete and the iron railing.
Image

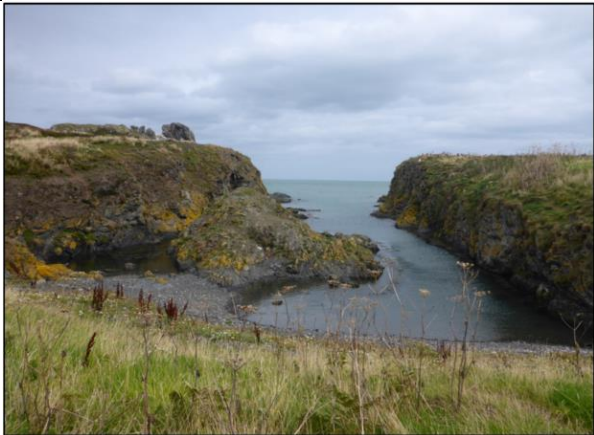
Cultural Heritage Feature	The Long Hole
Statutory Protection	None
Location	At the south-eastern end of the island
Description	A narrow inlet with a small, curved cobbled beach which was the scene of Maria Kirwan's murder. There is no visible trace of the former landing place described by Mr Doyle, and no evidence for any other built structures or features of archaeological potential. It holds a cultural heritage value as the site of an historical event.

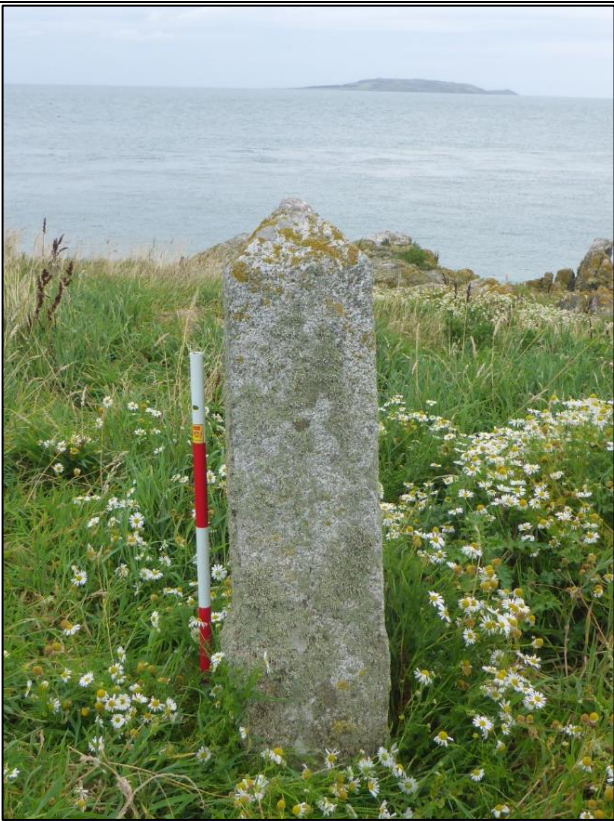
Cultural Heritage Feature	Boundary Stone 1
Statutory Protection	None
Location	Northwestern corner of island (ITM) Cf. Figure 32 for the locations of Boundary Stones 1-9
Description	<p>War Office replacement of original Board of Ordnance boundary stone, c. 1850s. Cut granite pillar stone with pyramidal top. Dimensions c. 1.2m visible height, with each face measuring c. 20cm in width. Very eroded with no inscriptions evident. Marking the north / northeastern extent of the Board of Ordnance lands, close to the cliff edge; it is roughly aligned with Boundary Stones 2-4. Stands slightly askew. The images below show the stone with a view towards Lambay Island (facing north) and in relation to the Martello Tower (facing northwest).</p>
Image

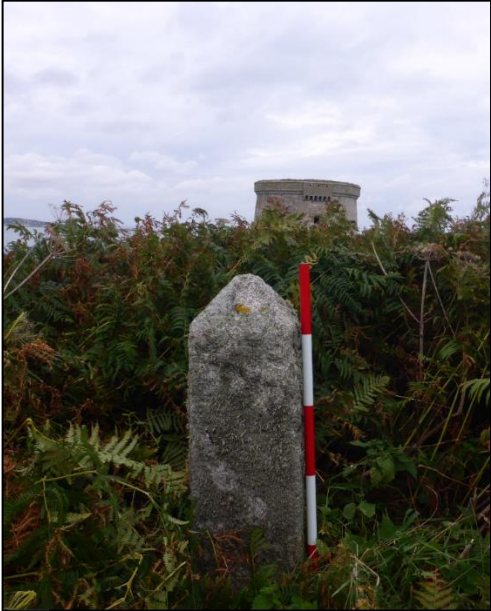
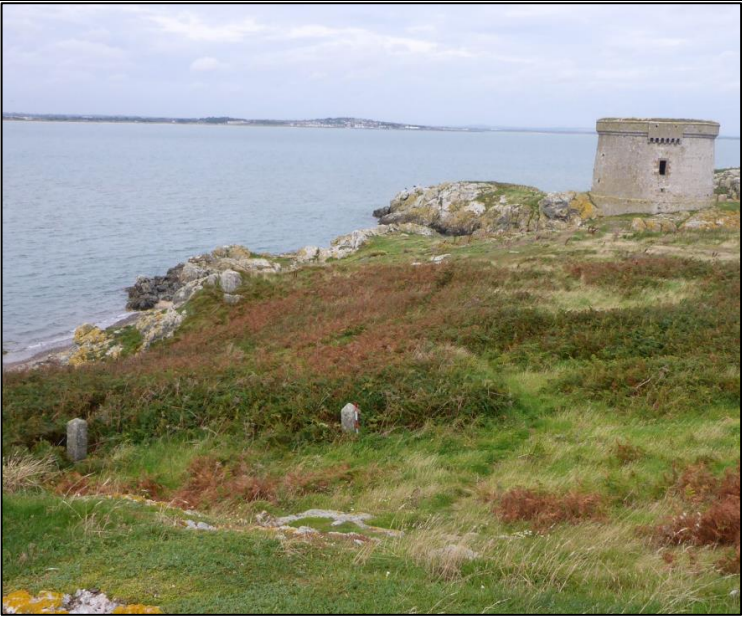
Cultural Heritage Feature	Boundary Stone 2
Statutory Protection	None
Location	Northwestern corner of island (ITM) Cf. Figure 32 for the locations of Boundary Stones 1-9
Description	War Office replacement of original Board of Ordnance boundary stone, c. 1850s. Cut granite pillar stone with pyramidal top. Dimensions c. 1.2m visible height, with each face measuring c. 20cm in width. Very eroded and lichen-covered with no inscriptions evident. One of a pair of stones (c. 5m apart) marking the principal right-of-way from Carrigeen Bay to the Martello Tower, at the northern end of the pathway (see also Boundary Stone 3). Completely obscured by dense vegetation, which had to be beaten down for the photograph. The images below show Boundary Stone 2 (detail) and Boundary Stones 2 & 3 in relation to the Martello Tower (with Boundary Stone 2 on the right).
Image

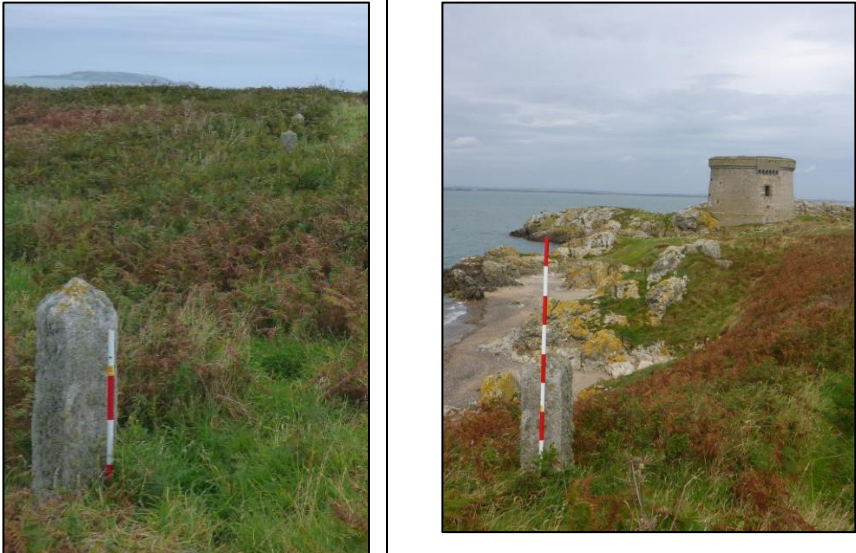
Cultural Heritage Feature	Boundary Stone 4	
Statutory Protection	None	
Location	Northwestern corner of island (ITM) Cf. Figure 32 for the locations of Boundary Stones 1-9	
Description	War Office replacement of original Board of Ordnance boundary stone, c. 1850s. Cut granite pillar stone with pyramidal top. Dimensions c. 1.2m visible height, with each face measuring c. 20cm in width. Very eroded and lichen-covered with no inscriptions evident. v Marking the south / southwestern extent of the Board of Ordnance lands, close to the cliff edge; it is roughly aligned with Boundary Stones 1-3. The images below show the stone in the foreground with Boundary Stones 2 & 3 in the background (top right in the image; Boundary Stone 1 is not visible as it sits on slightly lower ground on the far side of the small headland), as well as the stone in relation to the Martello Tower.	
Image

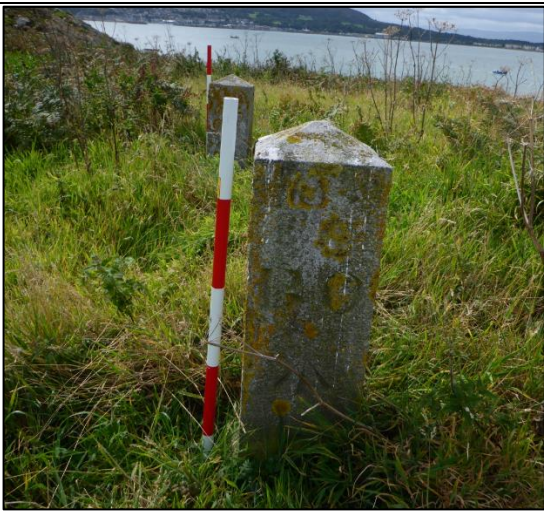
<p>Cultural Heritage Feature</p>	<p>Boundary Stone 6</p>
<p>Statutory Protection</p>	<p>None</p>
<p>Location</p>	<p>Northwestern corner of island (ITM) Cf. Figure 32 for the locations of Boundary Stones 1-9</p>
<p>Description</p>	<p>Original Board of Ordnance boundary stone, c. 1805. Cut limestone pillar stone with pyramidal top. Dimensions c. 1m visible height, with each face measuring c. 28cm in width. The condition of the stone is considerably better than the later granite boundary stones, with crisp edges and clear inscriptions: 'B.O.' and the arrow mark. One of a pair now standing on the northwest side of the spring, positioned c. 2m apart. Only one is depicted at this location on the Board of Ordnance map c. 1848 and the later OS 25-inch map c. 1906-9. The second stone was presumably removed from its original location during the War Office works in the mid-19th century and placed at the spring some time after 1906-9. The images below shows Boundary Stone 6 in the foreground, with Boundary Stone 5 to the rear, as well as both stones in relation to the spring (visible as the circle of lighter green vegetation just beyond the stones).</p>

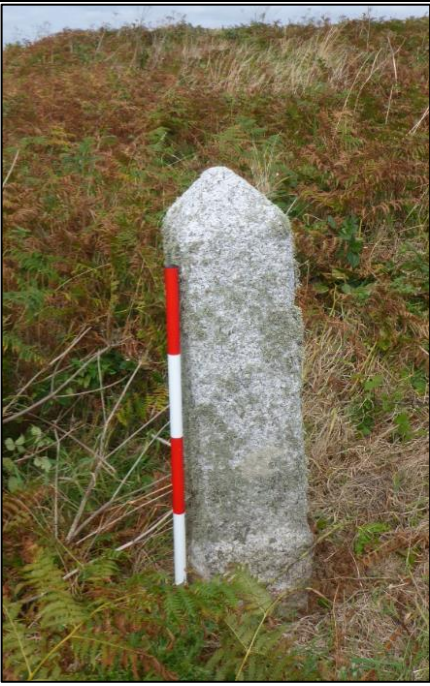
Cultural Heritage Feature	Boundary Stone 7
Statutory Protection	None
Location	Northwestern corner of island (ITM) Cf. Figure 32 for the locations of Boundary Stones 1-9
Description	War Office replacement of original Board of Ordnance boundary stone, c. 1850s. Cut granite pillar stone with pyramidal top. Dimensions c. 1.2m visible height, with each face measuring c. 20cm in width. Very eroded and partly lichen-covered with no inscriptions evident. One of a pair of stones (c. 5m apart) marking the principal right-of-way from Carrigeen Bay to the Martello Tower, at the southern end of the pathway (see also Boundary Stone 8). Completely obscured by dense vegetation, which had to be beaten down for the photograph.
Image

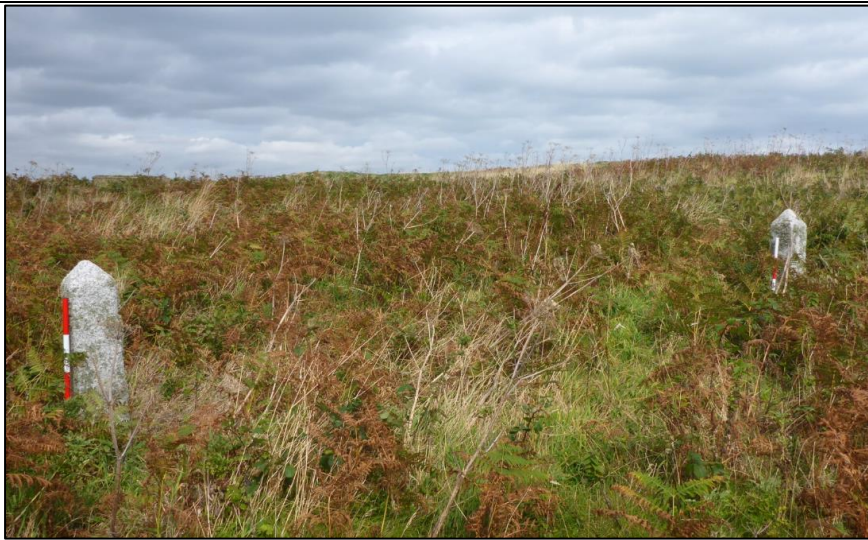
Cultural Heritage Feature	Boundary Stone 8
Statutory Protection	None
Location	Northwestern corner of island (ITM) Cf. Figure 32 for the locations of Boundary Stones 1-9
Description	War Office replacement of original Board of Ordnance boundary stone, c. 1850s. Cut granite pillar stone with pyramidal top. Dimensions c. 1.2m visible height, with each face measuring c. 20cm in width. Very eroded and partly lichen-covered with no inscriptions evident. One of a pair of stones (c. 5m apart) marking the principal right-of-way from Carrigeen Bay to the Martello Tower, at the southern end of the pathway (see also Boundary Stone 7). Completely obscured by dense vegetation, which had to be beaten down for the photograph. Image below showing Boundary Stones 7 & 8, with Boundary Stone 8 on far right of photograph.
Image
