## Cloud Hill Wind Farm

### Technical Appendix 13.1: Abnormal Load Route Assessment

Route Access Survey  
360700 Rev 0.1

Cloud Hill Wind Farm – Routes A & B

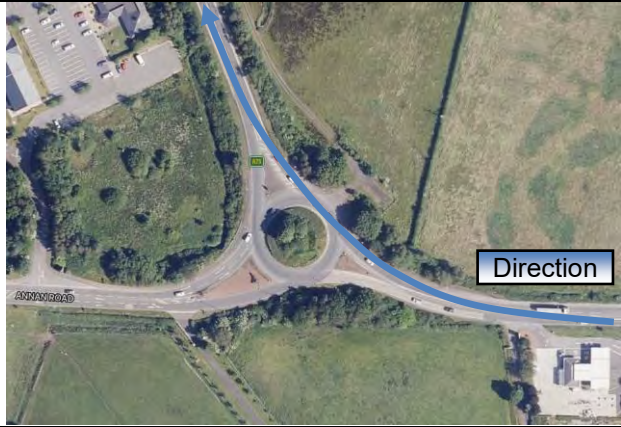
| <p>Swept path analysis indicates that the loaded vehicle will oversail on both sides of the road whilst negotiating the roundabout.</p> <p>The load will oversail on the offside. Two lamp posts are to be removed and trees will require pruning.</p> <p>The rear projection will oversail the nearside prior to the roundabout. Trees will require pruning. The entry and exit splitter islands and the island will incur rear projection oversail.</p> <p>Manual steering and utilisation of the full extents of the road are required to execute the manoeuvre at this location.</p> | | <p>Direction</p> <p>Aerial View of Location</p> | |

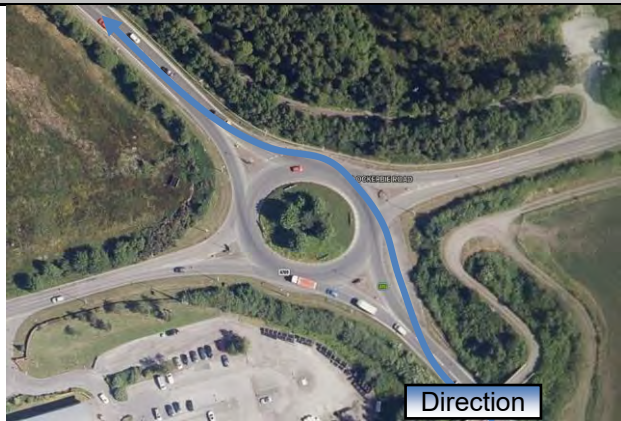
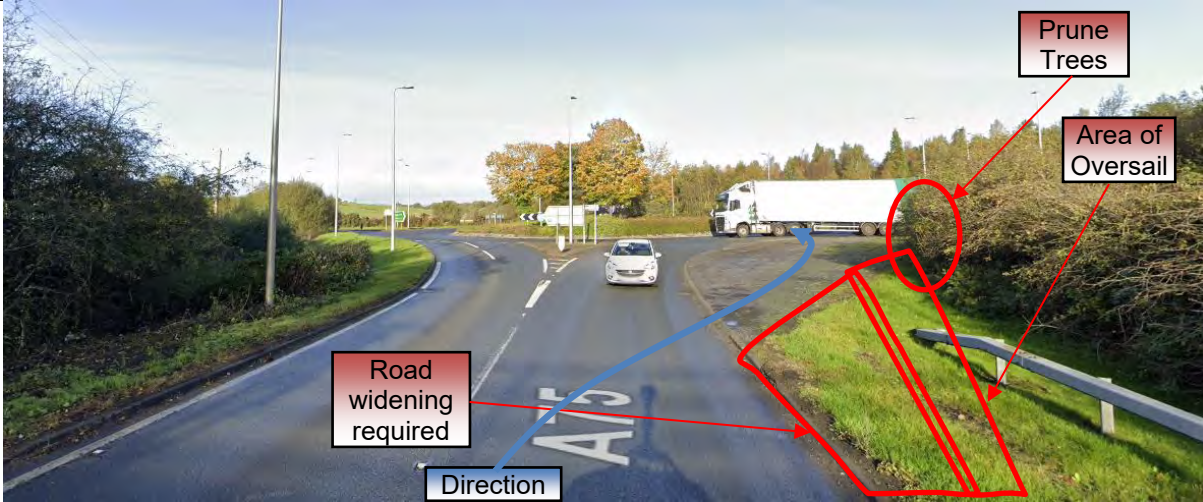
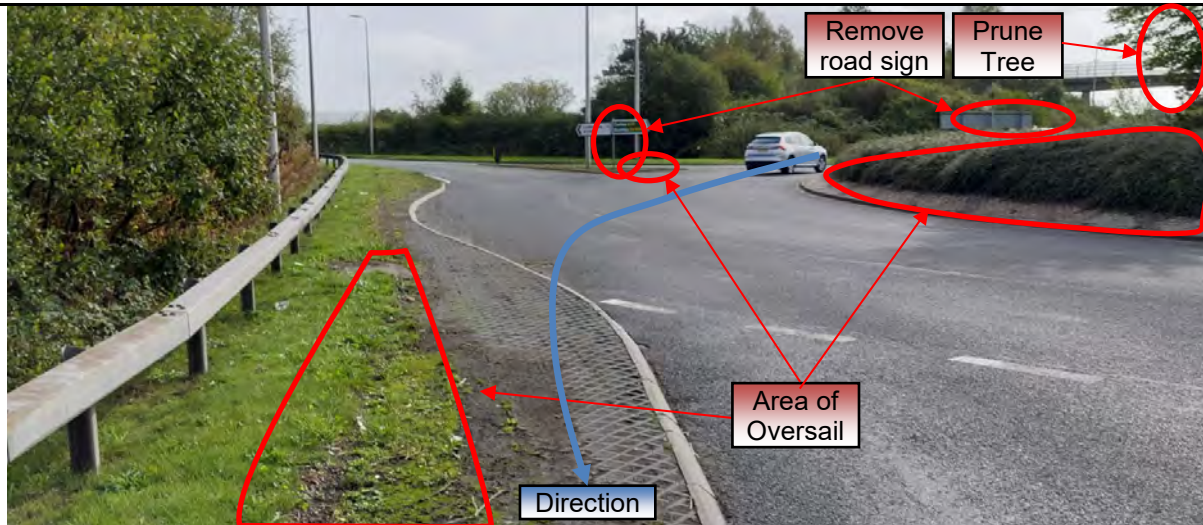
| MODIFICATION AND DESCRIPTION | <p>Swept path analysis indicates that road widening is required on the offside of the roundabout entry to avoid a rear projection clash with the bridge prior to the roundabout.</p> <p>Oversail will occur on the offside of the entry and exits, the eastern splitter island and the roundabout island.</p> <p>Trees are to be pruned on the offside of the entry and the roundabout island.</p> <p>A road sign on the roundabout and the eastern splitter island are to be removed.</p> <p>Manual steering and utilisation of the full extents of the road are required to execute the manoeuvre at this location.</p> | | |

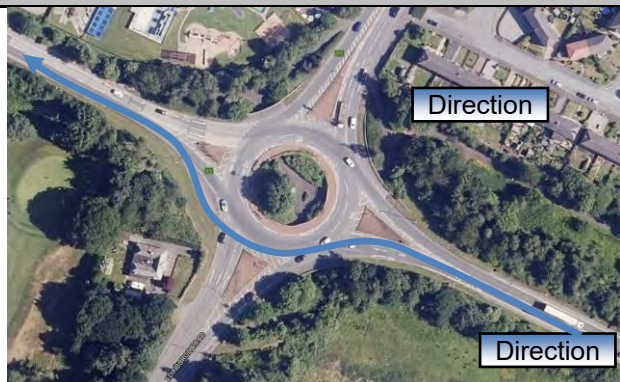
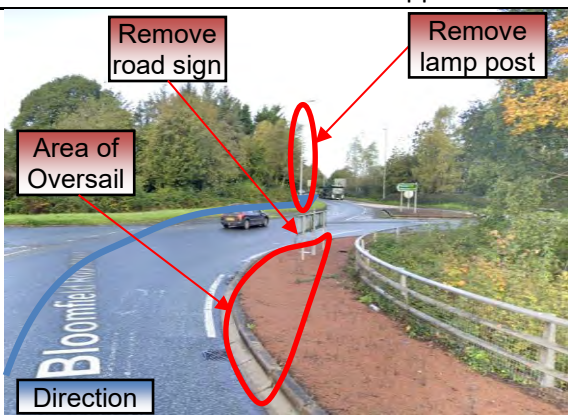
| <p>Swept path analysis indicates that road widening will be required on the nearside of the roundabout exit. A lamp post is required to be removed. Oversail occurs on the nearside of the entry and exits and the on the offside of the roundabout. A solar panel column, junction box on the nearside entry and a road sign on the roundabout are to be removed.</p> <p>Trees on the nearside entry are to be pruned. Manual steering and utilisation of the full extents of the road are required to execute the manoeuvre at this location.</p> | | | <p>Aerial View of Location</p> | | |

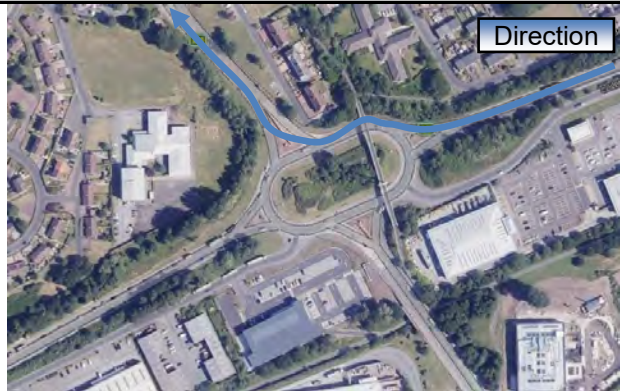
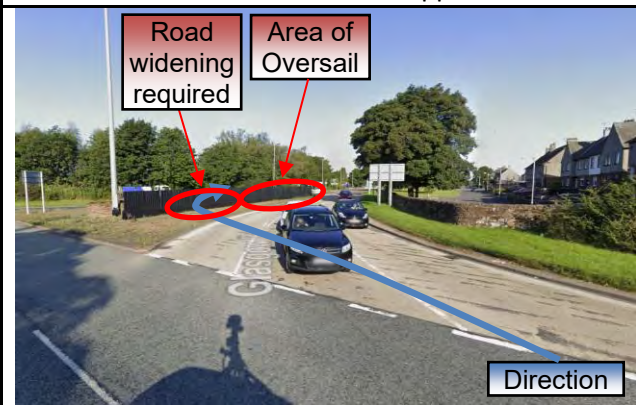
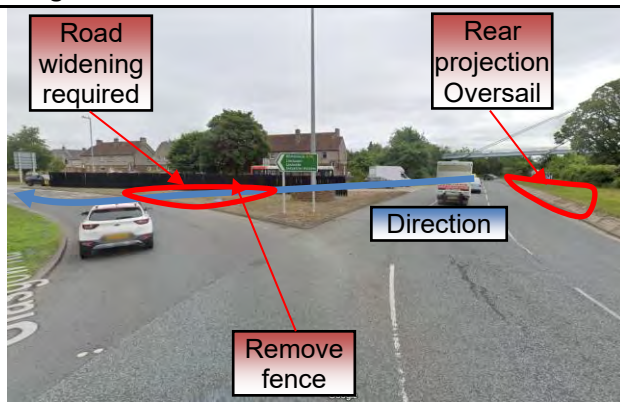
| <p>Swept path analysis indicates that road widening is required on the exit splitter island to allow the vehicle to join the left hand carriageway. The fence on the splitter island is to be removed.</p> <p>The load will oversail the offside of the entry and exits of the roundabout and exit splitter island. The rear projection will oversail the roundabout island prior to the exit.</p> <p>Trees are to be pruned on the offside entry of the roundabout.</p> <p>Manual steering and utilisation of the full extents of the road are required to execute the manoeuvre at this location.</p> | | <p>Direction</p> <p>Aerial View of Location</p> | | |
| <p>Rear projection Oversail</p> <p>Area of Oversail</p> <p>Prune Trees</p> <p>Direction</p> <p>Approach to Cuckoo Bridge Roundabout</p> | | <p>Road widening required</p> <p>Area of Oversail</p> <p>Direction</p> <p>Contraflow Exit</p> | | |
| <p>Road widening required</p> <p>Rear projection Oversail</p> <p>Remove fence</p> <p>Direction</p> <p>Reverse View of Exit</p> | | | | |

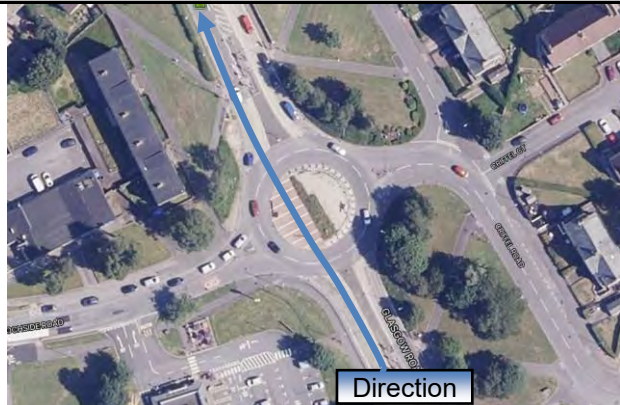
| <p>Swept path analysis indicates that the load will oversail the splitter island after the roundabout. Road signs on the widened area of the roundabout are to be demounted.</p> <p>Manual steering is required to execute the manoeuvre at this location.</p> | | <p>Aerial View of Location</p> | |

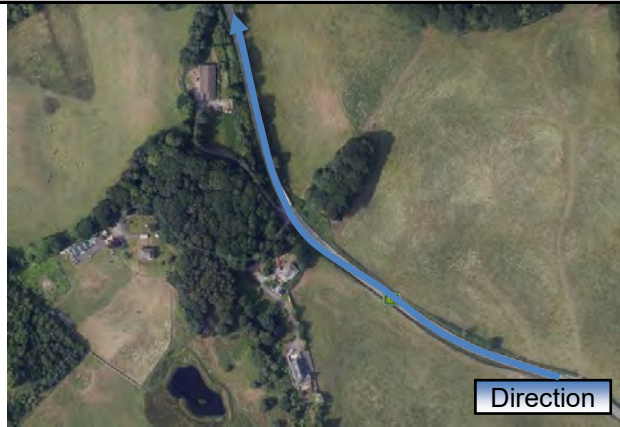
| <p>Swept path analysis indicates that the load will oversail both sides of the bend. There are no third party issues raised at this location.</p> <p>Three road signs on the nearside to be removed.</p> <p>Trees/ vegetation are to be pruned on the nearside of the bend.</p> <p>Manual steering and utilisation of the full extents of the road are required at this location.</p> | | <p>Direction</p> <p>Aerial View of Location</p> | | |

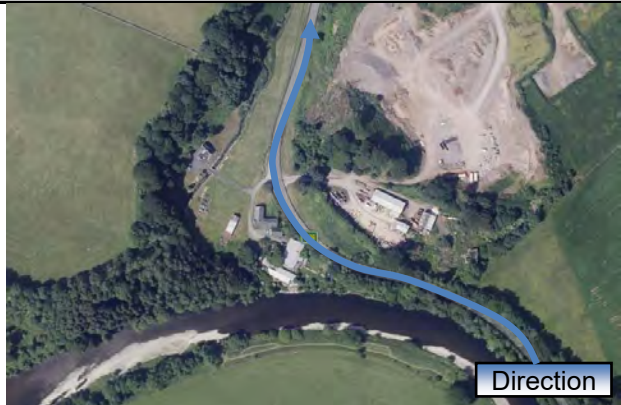
| MODIFICATION AND DESCRIPTION | <p>Swept path analysis indicates that road widening is required of the offside of the bend to avoid rear projection oversail/ third party issues on the nearside whilst negotiating the bend.</p> <p>The loaded component will continue to oversail the verge on the offside.</p> <p>Manual steering and utilisation of the full extents of the road are required at this location.</p> | | |

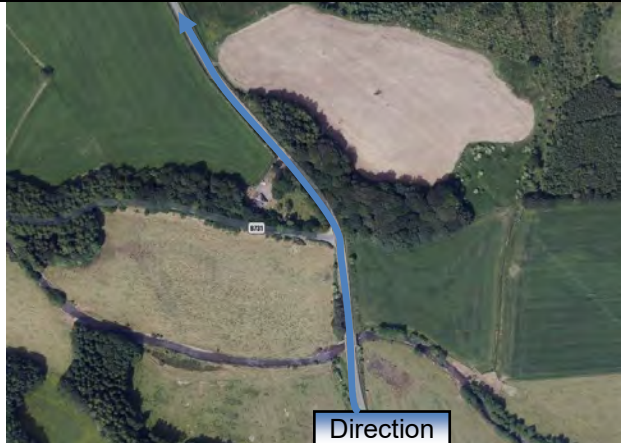
| <p>Swept path analysis indicates that the load will oversail both sides of the bend. There are no third party issues raised at this location.</p> <p>Trees/ vegetation are to be pruned on both sides of the bend.</p> <p>Manual steering and utilisation of the full extents of the road are required at this location.</p> | | <p>Aerial View of Location</p> | |

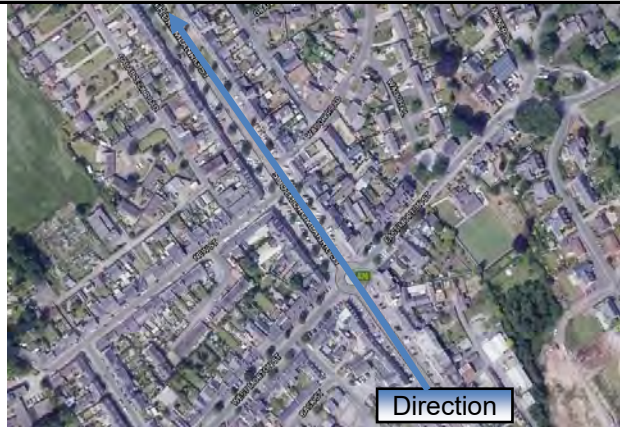
| Swept path analysis indicates that the bollard on the offside is to be removed. | | <p>Direction</p> <p>Aerial View of Location</p> | |

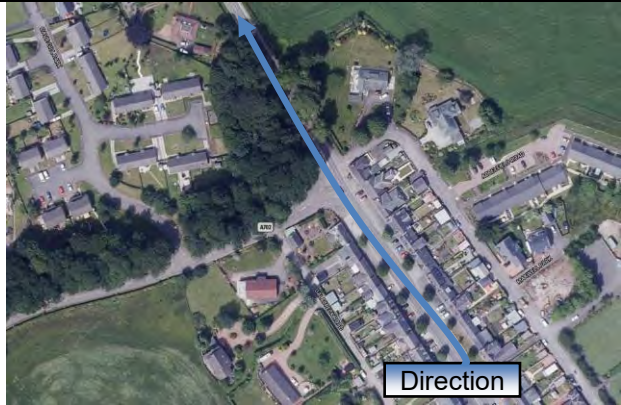
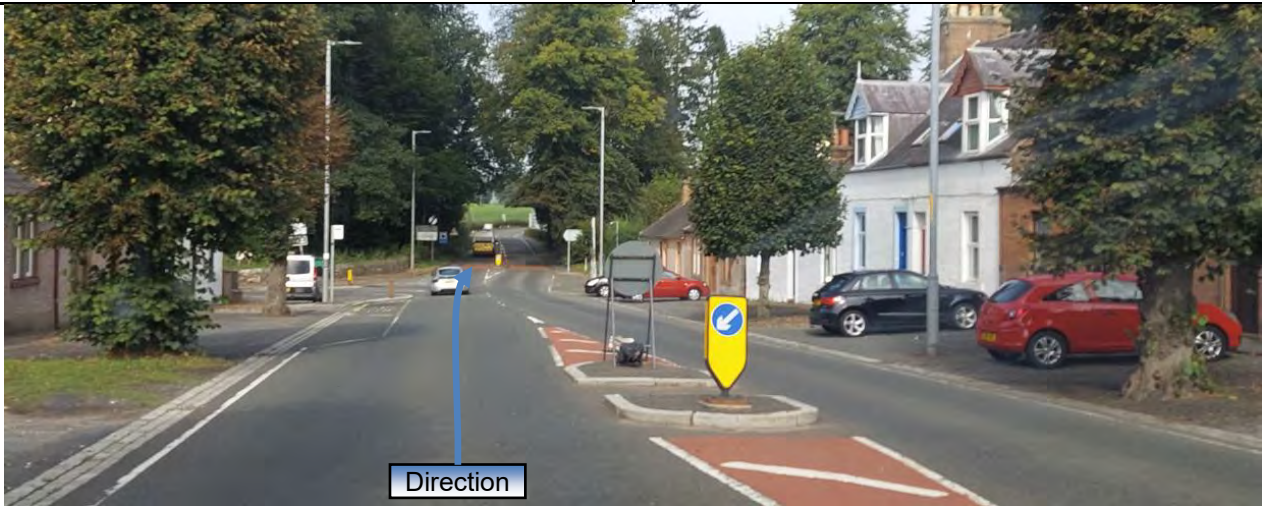
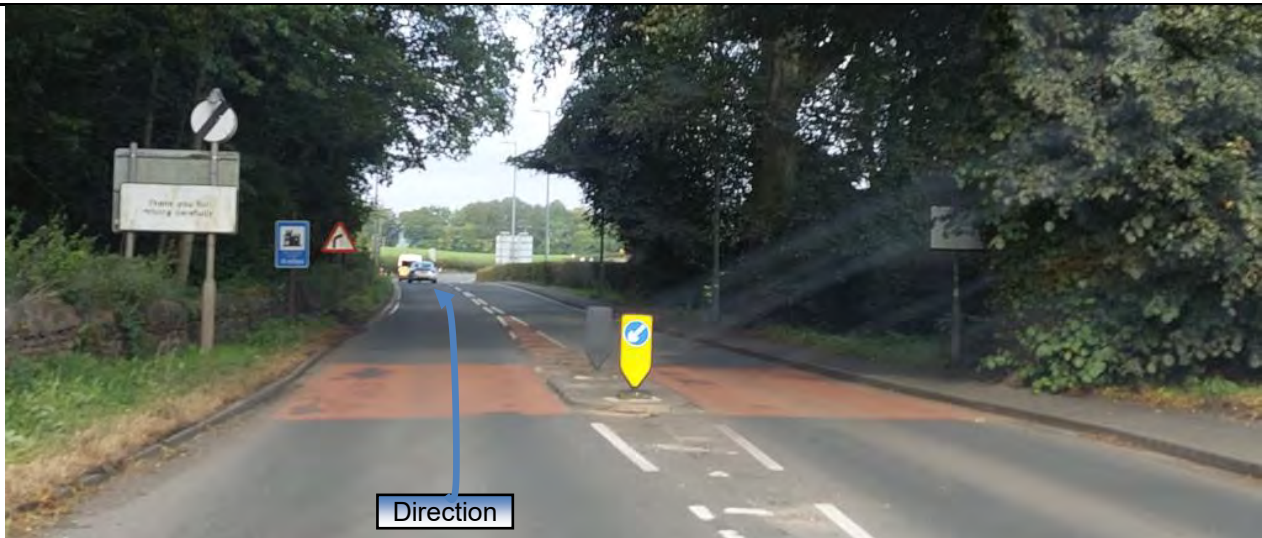
| Visual inspection indicates that there are no issues at this location. | | <p>Direction</p> <p>Aerial View of Location</p> | | |

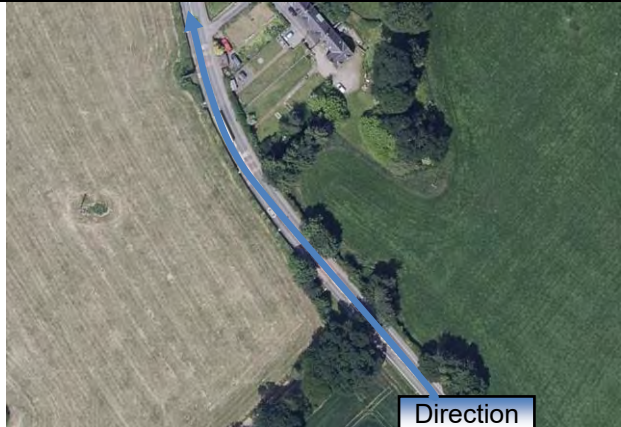
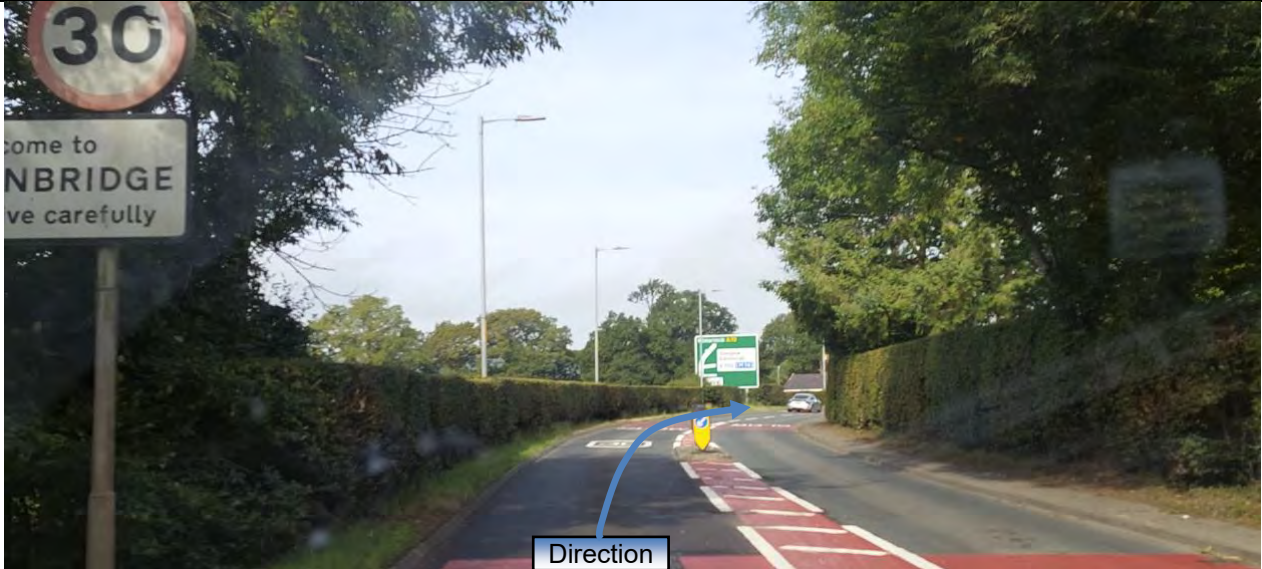
| Splitter Island 16 | | | | |

| Visual inspection indicates that there are no issues at this location. | | | | |

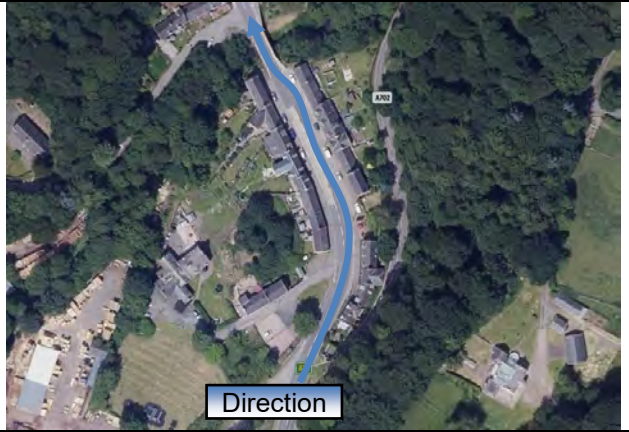
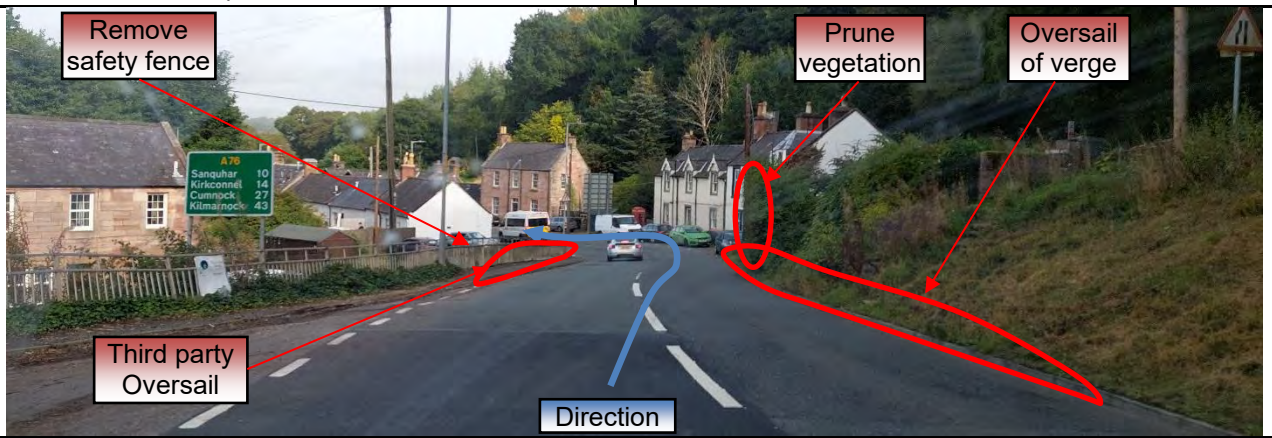
| <p>Swept path analysis indicates that third party land is required on the nearside to allow the load to oversail on the approach to the left bend. A lamp post and safety fence are required to be removed. Oversail will occur on both sides of the bend. Street furniture is required to be removed where indicated.</p> <p>Vegetation is to be removed on the offside prior to the bend.</p> <p>Parking restrictions are required both sides after the bend.</p> <p>Manual steering and utilisation of the full extents of the road are required at this location.</p> | | <p>Direction</p> <p>Aerial View of Location</p> | |
| <p>Remove safety fence</p> <p>Third party Oversail</p> <p>Prune vegetation</p> <p>Oversail of verge</p> <p>Direction</p> <p>Approach to Left Bend</p> | | <p>Third party Oversail</p> <p>Areas of Oversail/Overrun</p> <p>Remove street furniture</p> <p>Direction</p> <p>Left Bend</p> | |

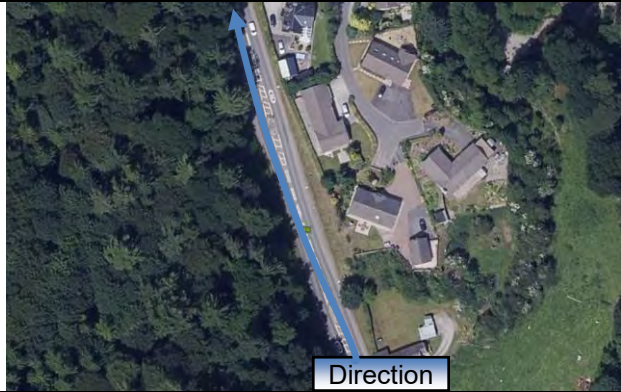
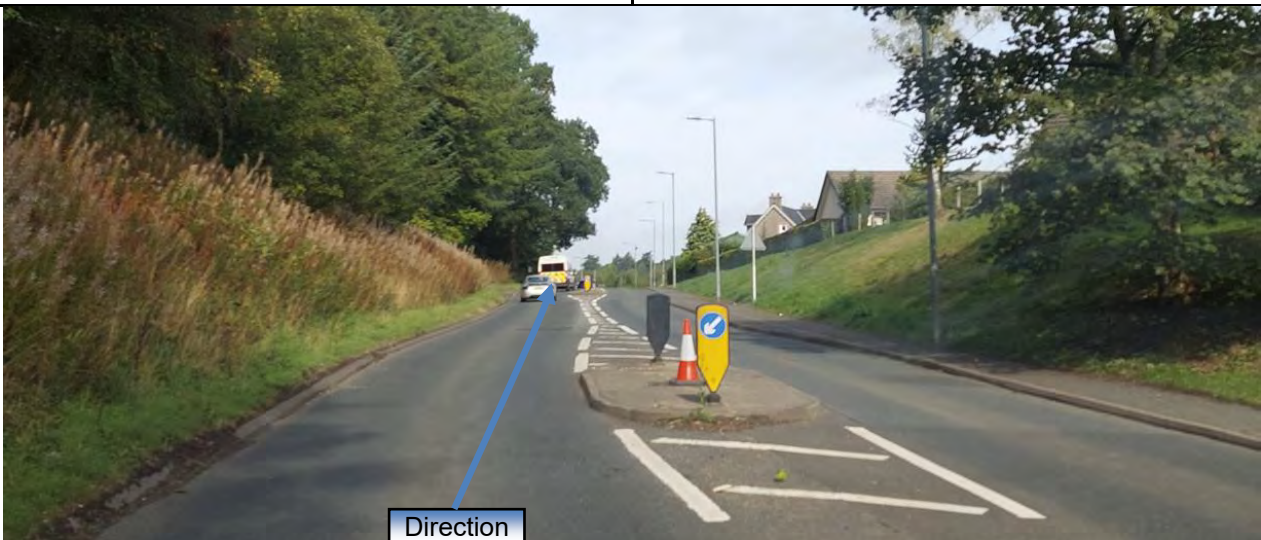
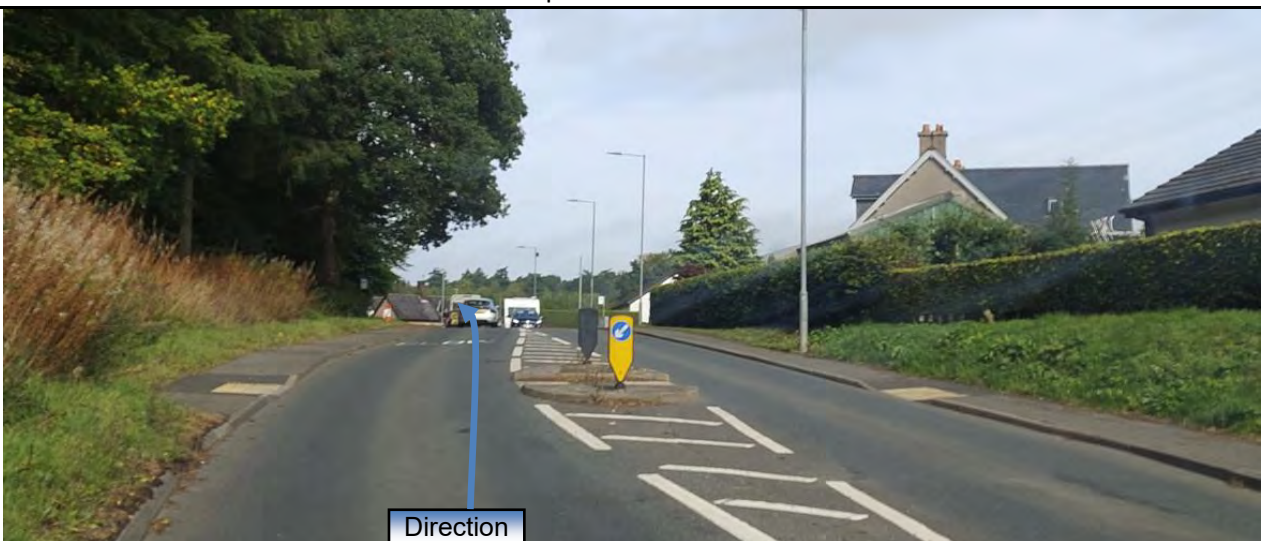
| Visual inspection indicates that there are no issues at this location. | | <p>Direction</p> <p>Aerial View of Location</p> | | |

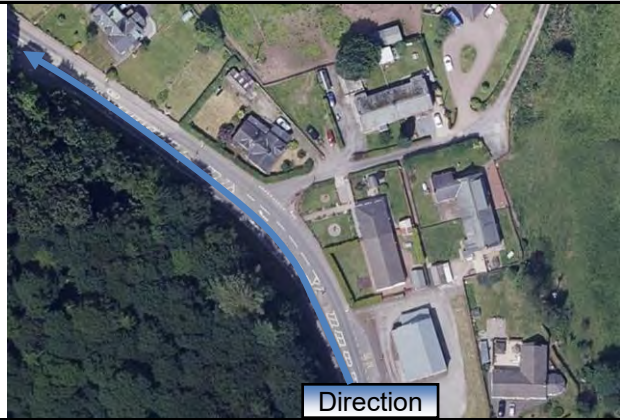
| <p>Swept path analysis indicates that the splitter island before the bend is to be removed to avoid more extensive road widening on the nearside. The load will oversail the verge on the nearside and the rear projection will oversail the footpath on the offside.</p> <p>No third party issues are raised at this location. Manual steering &amp; utilisation of the full extents of the road will be required to navigate at this location.</p> | | <p>Direction</p> <p>Aerial View of Location</p> | | |

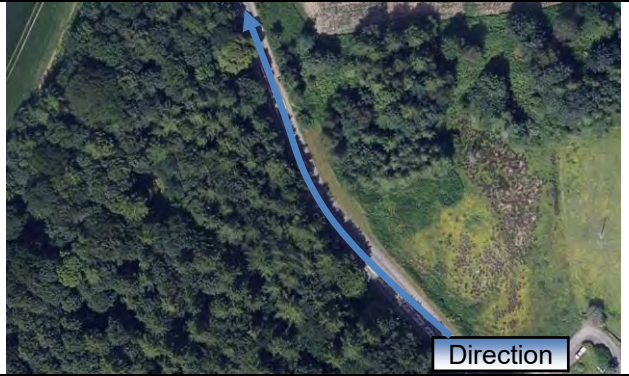
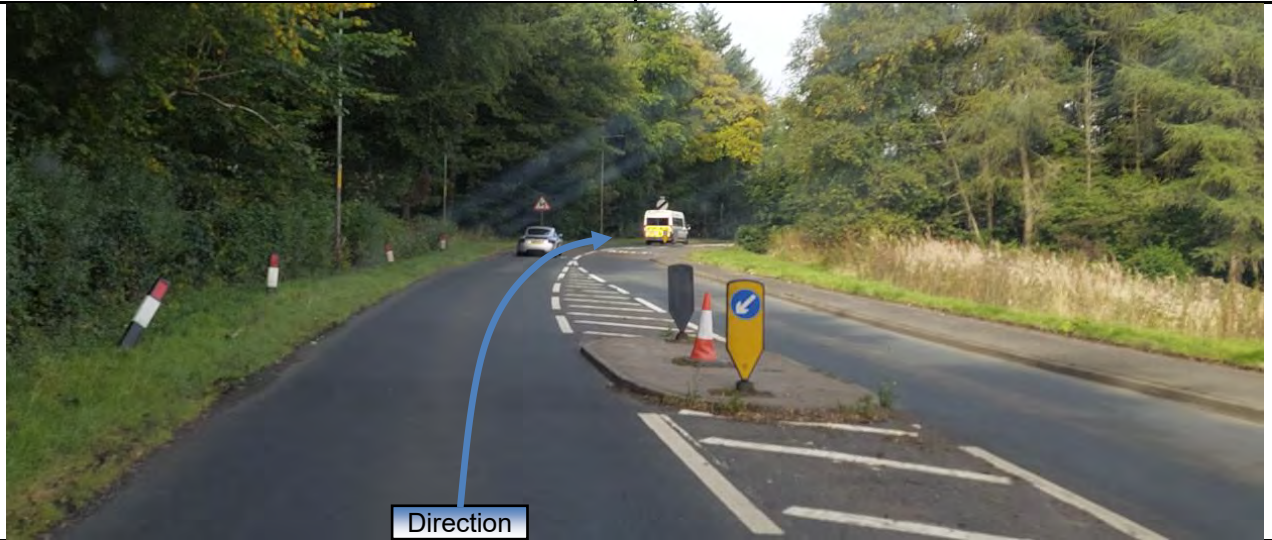
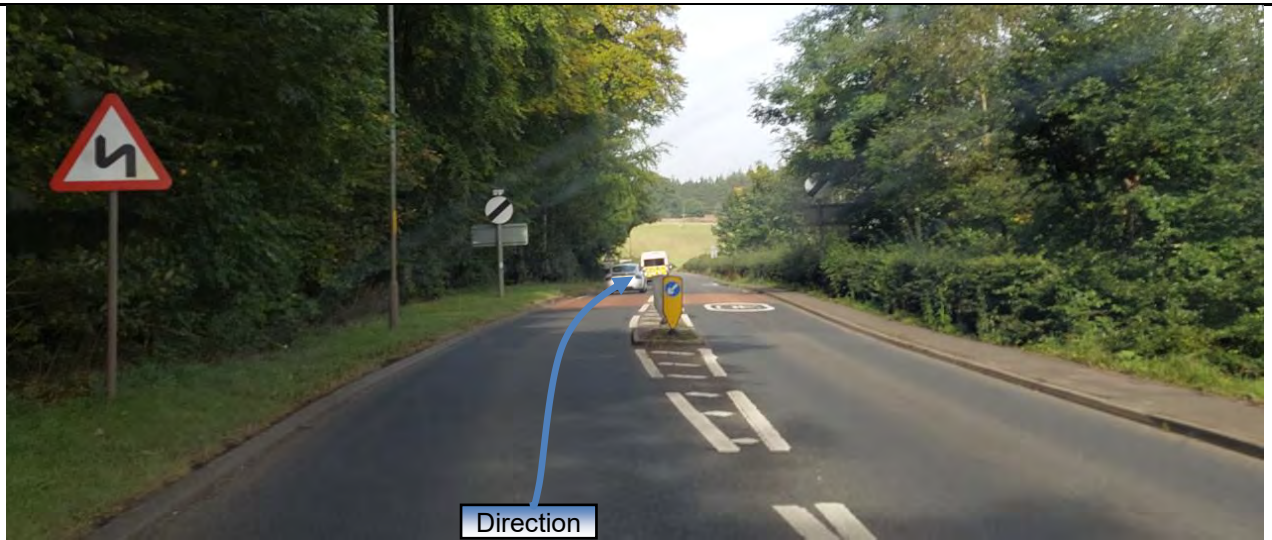
| Visual inspection indicates that there are no issues at this location. | | <p>Aerial View of Location</p> | | |

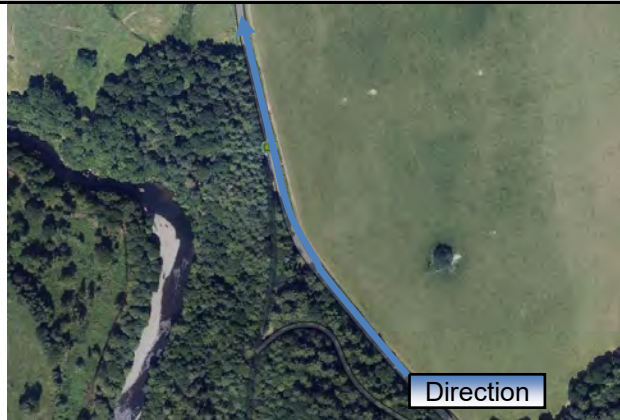
| <p>Swept path analysis indicates that third party land is required on the offside to widen the road to avoid rear projection oversail in the wood on the nearside.</p> <p>The hedgerow on the offside is to be removed/ pruned where necessary.</p> <p>Manual steering &amp; utilisation of the full extents of the road will be required to navigate at this location.</p> | | <p>Direction</p> <p>Aerial View of Location</p> | |

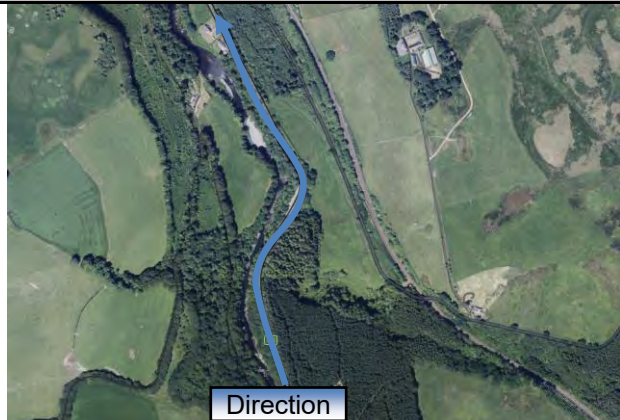
| <p>Swept path analysis indicates the loaded component will oversail both sides of the bend. Trees are to be pruned on both sides of the road. Manual steering &amp; utilisation of the full extents of the road will be required to navigate at this location.</p> | | <p>Direction</p> <p>Aerial View of Location</p> | | |

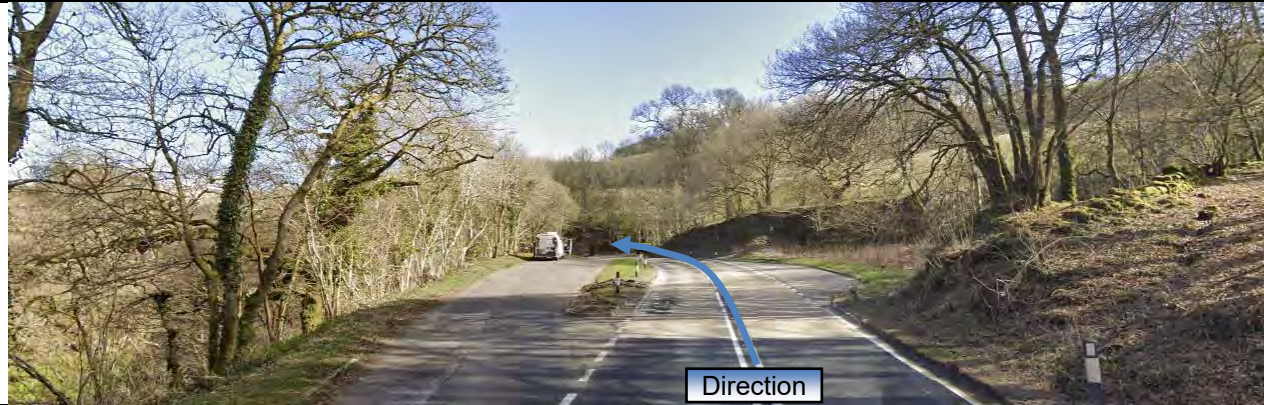
| <p>Swept path analysis indicates the loaded component will oversail both sides of the bend. Trees are to be pruned on both sides of the road. Manual steering &amp; utilisation of the full extents of the road will be required to navigate at this location.</p> | | <p>Direction</p> <p>Aerial View of Location</p> | |

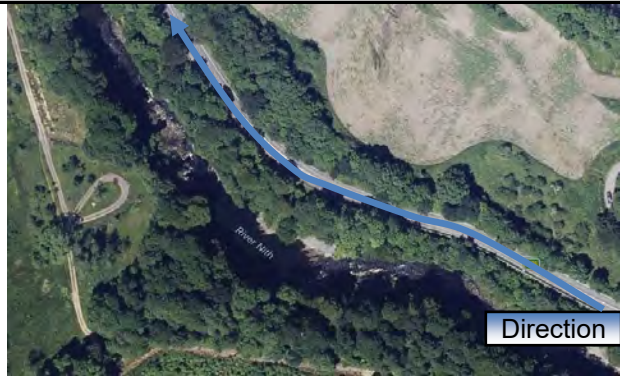
| <p>Swept path analysis indicates that the loaded component will oversail both sides of the bend. Two road signs on the nearside are to be removed. Trees are to be pruned/removed on the offside of the road.</p> <p>Manual steering &amp; utilisation of the full extents of the road will be required to navigate at this location.</p> | | <p>Direction</p> | | |

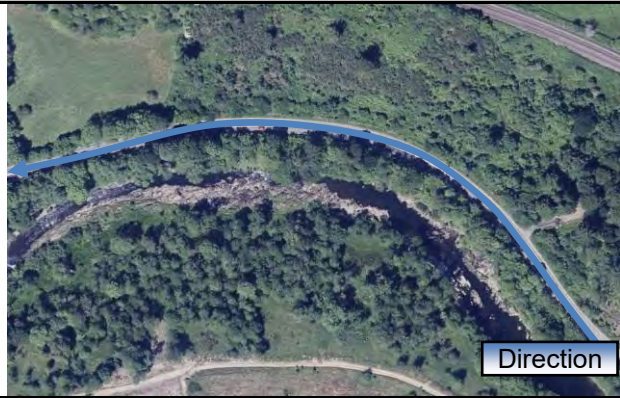
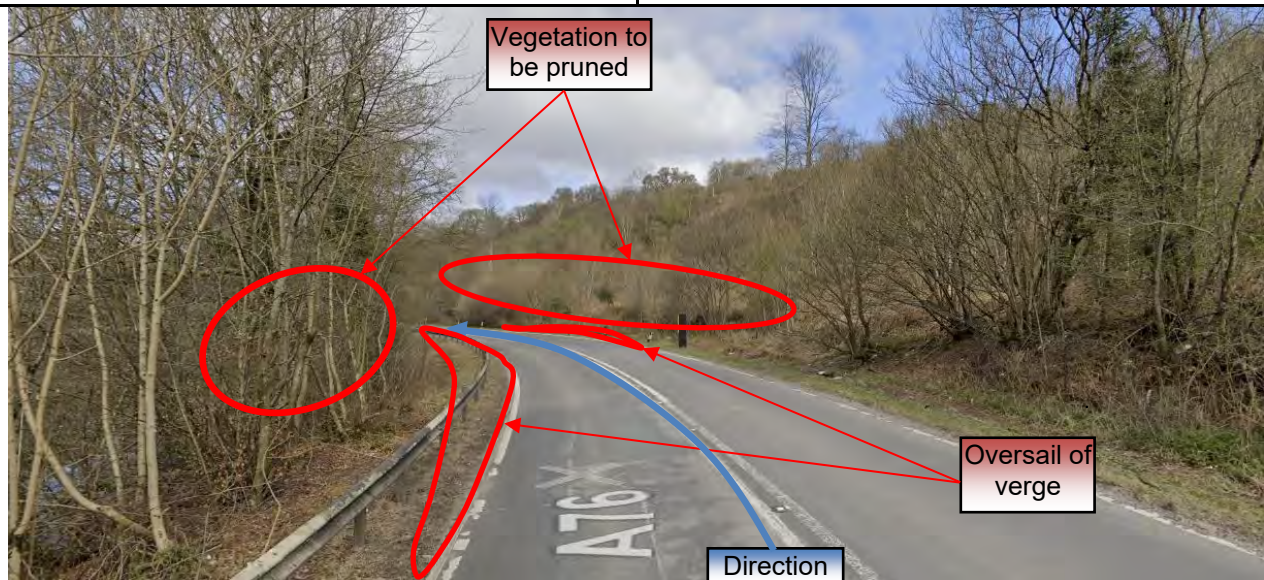
| <p>Swept path analysis indicates that the loaded component will oversail both sides of the bend. Trees are to be pruned on both sides of the bend. Manual steering &amp; utilisation of the full extents of the road will be required to navigate at this location.</p> | | | | |

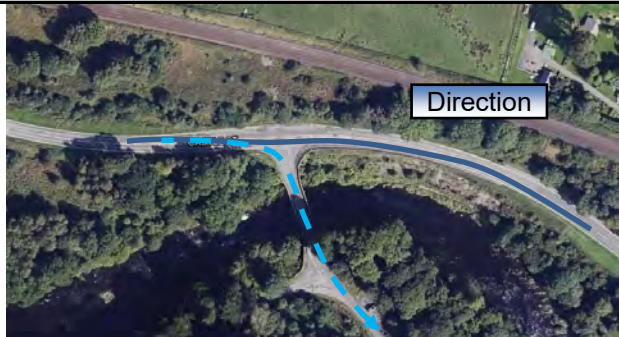
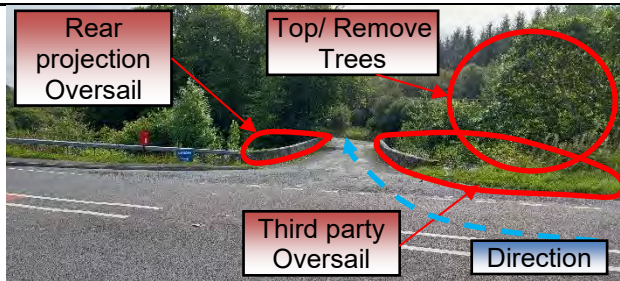
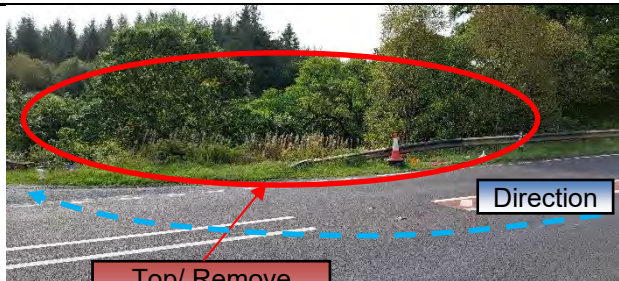
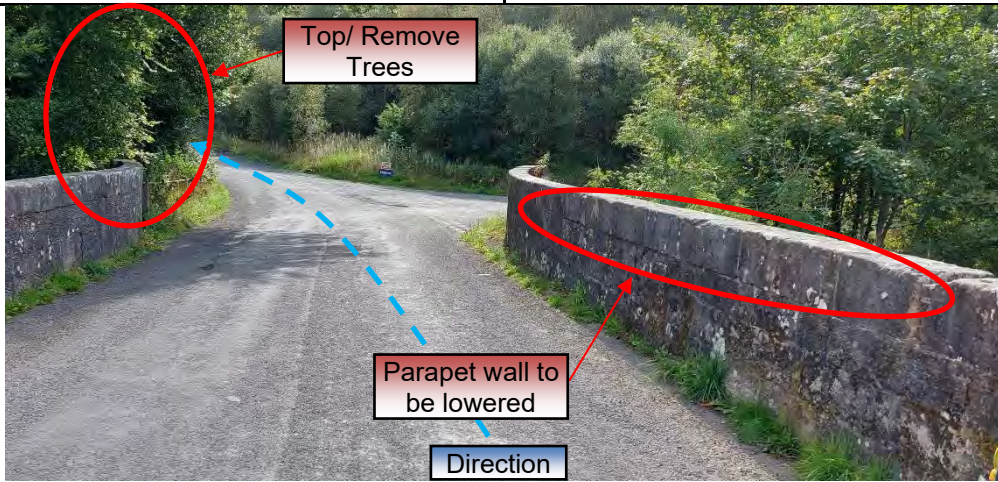
| <p>Swept path analysis indicates that third party land is required on the nearside of the junction with of the A76 &amp; Eliock Bridge to allow for the loaded component to oversail. Trees on the nearside of the junction are to be topped/ removed.</p> <p>The rear projection will oversail the nearside of the bridge. Trees on both embankments are to be topped or removed.</p> <p>The parapet wall on the offside of the bridge will require lowering to allow the load to oversail.</p> <p>Manual steering and utilisation of the full extents of the road are required to execute the manoeuvre at this location.</p> | | | | |
| <p>Bridge width = 6.4m Wide<br/>Parapet height = 0.66 - 1.36m High</p> | | | | |

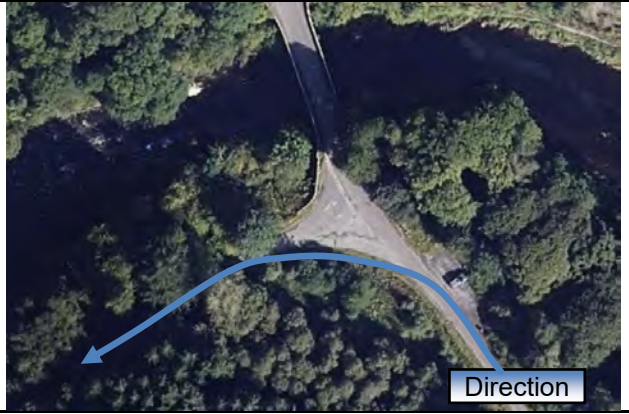
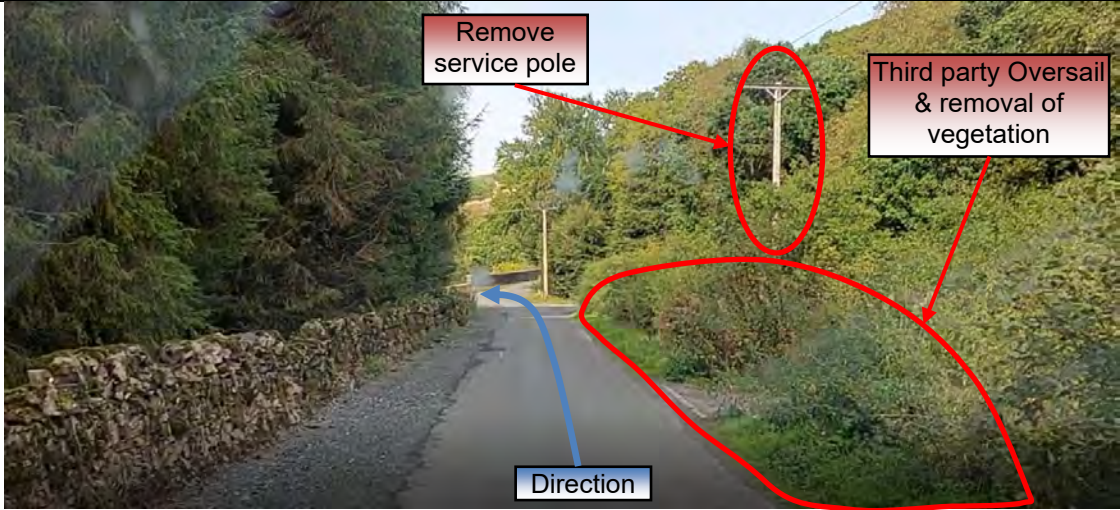
| <p>Swept path analysis indicates that third party land is required on both sides of the road to allow for oversailing. Trees/ vegetation are to be removed on both sides of the road.</p> <p>A service pole on the offside of the road and a road sign on the nearside are to be removed.</p> <p>Manual steering is required to navigate the bend at this location.</p> <p>The road is to be upgraded where necessary to meet the manufacturer's specification.</p> | | <p>Direction</p> <p>Aerial View of Location</p> | |
| <p>Remove service pole</p> <p>Third party Oversail &amp; removal of vegetation</p> <p>Direction</p> <p>View on Road</p> | | <p>Remove road sign</p> <p>Third party Oversail &amp; removal of vegetation</p> <p>Direction</p> <p>'Street View' of Left Turn</p> | |

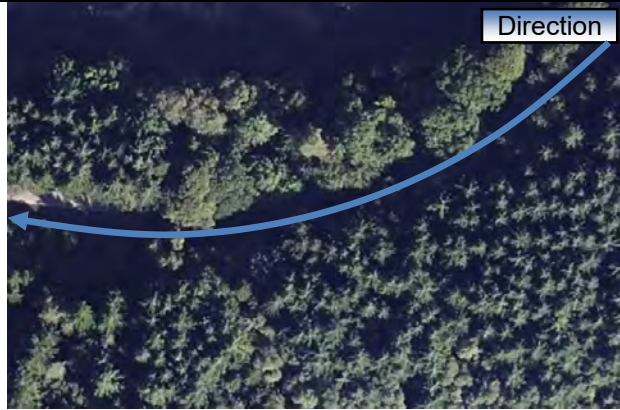
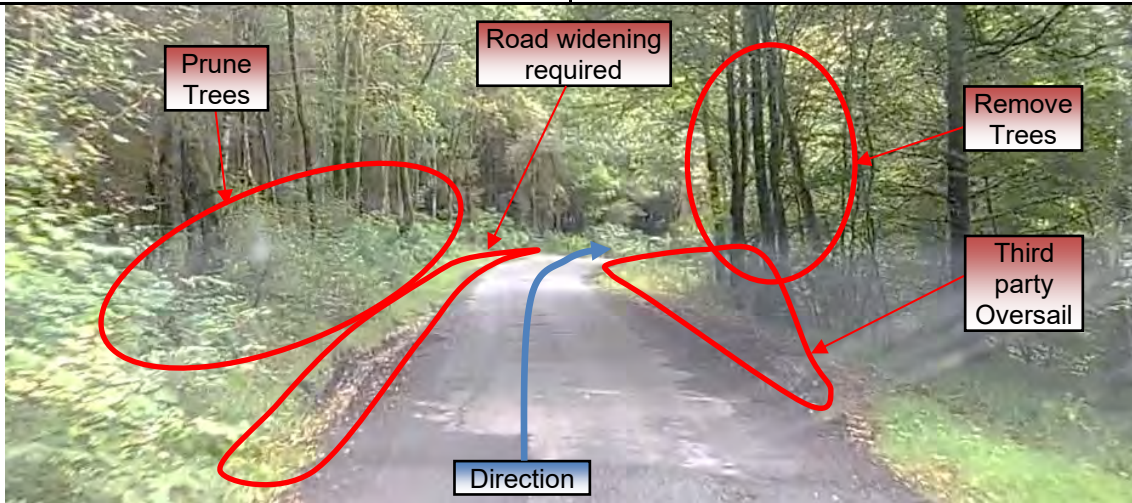
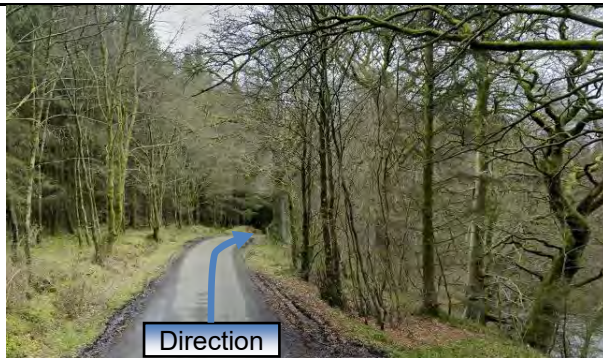
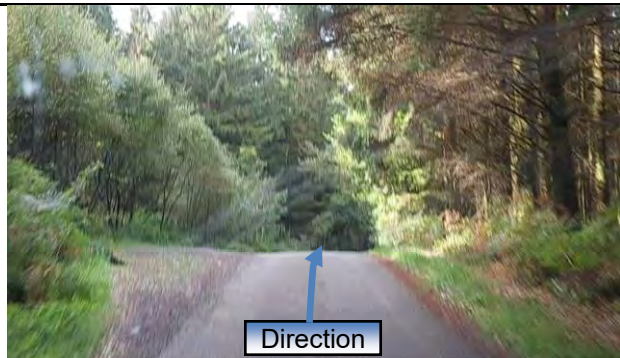
| <p>Visual inspection indicates that road widening is required on the nearside of the road. Trees on the nearside are to be pruned.</p> <p>Third party Oversail is required on the offside.</p> <p>Trees on the offside of the bend are to be removed to allow the load to oversail.</p> <p>Analysis of the vertical alignment of the crest at this location is required.</p> | | | | |

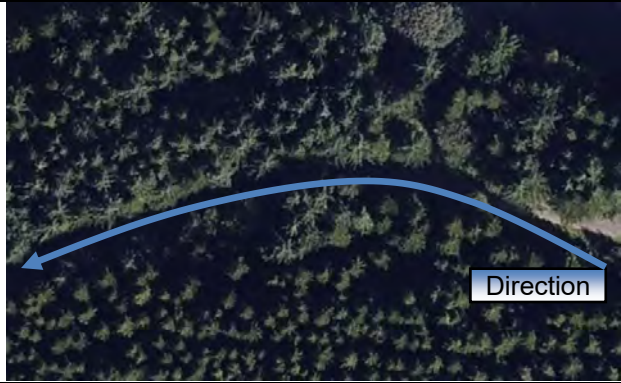
| <p>Visual inspection indicates that Third party land is required on the nearside of the bend to allow the load to oversail. Trees on the nearside are to be removed.</p> <p>Tree pruning is required on the offside, prior to the bend to allow the rear projection to oversail.</p> <p>Tree pruning is required on both sides of the road after the bend.</p> <p>Manual steering is required at this location.</p> | | <p>Aerial View of Location</p> | | |

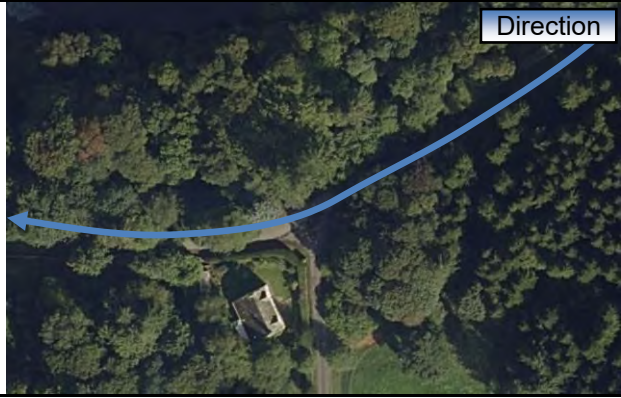
| <p>Visual inspection indicates that third party land is required on the nearside, prior to the junction on the nearside, to allow the rear projection to oversail. Trees in the area of oversail are to be removed.</p> <p>Road widening is required on the nearside of the road.</p> <p>The load will oversail on the offside of the verge. Trees in this area are to be removed.</p> <p>Two road signs on the offside are to be removed.</p> <p>Manual steering is required at this location.</p> | | <p>Direction</p> <p>Aerial View of Location</p> | |

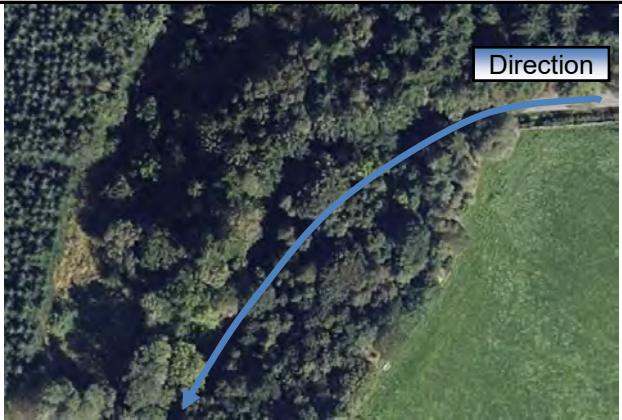
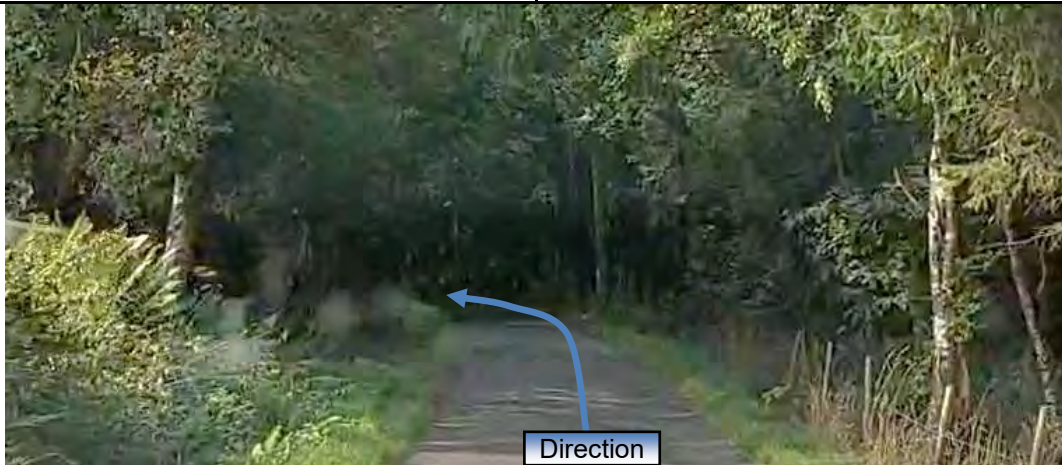
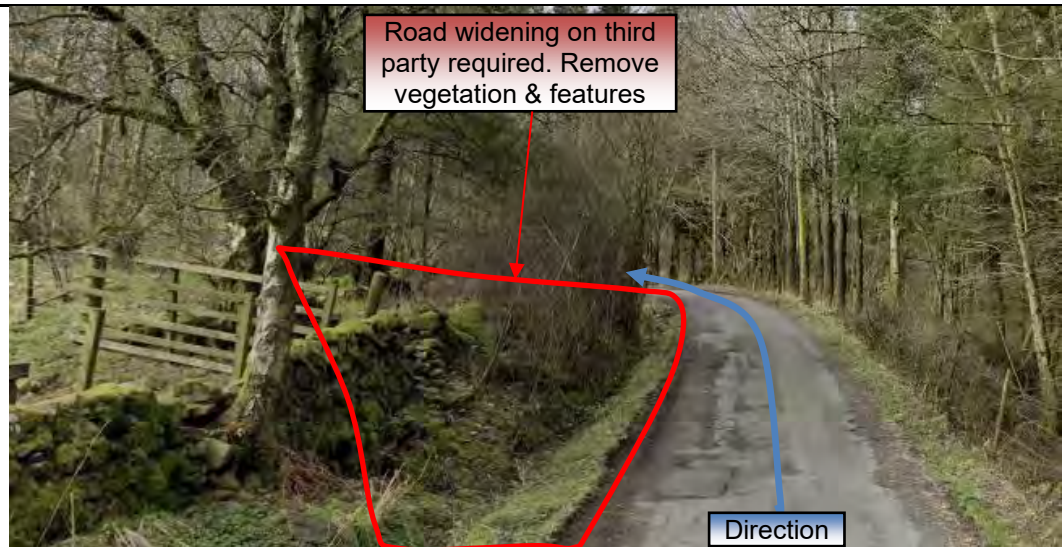
| Visual inspection indicates that road widening on third party land is required on the nearside of the road to negate tree removal & third party and issues on the offside of the bend. Trees, walls & fences on the nearside are to be removed. Manual steering is required at this location. | | | |

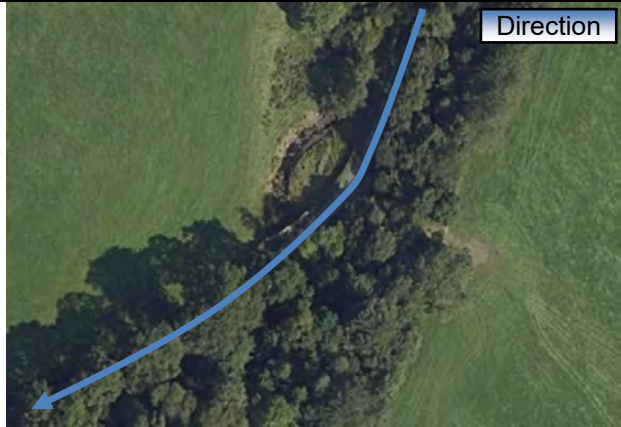
| <p>Visual inspection indicates that third party land is required on the offside of the bend to allow the loaded component to Oversail.</p> <p>The rear projection will oversail the verge on the nearside of the road prior to the bend.</p> <p>A service pole and a tree on the offside are to be removed.</p> <p>Manual steering is required at this location.</p> | | <p>Direction</p> <p>Aerial View of Location</p> | |
