Proposed CSCOA funding not to exceed \$10,000

Proposed Projects – Photos, July 2022

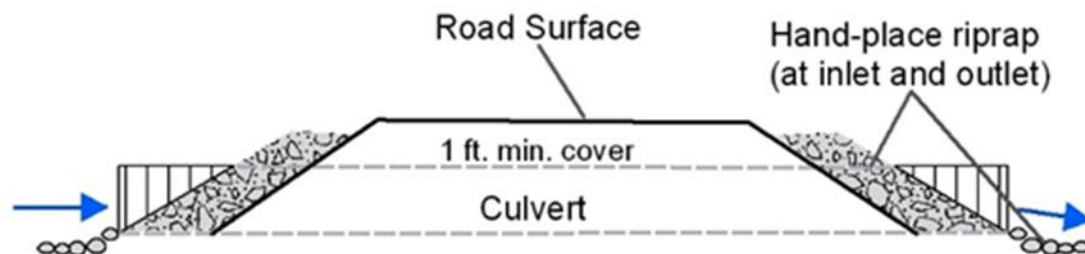
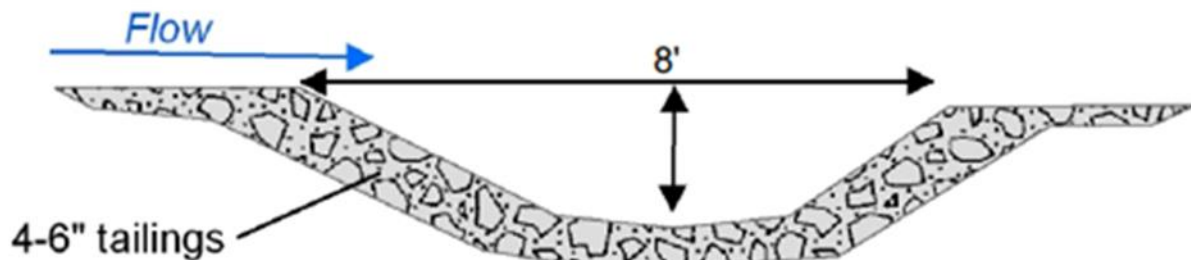
Rock-lined Plunge Pool Cross Section

The existing culvert at driveway # 40 has failed and has no bottom plate. Water is piping around and under the existing pipe and is at risk for collapse from heavy vehicles. Culvert should be replaced with a 24" diameter HPDE culvert with **sufficient length** to armor both inlet and outlet ends with 4-6" riprap stone. To capture any eroded gravel or sediment that gets through the culvert, before it reaches the lake, an 8' plunge pool should be constructed at the outlet end of the new pipe. This pool should have a bottom with a finished grade 12-14" below the bottom of the new culvert and be armored with 4-6" riprap for stabilization.

The new culvert should have a minimum of 12" of properly compacted cover material over the top of the pipe and needs to provide positive drainage along its length. If ledge is encountered and sufficient cover is not possible over the 24" culvert, a pair of 12" culverts can be substituted. This will not be as effective against freezing as the proposed, larger 24" culvert but will pass similar water volumes.
