Fatigue assessment – Akulon K224-G6 (PA6) at 8°C

Service life assessment – Akulon (PA6) at 23°C

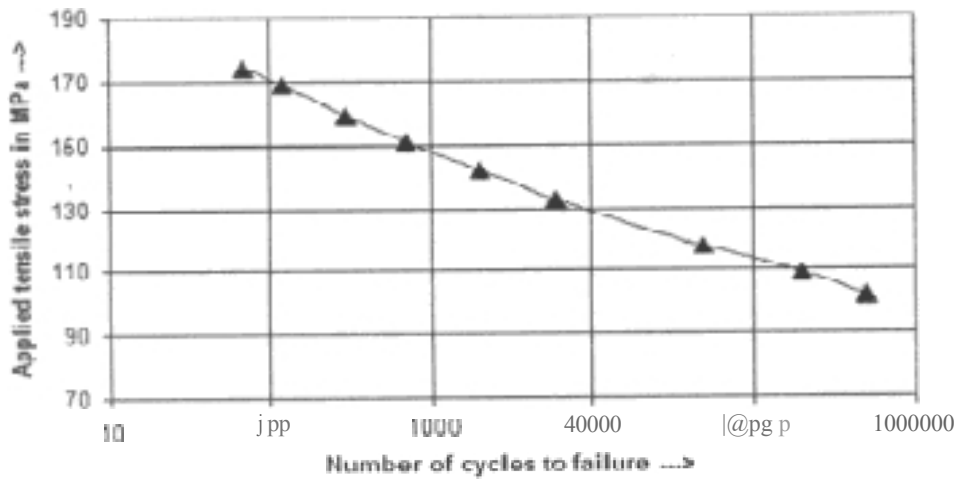
Fatigue curve (reference)

Fatigue life time of Akulon K224-G6 at 23°C

Fatigue assessment

At 10⁶ cycles: approx. 100 MPa
