# Test Report

**Reference No.**..... : WTH24H05109990P  
**Applicant**..... : Shenzhen Yuejiang Technology Co., Ltd.  
**Address**..... : Room 1003, Building 2, Chongwen Park, Nanshan iPark, No.3370,  
Liuxian Blvd, Fuguang Community, Taoyuan Street, Nanshan District,  
Shenzhen, China  
**Manufacturer**..... : Shenzhen Yuejiang Technology Co., Ltd.  
**Address**..... : Room 1003, Building 2, Chongwen Park, Nanshan iPark, No.3370,  
Liuxian Blvd, Fuguang Community, Taoyuan Street, Nanshan District,  
Shenzhen, China  
**Product Name**..... : Controller  
**Model No.**..... : DT-CC262-0A

**1.Test item: IP5X test**

## 2. Test item: IPX4 test

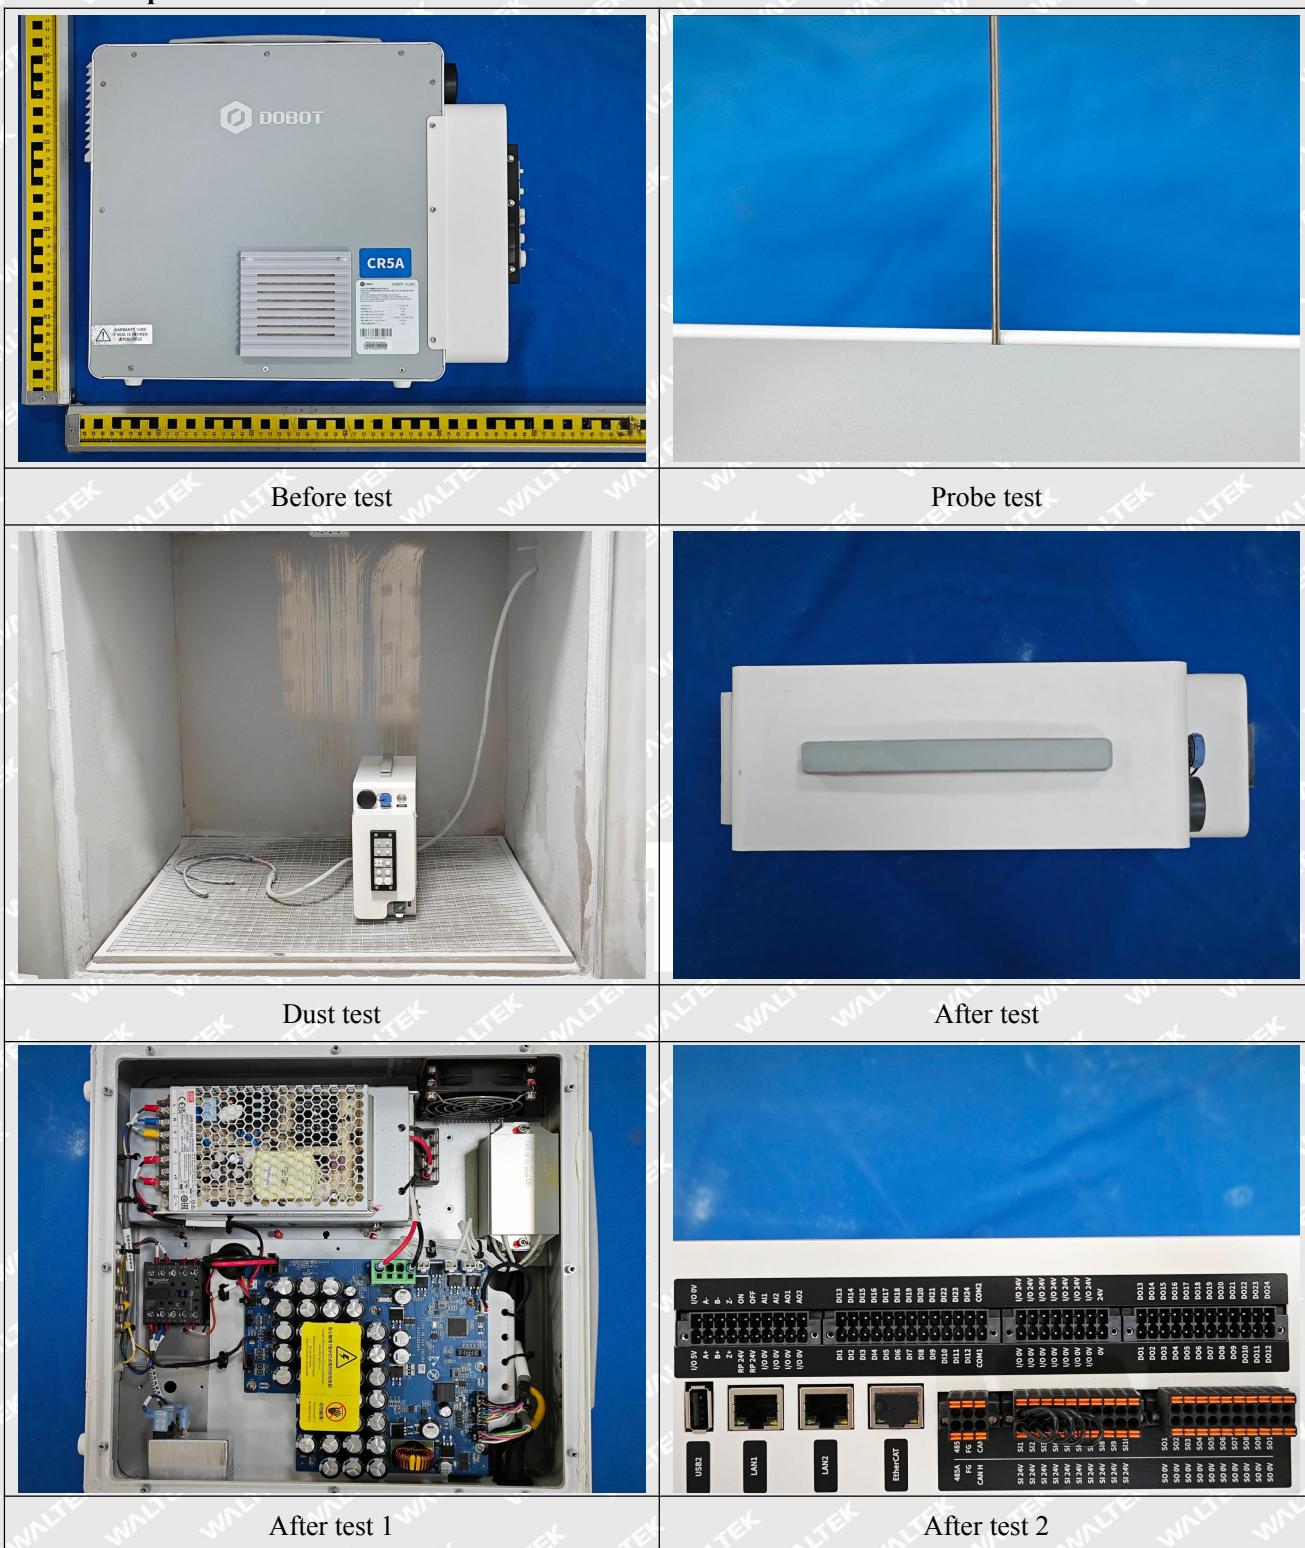
(7) Test photos:

- 1) The test prober of 1.0 mm diameter is pushed against any opening of the sample with force of 1 N;
- 2) After that, it was placed in a dust test chamber containing 2kg/m<sup>3</sup> talc for continuous testing for 8h.

| Sample No. | Sample Name | Test Results (Visual inspection) |
|---|---|---|
| S-01 | Controller | The probe cannot enter the inside of the sample;After testing, no dust entered the inside of the sample. |

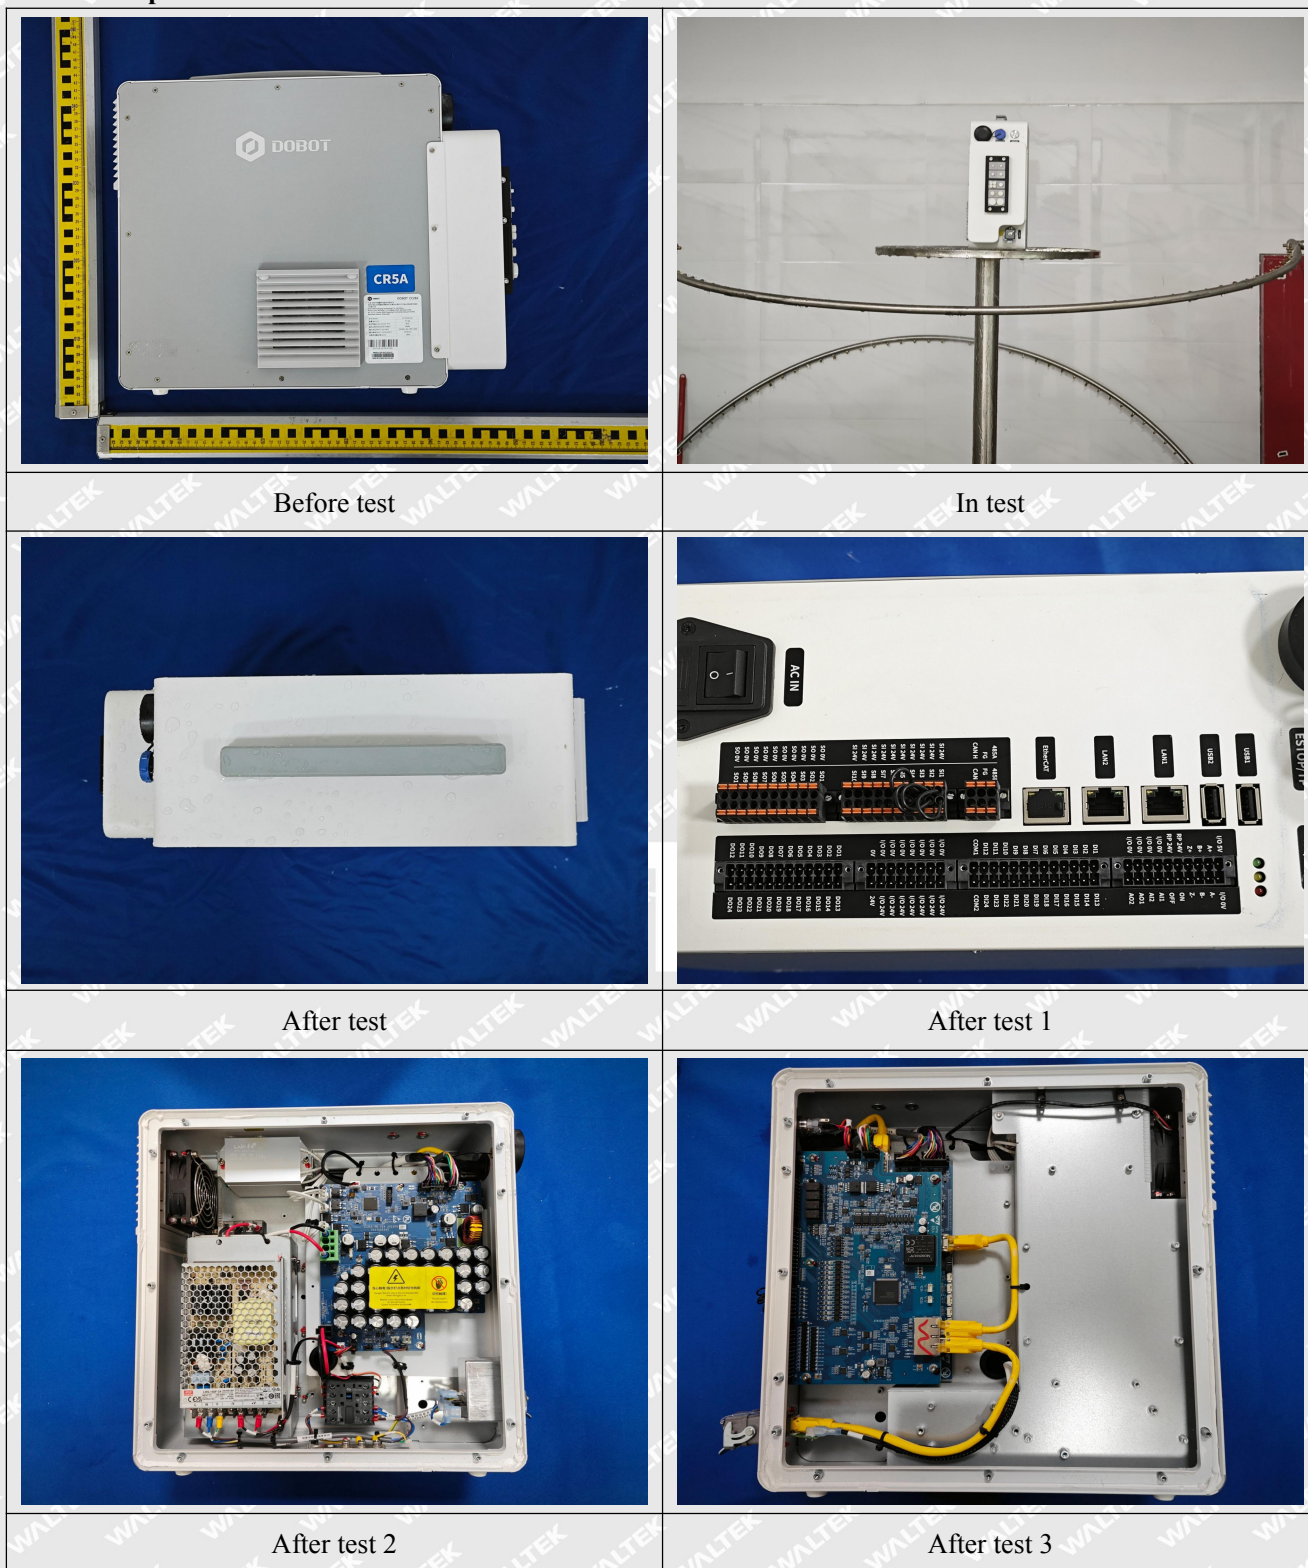
(7) Test photos:

- 1) Water flow: 3.5 L/min;
- 2) Turntable speed: 1 r/min;
- 3) Pendulum tube Angle:  $\pm 180^\circ$ ;
- 4) Pendulum tube radius: 800 mm;
- 5) Distance from sample to pendulum tube: 200 mm;
- 6) Test time: 10 min.

| Sample No. | Sample name | Test Results (Visual inspection) |
|---|---|---|
| S-02 | Controller | After the test, no water entered inside the sample. |
