# Test Report

**Reference No.**..... : WTH24H05109993P  
**Applicant**..... : Shenzhen Yuejiang Technology Co., Ltd.  
**Address**..... : Room 1003, Building 2, Chongwen Park, Nanshan iPark, No.3370,  
Liuxian Blvd, Fuguang Community, Taoyuan Street, Nanshan District,  
Shenzhen, China  
**Manufacturer**..... : Shenzhen Yuejiang Technology Co., Ltd.  
**Address**..... : Room 1003, Building 2, Chongwen Park, Nanshan iPark, No.3370,  
Liuxian Blvd, Fuguang Community, Taoyuan Street, Nanshan District,  
Shenzhen, China  
**Product Name**..... : Controller  
**Model No.**..... : DT-CC263-0A

## 1. Test item: IP5X test

## 2. Test item: IPX4 test

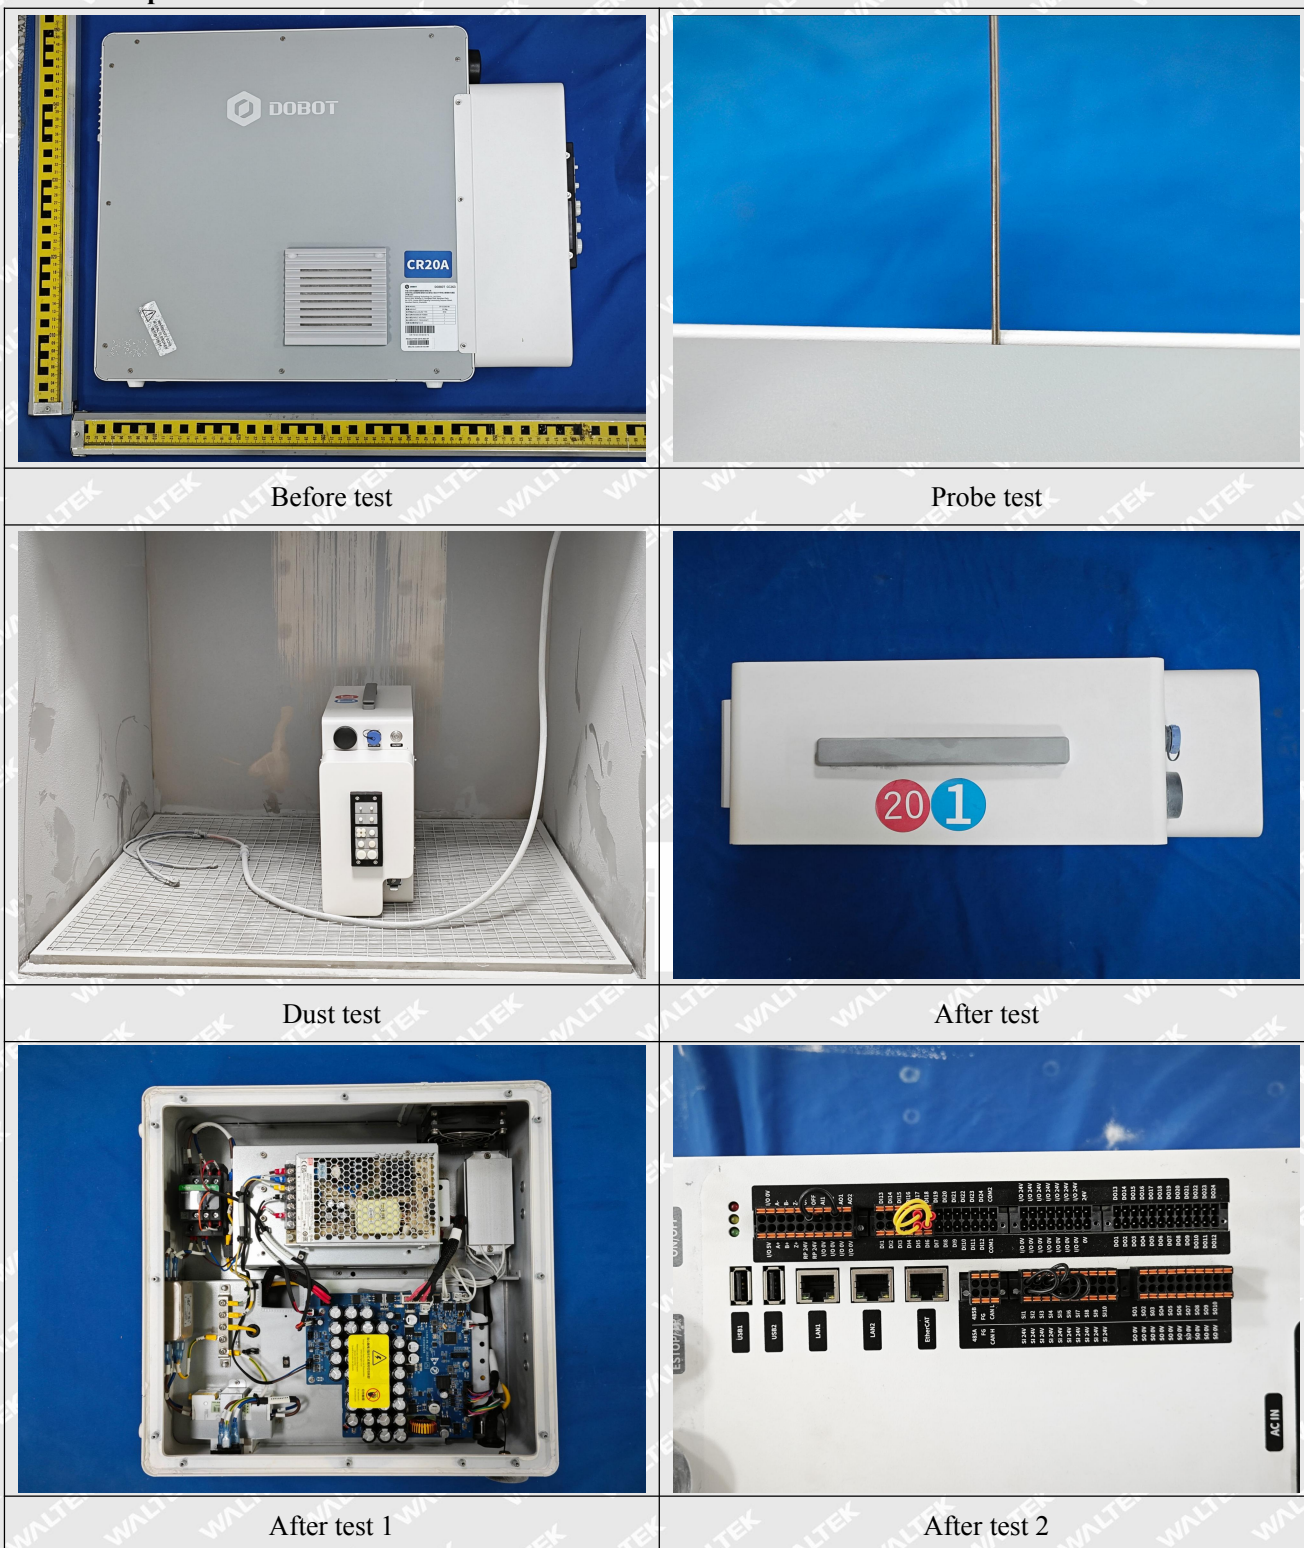
(7) Test photos:

- 1) The test prober of 1.0 mm diameter is pushed against any opening of the sample with force of 1 N;
- 2) After that, it was placed in a dust test chamber containing 2kg/m<sup>3</sup> talc for continuous testing for 8h.

| Sample No. | Sample Name | Test Results (Visual inspection) |
|---|---|---|
| S-01 | Controller | The probe cannot enter the inside of the sample; After testing, no dust entered the inside of the sample. |

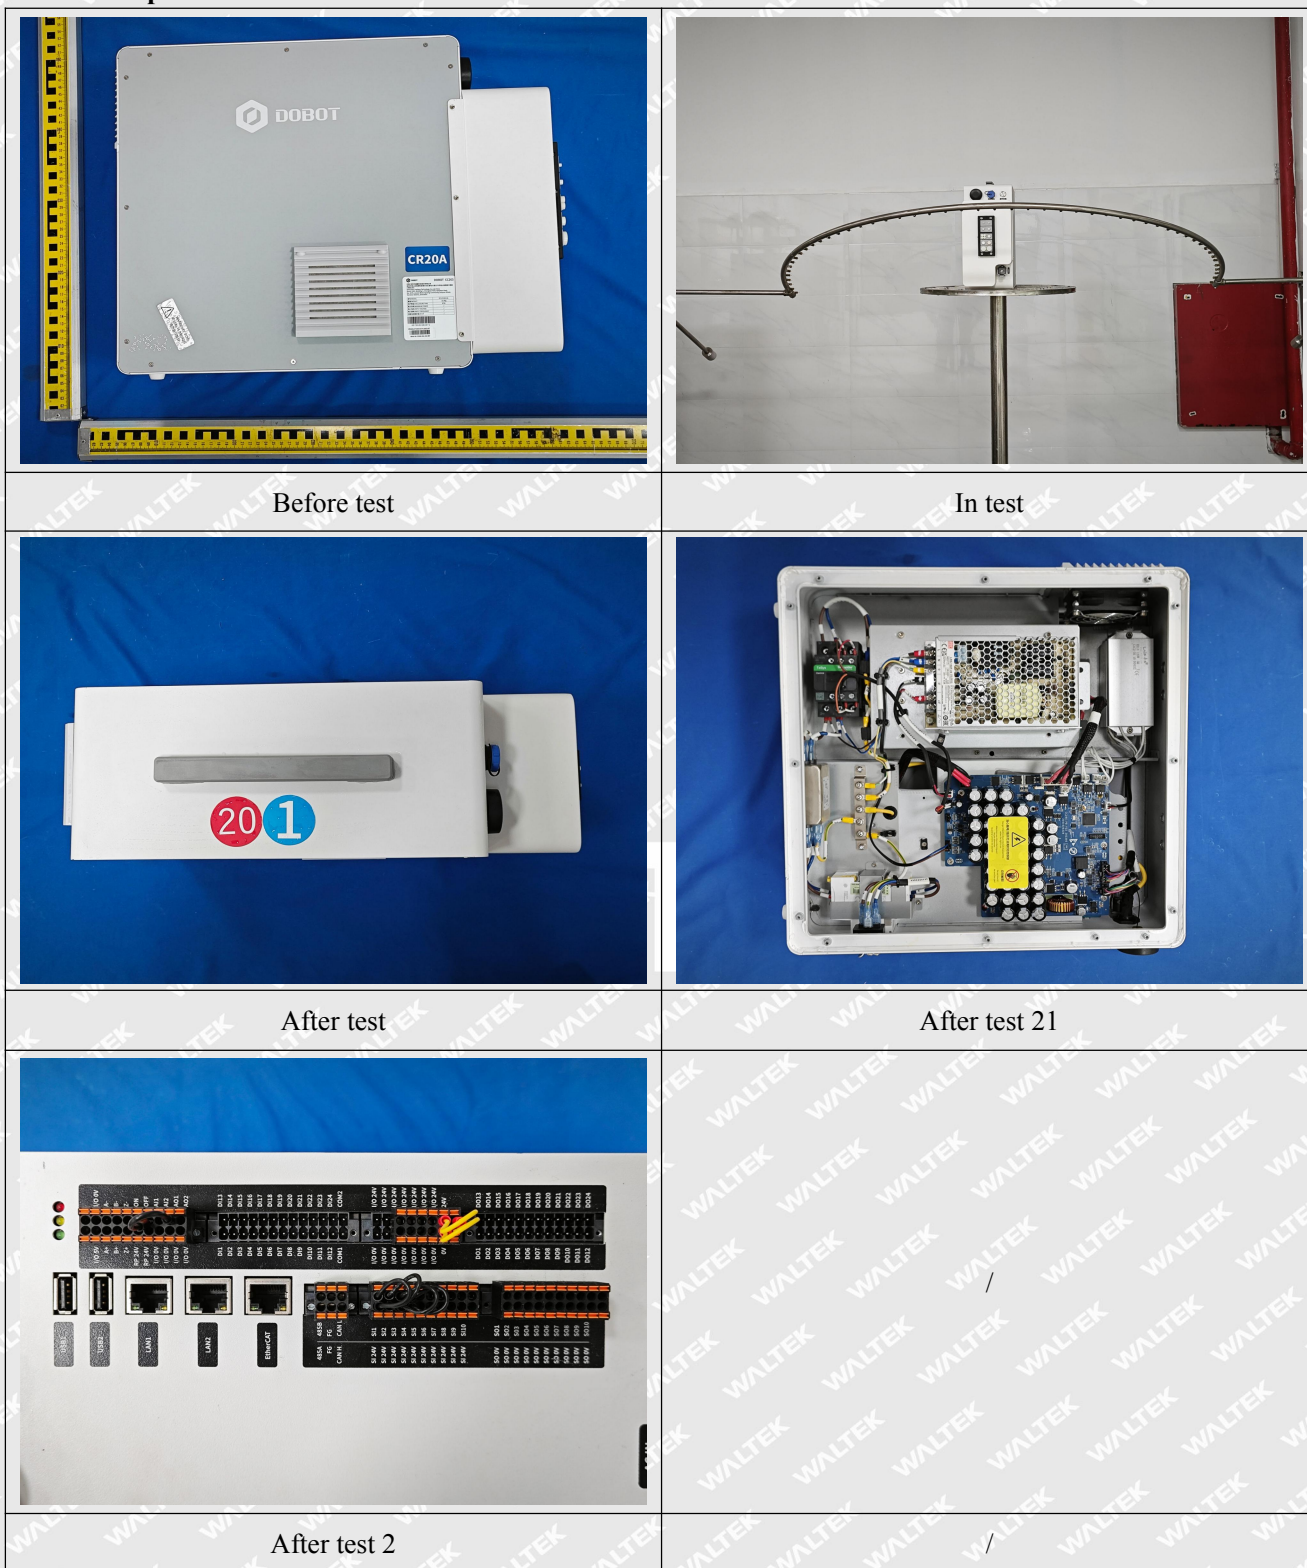
(7) Test photos:

- 1) Water flow: 3.5 L/min;
- 2) Turntable speed: 1 r/min;
- 3) Pendulum tube Angle:  $\pm 180^\circ$ ;
- 4) Pendulum tube radius: 800 mm;
- 5) Distance from sample to pendulum tube: 200 mm;
- 6) Test time: 10 min.

| Sample No. | Sample name | Test Results (Visual inspection) |
|---|---|---|
| S-01 | Controller | After the test, no water entered inside the sample. |
