X03.2 Manage Lead Hazards- 1: Lead assessment

Professional Narrative

WELL Building Standard™ version 2 (WELL v2™), Q4 2022 addenda

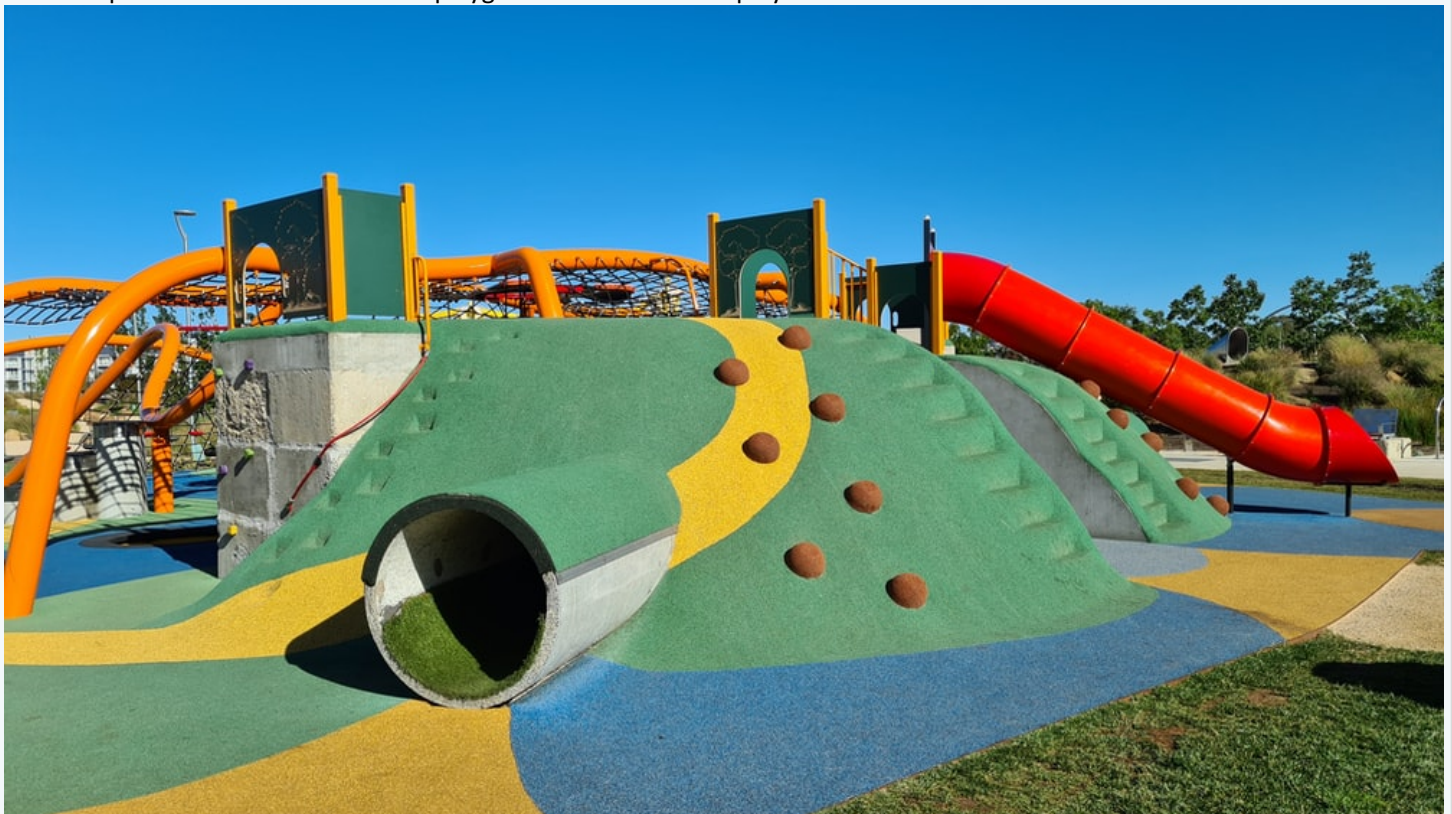
Here is a picture of the new lead-free playground with lead-free play surface:

- c. The playground area had loose-fill rubber from tires and the lead content was unknown. The lead testing specialist *[NAME AND COMPANY]* was also asked to take a sample of the turf fibers for testing (using an ISO certified testing protocol). The lead content was found to be 274 mg/lb, exceeding the WELL threshold of 136 mg/lb. The loose-fill rubber has been disposed of in compliance with local lead disposal regulations and replaced with a new lead-free playground play surface, see attached new product *[ATTACH PRODUCT DETAILS SHEET OR INSERT LINK TO PRODUCT DETAILS WEBSITE, HIGHLIGHT WHERE IT CLARIFIES THAT IT IS LEAD-FREE]*.

- d. Paint on the playground equipment was old and it was unknown what brand it was. The lead testing specialist *[NAME AND COMPANY]* was also asked to take a paint chip and test it for lead. The lab used World Health Organization(WHO) guidelines to measure the lead content in the paint chip. The lead content was greater than the WELL threshold of 90ppm. The project team decided to remove all of the playground equipment and replace it with lead-free state of the art equipment. The old playground equipment was disposed of in compliance with local laws *[ATTACH A COPY OF LOCAL REGULATIONS.]* A product data sheet confirming that the new equipment is lead-free is attached *[ATTACH PRODUCT DETAILS SHEET OR INSERT LINK TO PRODUCT DETAILS WEBSITE, HIGHLIGHT WHERE IT CLARIFIES THAT IT IS LEAD-FREE.]*
